Minnesota Airport System Pavement Evaluation 2012 Update

Redwood Falls Municipal Airport (RWF)

Redwood Falls, Minnesota

Final Report

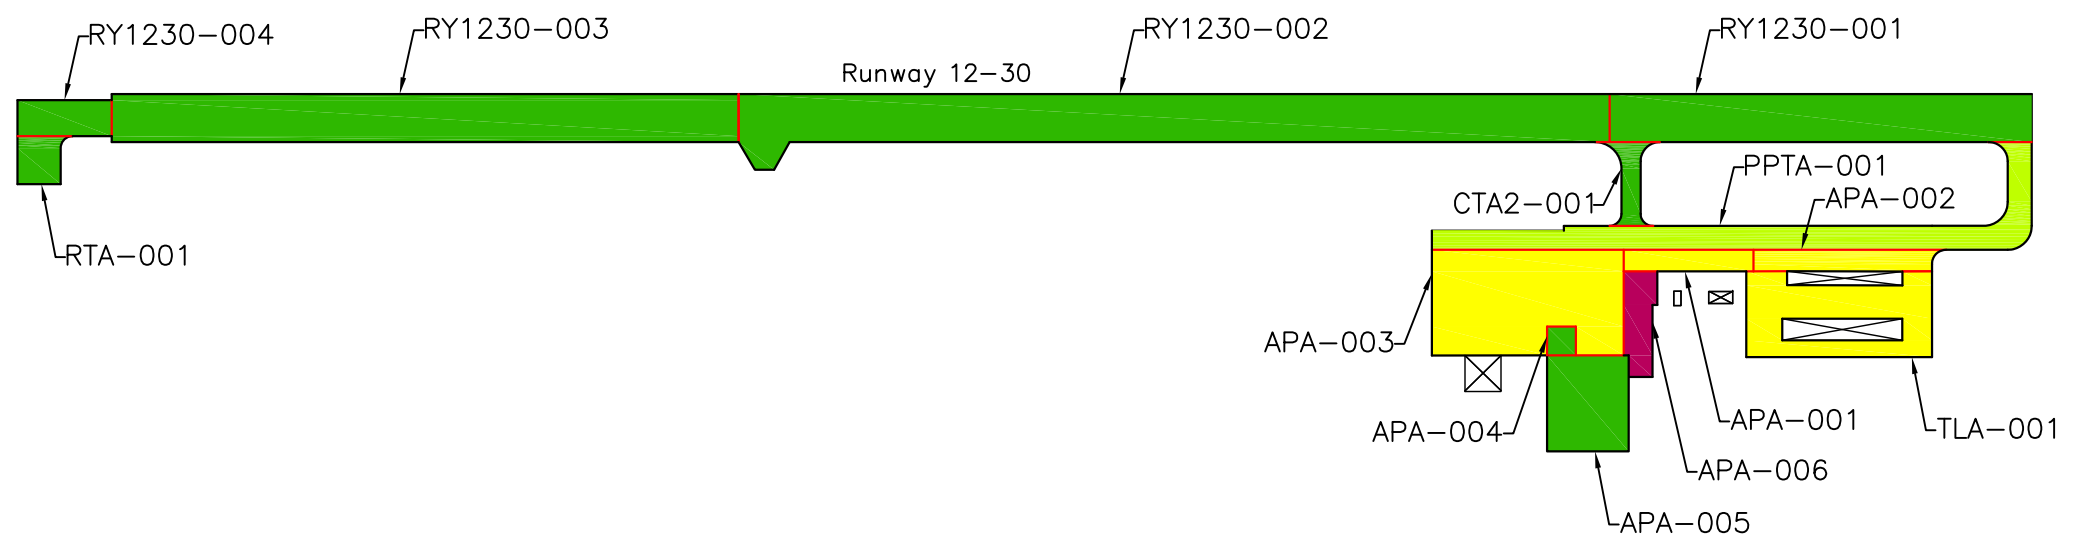
Figure 4. 2012 Pavement Condition Index Rating at Redwood Falls Municipal Airport (RWF).

The results of the 2012 PCI inspection are presented in figure 4. The overall area-weighted PCI for RWF is 79. When summarizing PCI values, an area-weighted calculation is used instead of a straight mathematical average because the area-weighted calculations eliminate the skewing of the PCI due to the disparity of the section sizes.
