# Minnesota Airport System Pavement Evaluation 2012 Update

St. Cloud Regional Airport (STC)

*Final Report*

Applied Research Associates, Inc.  
100 Trade Centre Dr., Suite 200  
Champaign, IL 61820  
(217) 356-4500

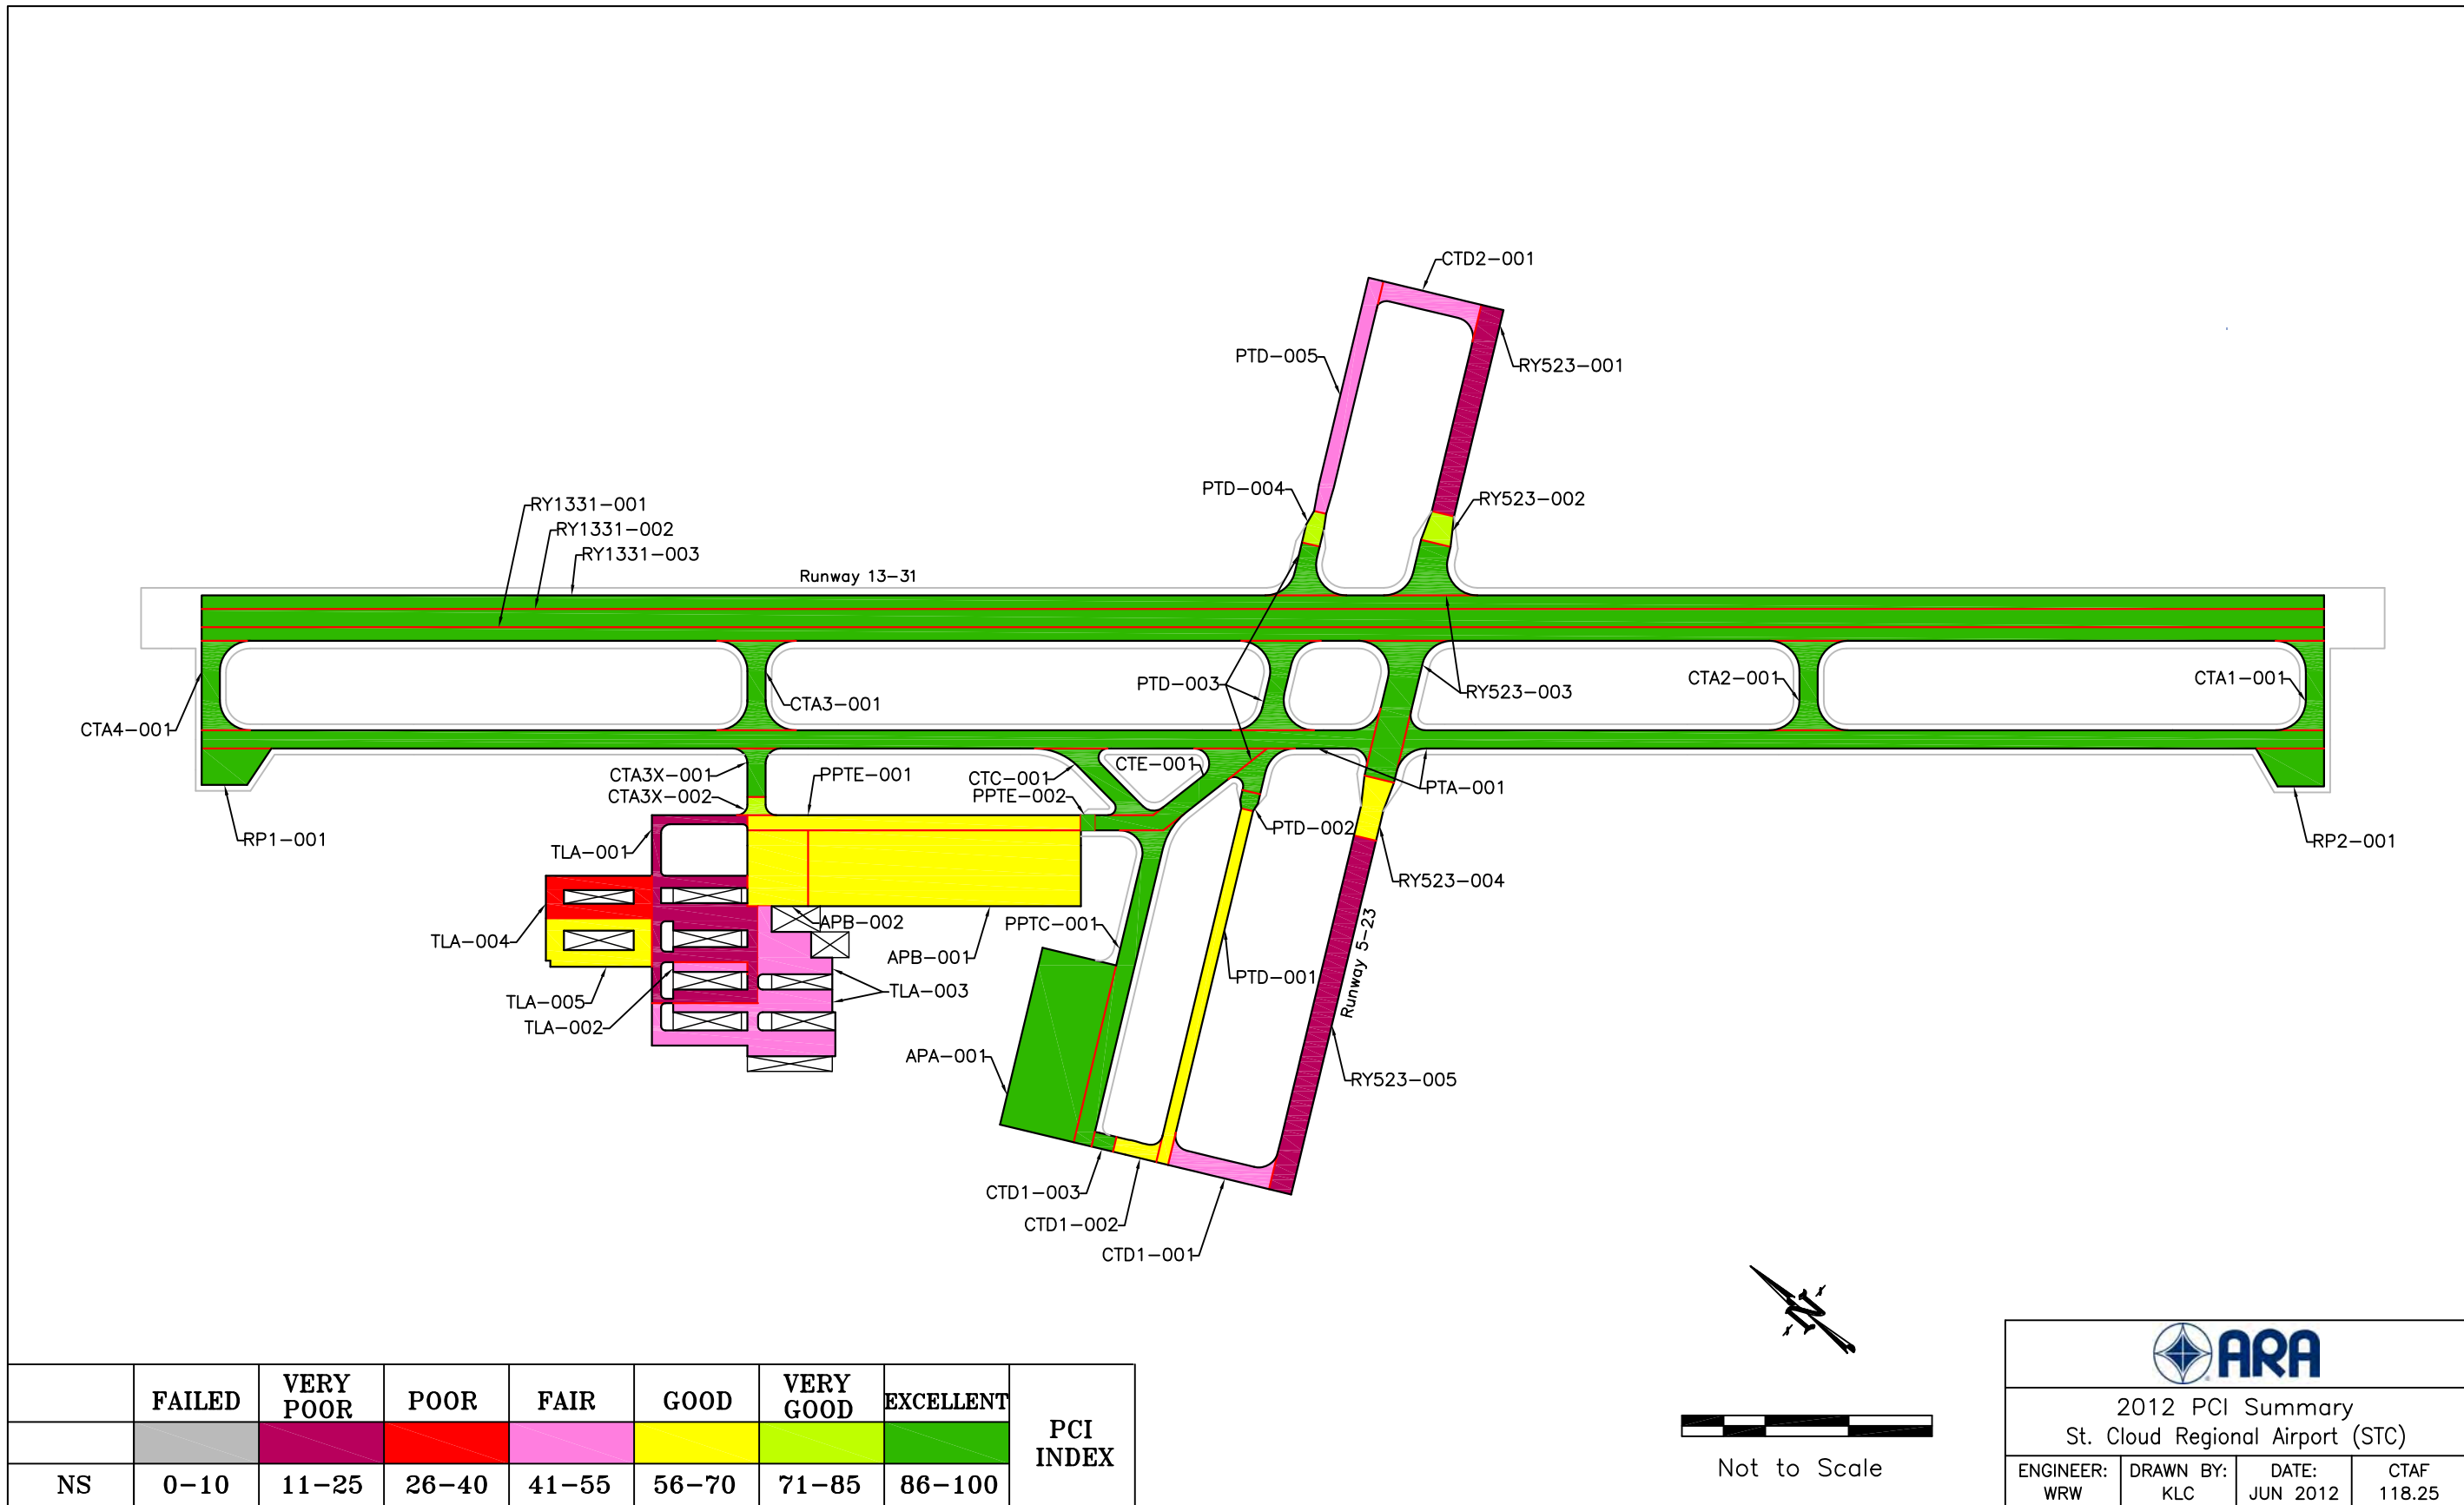
Figure 4. 2012 Pavement Condition Index Rating at St. Cloud Regional Airport (STC).

The results of the 2012 PCI inspection are presented in figure 4. The overall area-weighted PCI for STC is 81. When summarizing PCI values, an area-weighted calculation is used instead of a straight mathematical average because the area-weighted calculations eliminate the skewing of the PCI due to the disparity of the section sizes.

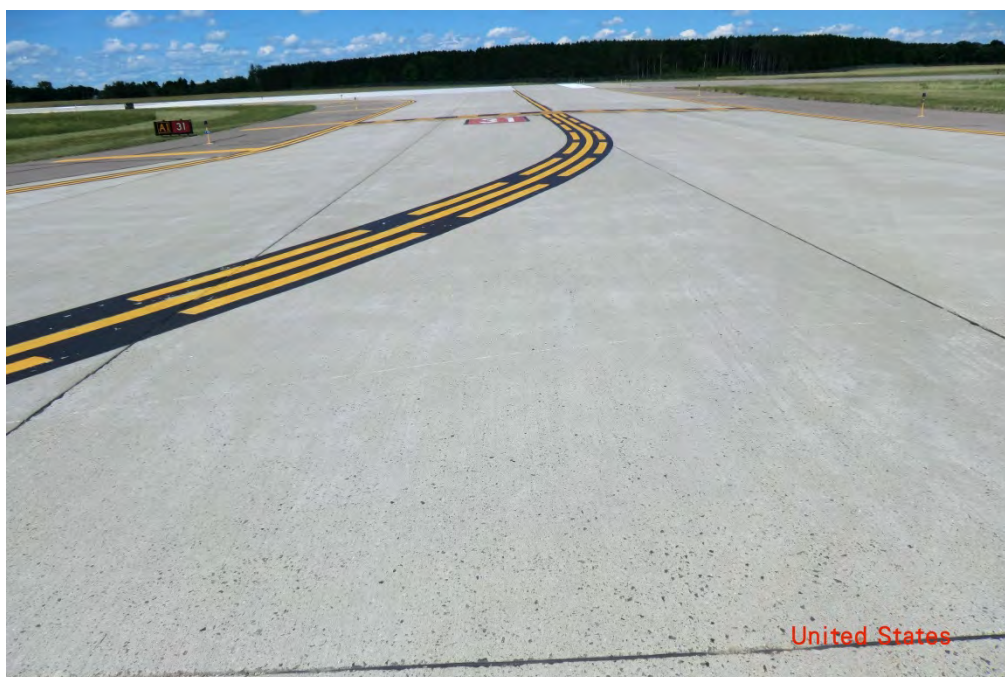
STC CTA1 001 (PCI = 97)

| Branch ID | Section ID | Surface type <sup>1</sup> | Section area (SF) | LCD <sup>2</sup> | 2009 PCI | 2012 PCI | Drop in PCI/Yr <sup>3</sup> | % Deduct due to | | Distress types |
|---|---|---|---|---|---|---|---|---|---|--|
| CTA1 | 1 | PCC | 20,400 | 2001 | 100 | 97 | 0.3 | 0 | 0 | Joint spalling |

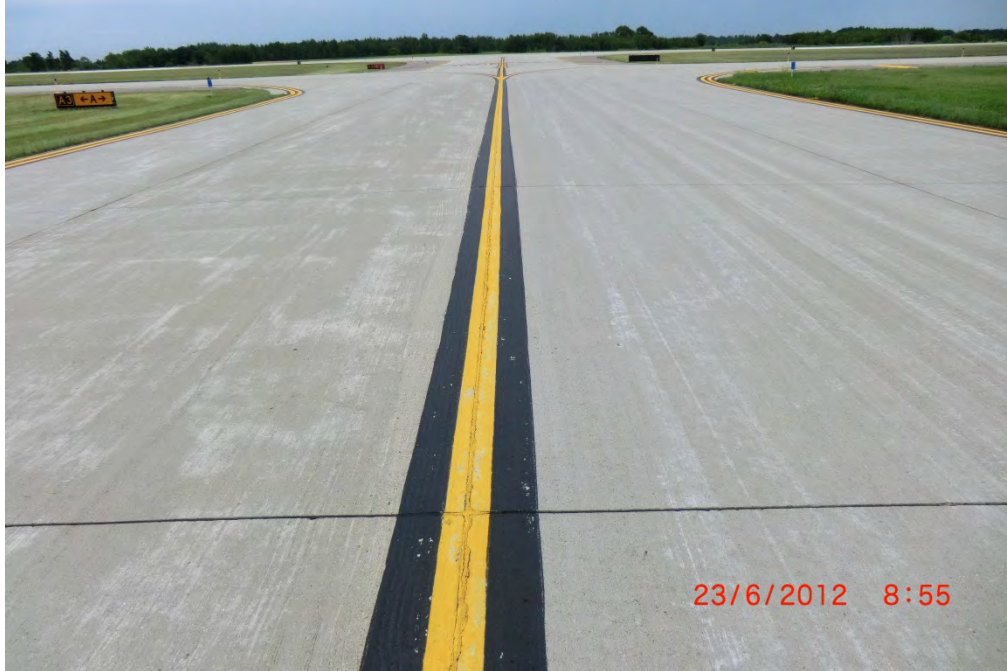
STC CTA3X 001 (PCI = 89)

| Branch ID | Section ID | Surface type <sup>1</sup> | Section area (SF) | LCD <sup>2</sup> | 2009 PCI | 2012 PCI | Drop in PCI/Yr <sup>3</sup> | % Deduct due to | | Distress types |
|---|---|---|---|---|---|---|---|---|---|--|
| CTA3X | 1 | PCC | 10,700 | 2001 | 90 | 89 | 1.0 | 0 | 66 | Joint seal damage, shrinkage cracking |

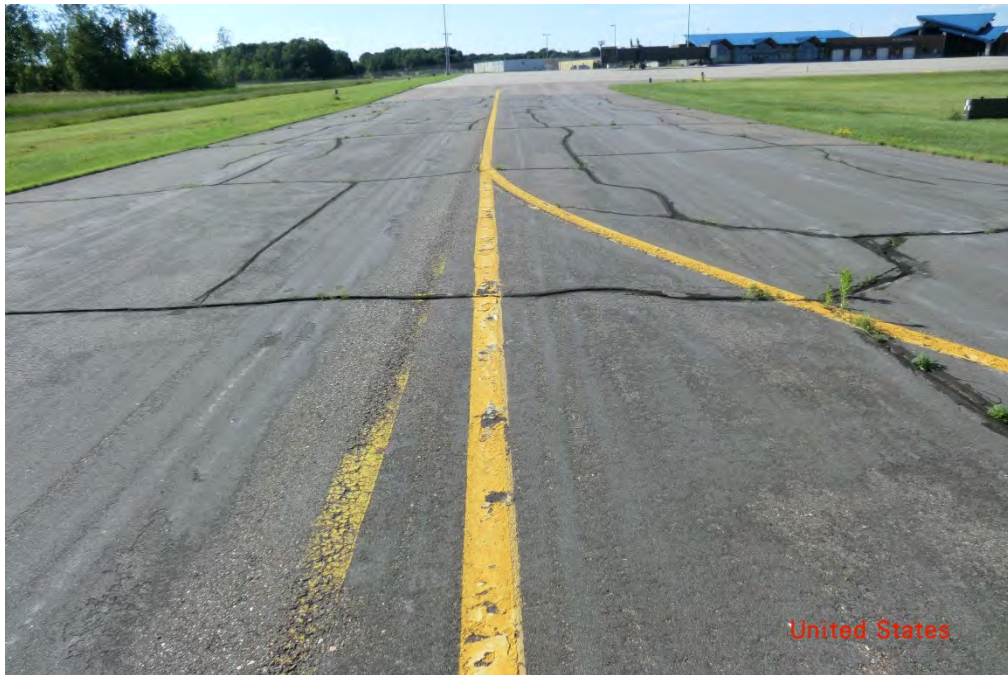
STC CTD1 002 (PCI = 61)

| Branch ID | Section ID | Surface type <sup>1</sup> | Section area (SF) | LCD <sup>2</sup> | 2009 PCI | 2012 PCI | Drop in PCI/Yr <sup>3</sup> | % Deduct due to | | Distress types |
|---|---|---|---|---|---|---|---|---|---|--|
| CTD1 | 2 | AC | 7,435 | 1985 | 63 | 61 | 1.4 | 22 | 78 | Alligator cracking, L&T cracking, raveling |

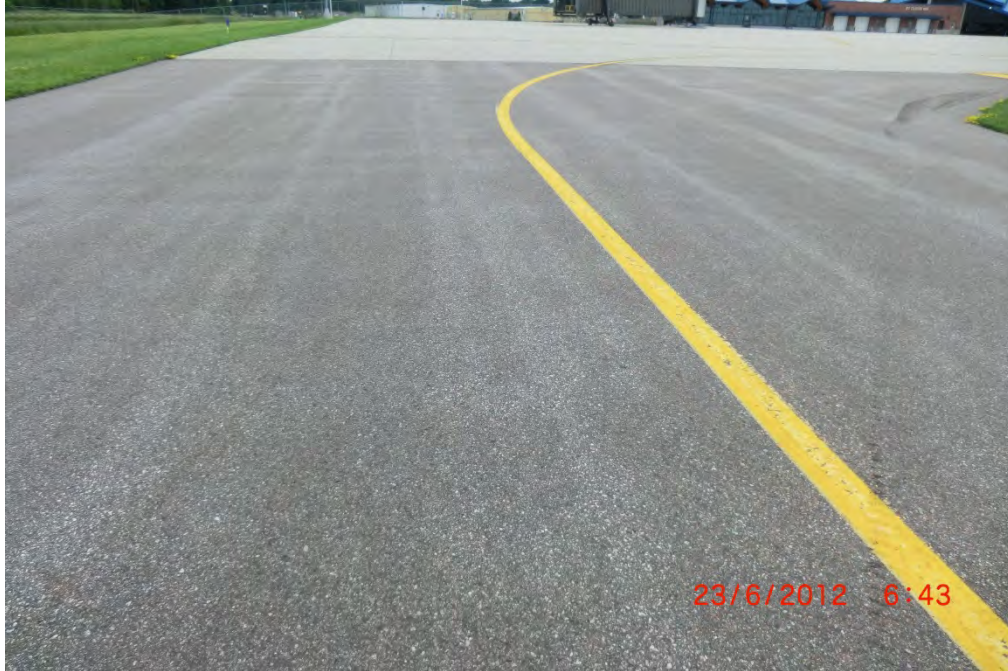
STC CTD1 003 (PCI = 86)

| Branch ID | Section ID | Surface type <sup>1</sup> | Section area (SF) | LCD <sup>2</sup> | 2009 PCI | 2012 PCI | Drop in PCI/Yr <sup>3</sup> | % Deduct due to | | Distress types |
|---|---|---|---|---|---|---|---|---|---|--|
| CTD1 | 3 | AC | 3,750 | 2001 | 92 | 86 | 1.3 | 0 | 100 | L&T cracking, raveling |

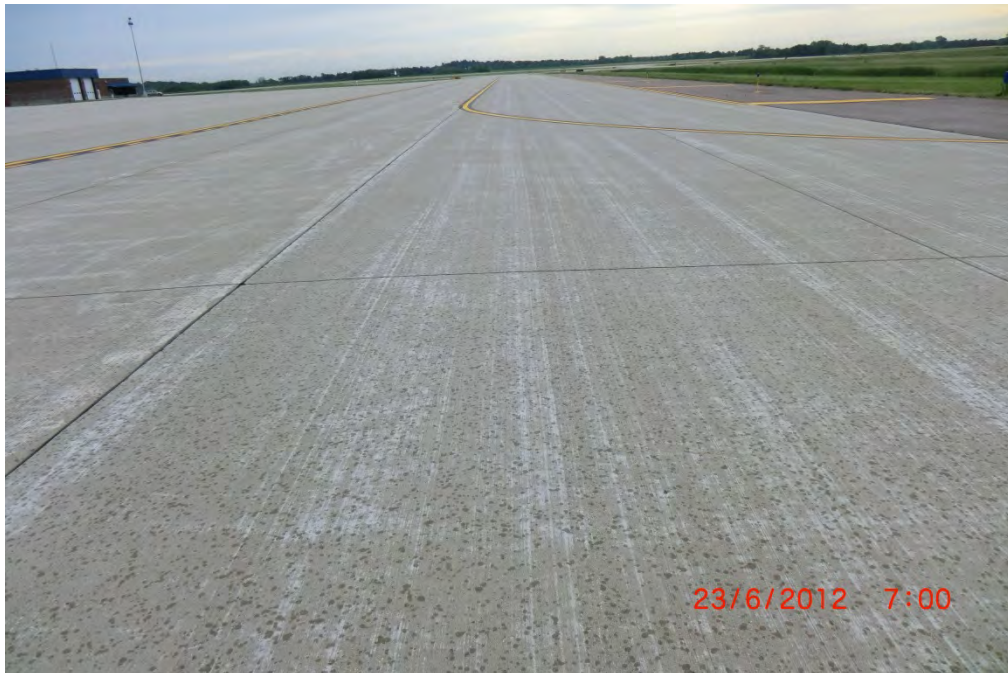
STC PPTC 001 (PCI = 98)

| Branch ID | Section ID | Surface type <sup>1</sup> | Section area (SF) | LCD <sup>2</sup> | 2009 PCI | 2012 PCI | Drop in PCI/Yr <sup>3</sup> | % Deduct due to | | Distress types |
|---|---|---|---|---|---|---|---|---|---|--|
| PPTC | 1 | PCC | 64,950 | 2001 | 98 | 98 | 0.2 | 0 | 58 | Joint seal damage, corner spalling |

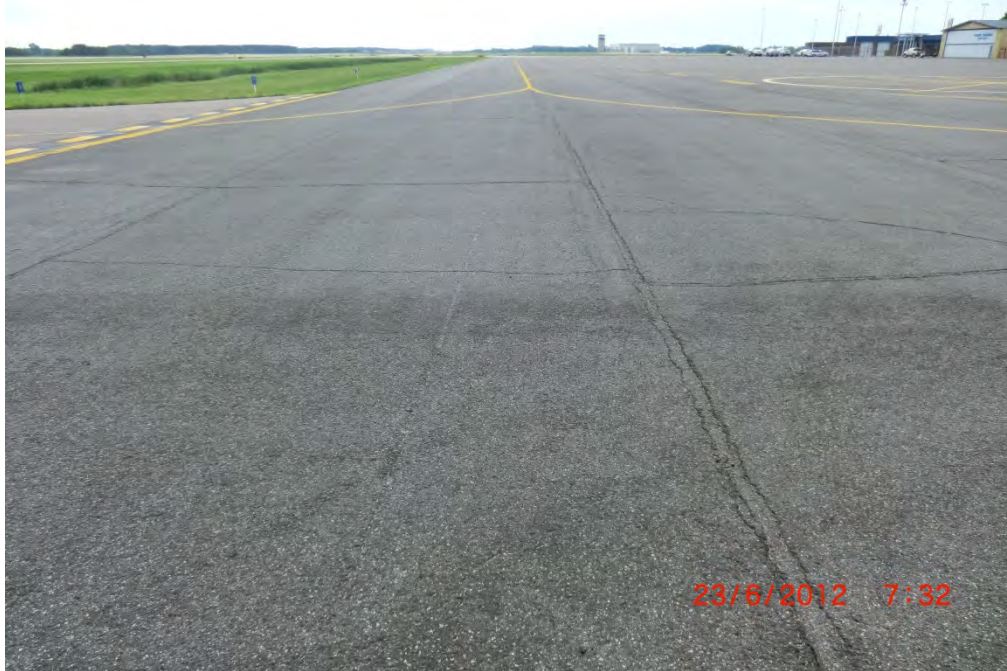
STC PPTE 001 (PCI = 70)

| Branch ID | Section ID | Surface type <sup>1</sup> | Section area (SF) | LCD <sup>2</sup> | 2009 PCI | 2012 PCI | Drop in PCI/Yr <sup>3</sup> | % Deduct due to | | Distress types |
|---|---|---|---|---|---|---|---|---|---|--|
| PPTE | 1** | AC | 55,000 | 1985 | 52 | 70 | 1.1 | 0 | 100 | L&T cracking |

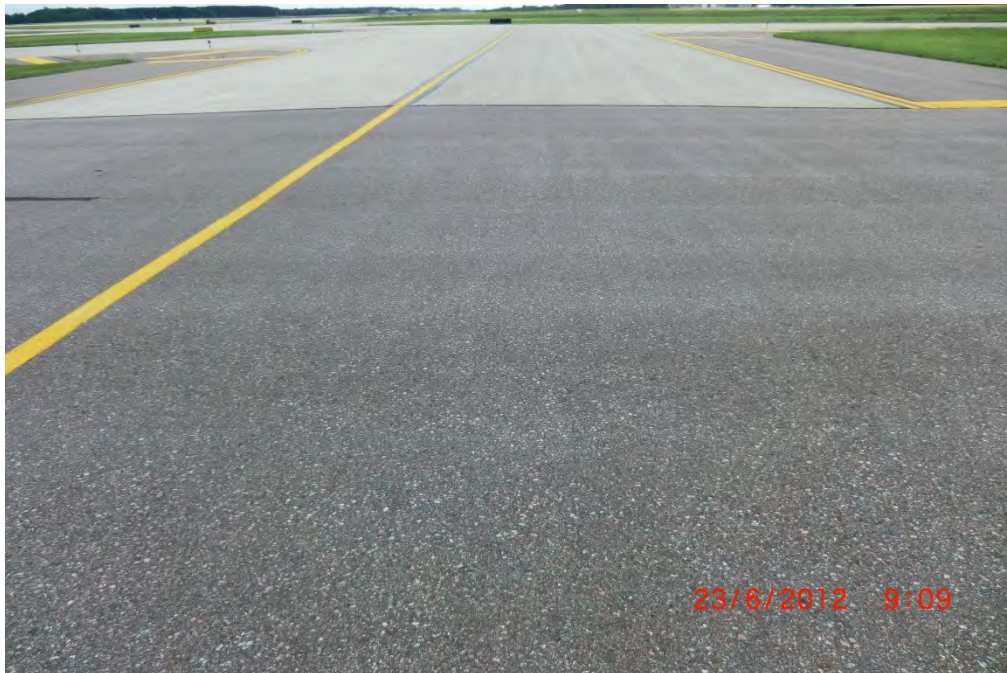
STC PPTE 002 (PCI = 95)

| Branch ID | Section ID | Surface type <sup>1</sup> | Section area (SF) | LCD <sup>2</sup> | 2009 PCI | 2012 PCI | Drop in PCI/Yr <sup>3</sup> | % Deduct due to | | Distress types |
|---|---|---|---|---|---|---|---|---|---|--|
| PPTE | 2 | AAC | 2,820 | 2001 | n/a | 95 | 0.5 | 0 | 100 | L&T cracking |

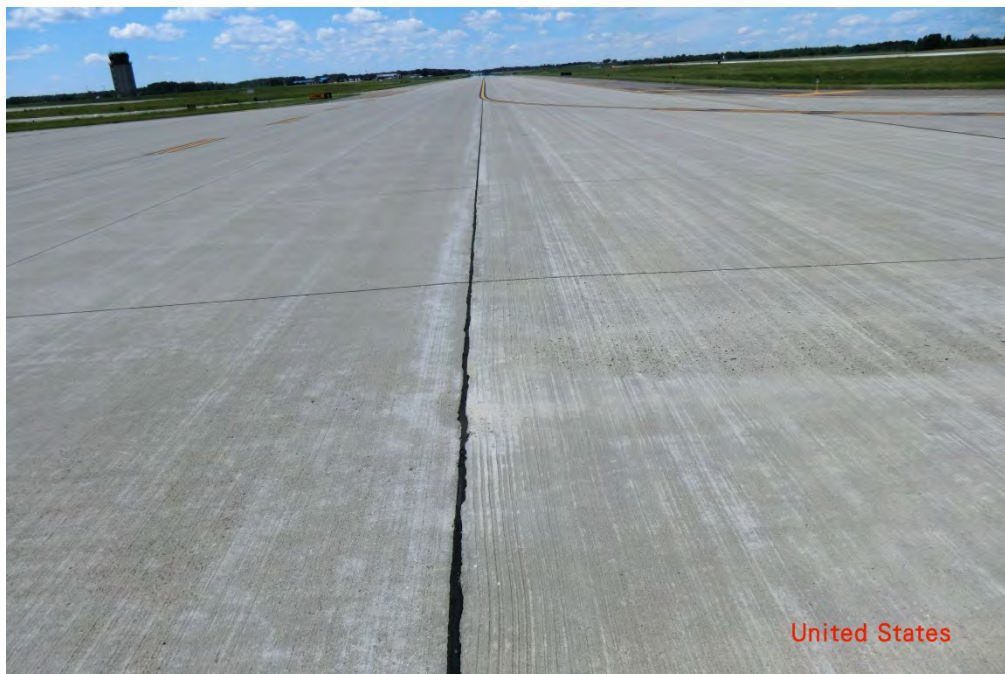
STC PTA 001 (PCI = 100)

| Branch ID | Section ID | Surface type <sup>1</sup> | Section area (SF) | LCD <sup>2</sup> | 2009 PCI | 2012 PCI | Drop in PCI/Yr <sup>3</sup> | % Deduct due to | | Distress types |
|---|---|---|---|---|---|---|---|---|---|--|
| PTA | 1 | PCC | 415,500 | 2001 | 100 | 100 | 0.0 | 0 | 0 | Corner spalling |

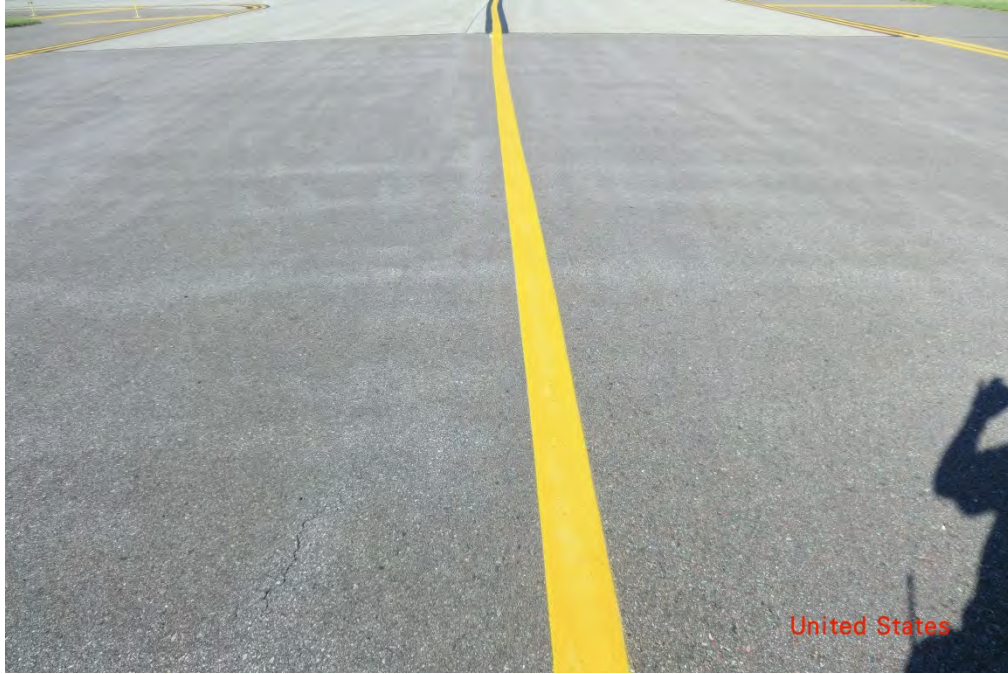
STC PTD 002 (PCI = 88)

| Branch ID | Section ID | Surface type <sup>1</sup> | Section area (SF) | LCD <sup>2</sup> | 2009 PCI | 2012 PCI | Drop in PCI/Yr <sup>3</sup> | % Deduct due to | | Distress types |
|---|---|---|---|---|---|---|---|---|---|--|
| PTD | 2 | AAC | 2,820 | 2001 | n/a | 88 | 1.1 | 0 | 100 | L&T cracking |

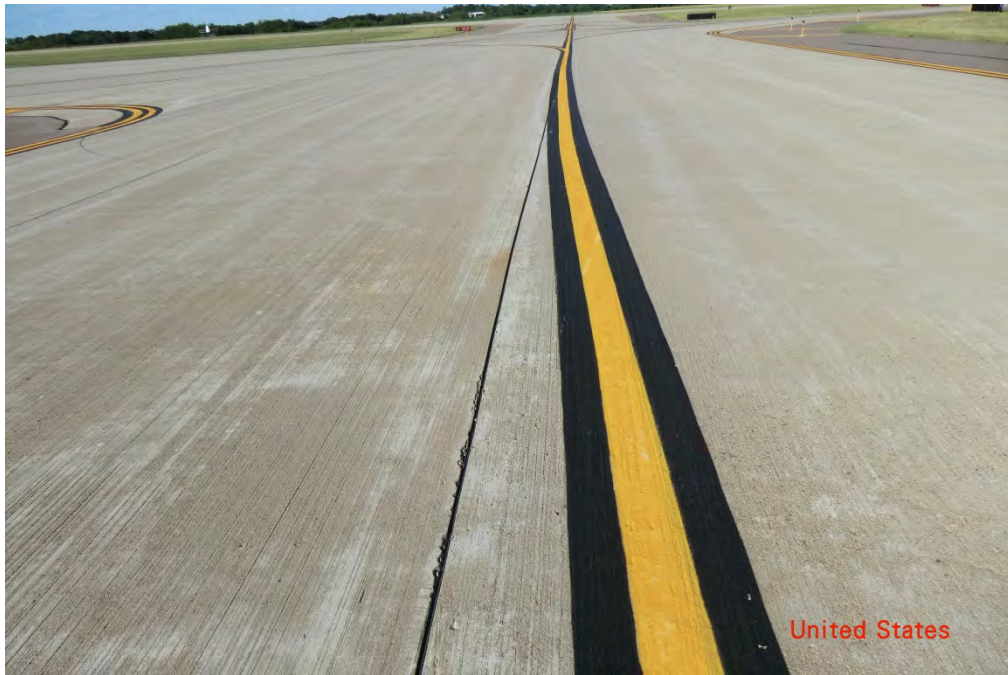
STC PTD 003 (PCI = 99)

| Branch ID | Section ID | Surface type <sup>1</sup> | Section area (SF) | LCD <sup>2</sup> | 2009 PCI | 2012 PCI | Drop in PCI/Yr <sup>3</sup> | % Deduct due to | | Distress types |
|---|---|---|---|---|---|---|---|---|---|--|
| PTD | 3 | PCC | 51,000 | 2001 | 100 | 99 | 0.1 | 0 | 0 | Joint spalling |

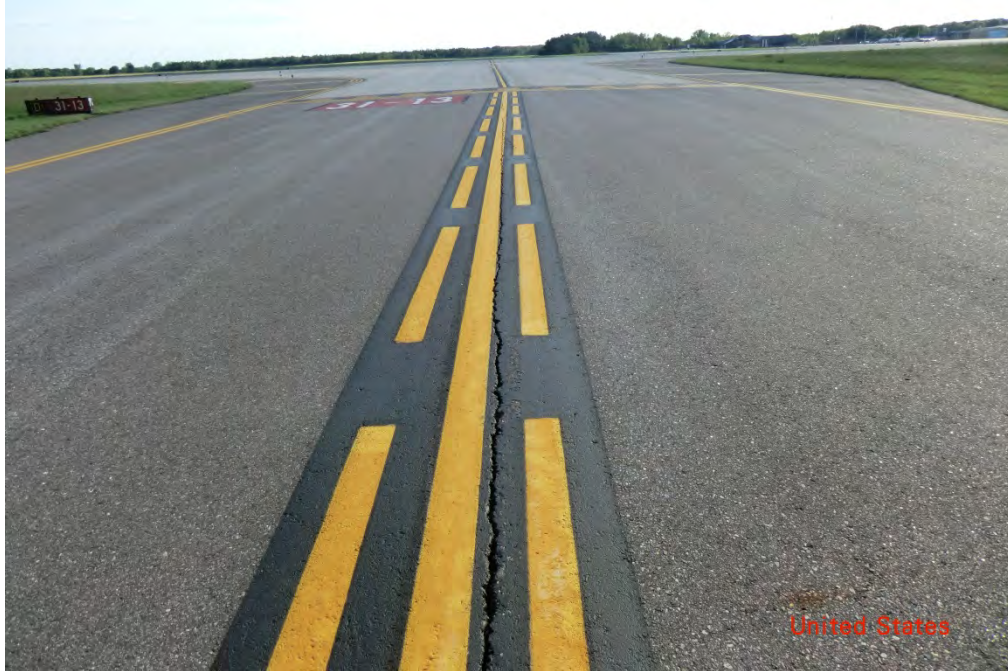
STC PTD 004 (PCI = 81)

| Branch ID | Section ID | Surface type <sup>1</sup> | Section area (SF) | LCD <sup>2</sup> | 2009 PCI | 2012 PCI | Drop in PCI/Yr <sup>3</sup> | % Deduct due to | | Distress types |
|---|---|---|---|---|---|---|---|---|---|--|
| PTD | 4 | AC | 6,050 | 2001 | 82 | 81 | 1.7 | 0 | 100 | L&T cracking |

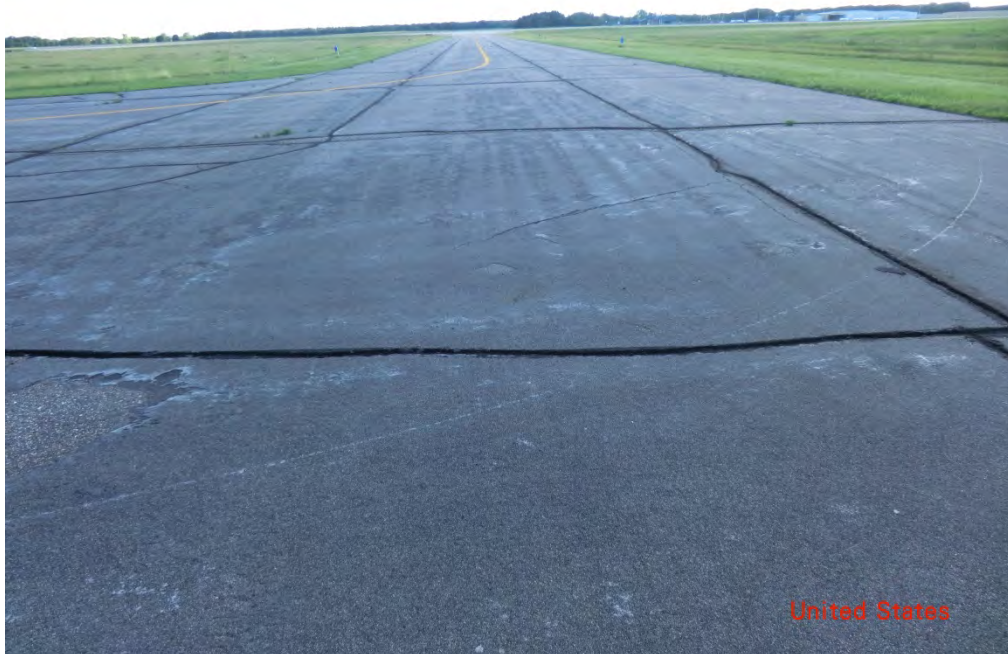
STC PTD 005 (PCI = 54)

| Branch ID | Section ID | Surface type <sup>1</sup> | Section area (SF) | LCD <sup>2</sup> | 2009 PCI | 2012 PCI | Drop in PCI/Yr <sup>3</sup> | % Deduct due to | | Distress types |
|---|---|---|---|---|---|---|---|---|---|--|
| PTD | 5 | AC | 40,000 | 1985 | 53 | 54 | 1.7 | 17 | 83 | Alligator cracking, L&T cracking, patching, raveling |

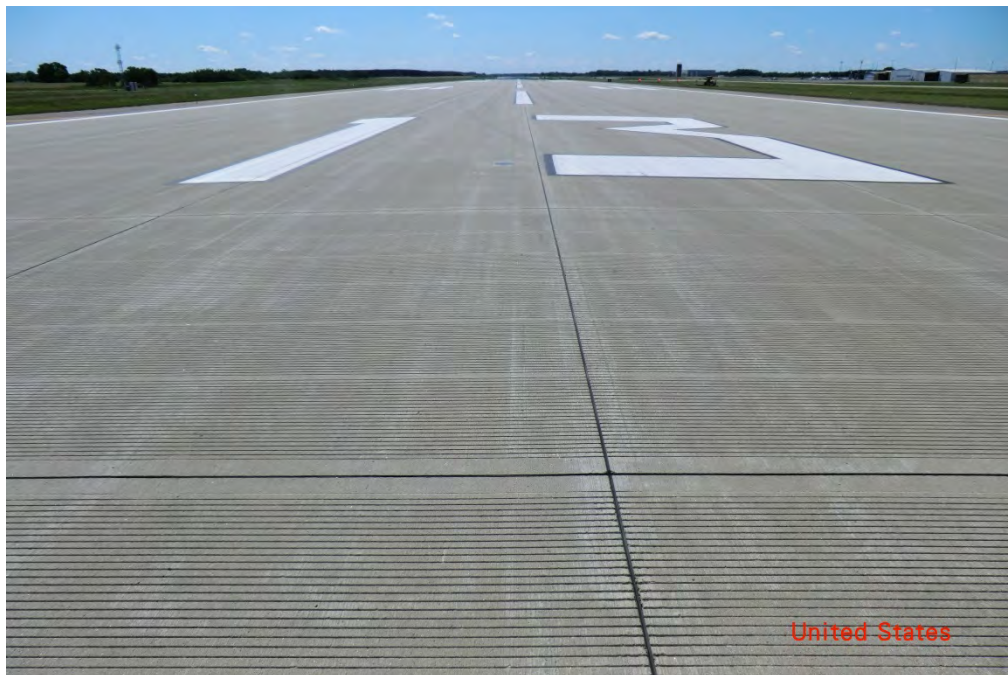
STC RY1331 001 (PCI = 98)

| Branch ID | Section ID | Surface type <sup>1</sup> | Section area (SF) | LCD <sup>2</sup> | 2009 PCI | 2012 PCI | Drop in PCI/Yr <sup>3</sup> | % Deduct due to | | Distress types |
|---|---|---|---|---|---|---|---|---|---|--|
| RY1331 | 1 | PCC | 350,000 | 2001 | 97 | 98 | 0.2 | 0 | 0 | Joint spalling, corner spalling |

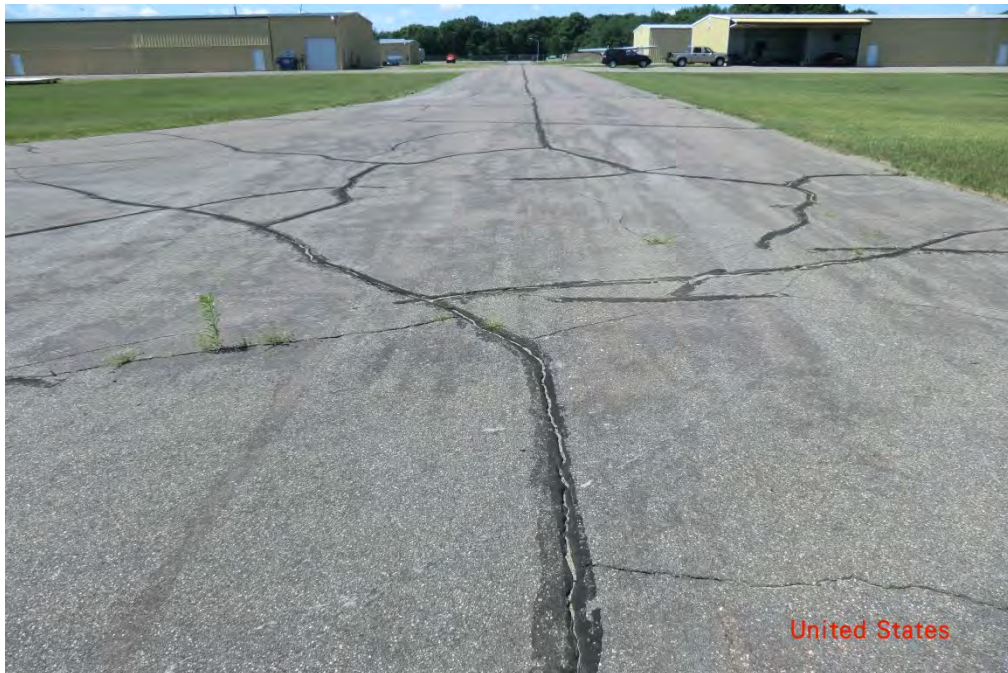
STC TLA 001 (PCI = 20)

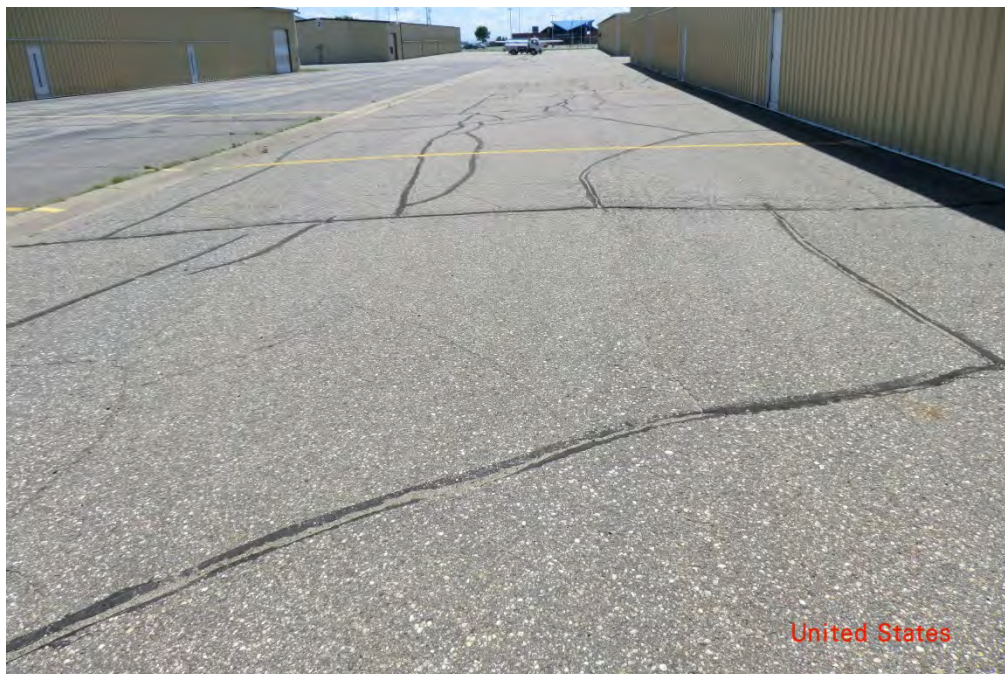
STC TLA 003 Depression, (PCI = 48)

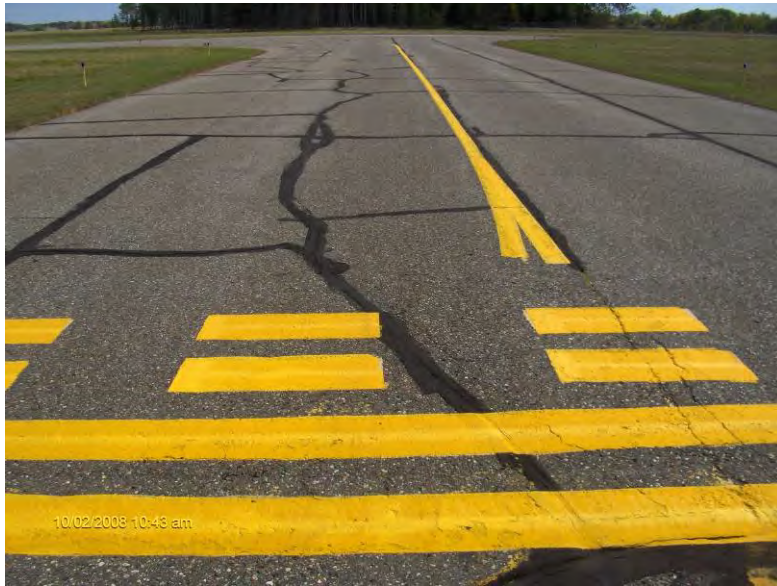
### *Example of Longitudinal and Transverse Cracking (L&T cracking)*

Longitudinal and transverse cracks are caused by pavement aging, by construction, and by subsurface movement. Aging occurs as pavement loses some of its components to the atmosphere and becomes more brittle. Consistent application of pavement sealcoats can help to prevent the occurrence of age related cracks. Cracks will also develop along poorly constructed paving lane joints. Ensuring that joints are made when both sides are still hot, and near the same temperature, is one of the best ways to mitigate this potential problem. Seasonal movement caused by changes in moisture content or temperature differences can also cause pavement cracks. Asphalt pavement placed over a PCC pavement or cement stabilized base course may evidence reflective cracking from the underlying material. Longitudinal and transverse cracks are not caused by wheel loads, although traffic may worsen their condition.

Low severity longitudinal and transverse cracks are less than  $\frac{1}{4}$  inch wide, or if sealed with suitable filler material in satisfactory condition can be any width, less than 3 inches, if they are not spalled. Maintenance usually is not indicated for low-severity cracking. Moderately spalled cracks and cracks wider than  $\frac{1}{4}$  inch which are not satisfactorily sealed are at medium severity. Medium-severity cracks should be sealed with a high-quality crack filling material. Severely spalled cracks and cracks wider than 3 inches are at high severity. High-severity L&T cracks normally require patching.

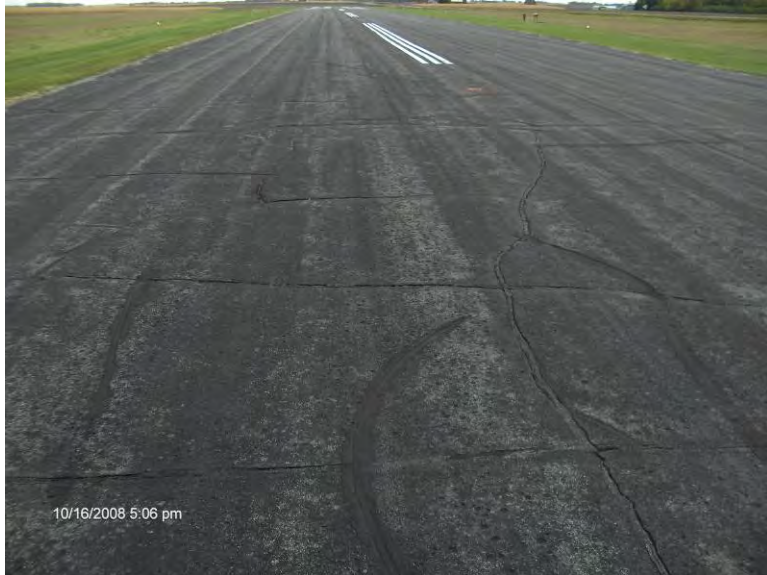
### ***Example of Block Cracking***

Block cracking is longitudinal and transverse cracking that has established a pattern of blocks ranging in size from 1ft x 1ft to 10ft x 10ft. This distress typically happens in older asphalt pavements and is an indication that the bituminous binder has lost most of its flexibility. The severity determination is basically determined by the crack width criteria defined for longitudinal and transverse cracking. Crack sealing typically is used to repair block cracking; however, the amount of required sealant can be extensive due to the high density of cracks.

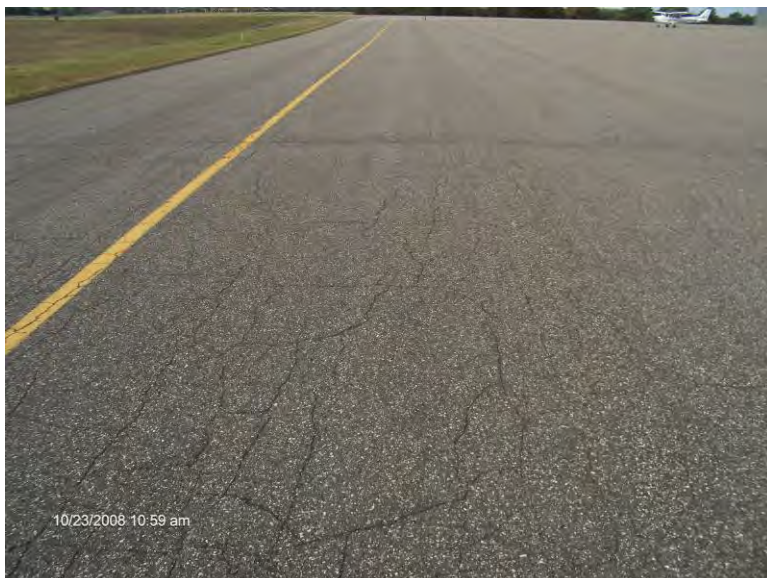
### ***Example of Alligator Cracking***

Alligator (or fatigue) cracks are a series of interconnected load-related cracks caused by fatigue of the asphalt surface. Alligator cracking is a significant structural distress and develops only in places subject to traffic loads. These cracks typically initiate at the bottom of the asphalt layer (where tensile strains

are highest) and propagate upward - so once a fatigue crack is visible, significant damage has already occurred.

At low severity, alligator cracks are evidenced by a series of parallel hairline cracks (usually in a wheel path). Further traffic and deterioration leads to the interconnection of these cracks. Medium severity alligator cracking is a well-defined pattern of interconnected cracks, some spalling may be present. High severity alligator cracks have lost aggregate interlock between adjacent pieces, the cracks may be severely spalled with FOD potential, and most likely the pieces will move freely under traffic. Alligator cracking is a structural failure and cannot be repaired with sealant, the proper repair is full-depth patching.

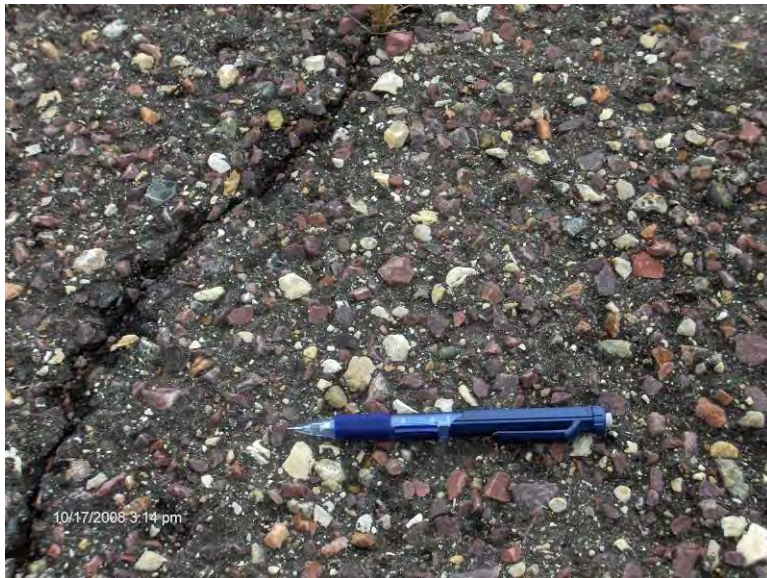
### *Example of Raveling/Weathering*

Raveling and weathering are the wearing away of the pavement surface. Raveling is the condition where the mid- to large size aggregates are becoming dislodged; weathering is when the fine aggregate wears away exposing the edges of the larger aggregate. This distress is usually evident over large areas. Raveling and weathering may indicate that the asphalt binder has hardened significantly. At low severity, the surface has started to wear away with few (if any) loose particles and the coarse surface aggregate is exposed to 1/4 of its diameter. At medium severity, the aggregate and/or binder have worn away with some loose and missing particles, and the surface texture is moderately rough and pitted, but the average depth of erosion is less than ¼ inch. At high severity, the aggregate and/or binder have worn away with a large amount of loose and missing particles, the surface texture is severely rough and pitted, and the top layer of aggregate has eroded away.

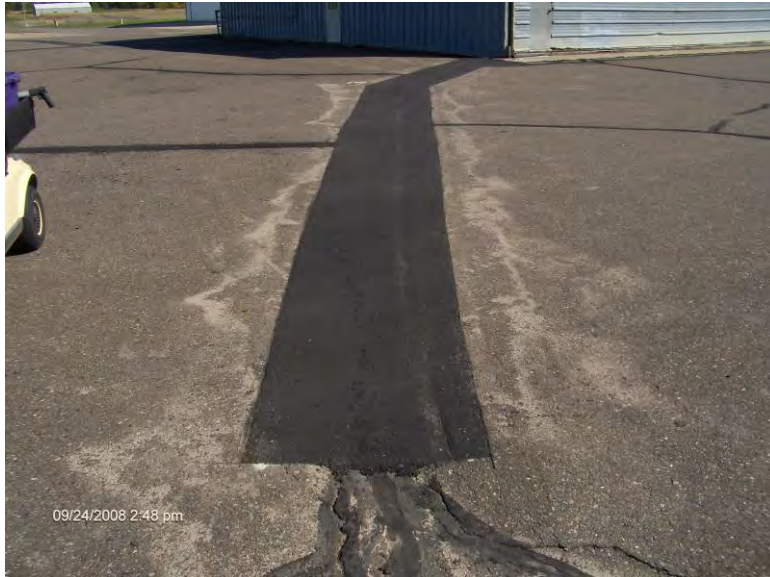
### Example of Patching

Patched areas are defined when a portion of the original pavement is replaced with a material intended as a semi-permanent repair. A patch is documented as a defect because it is considered a break in the integrity of the pavement structure. Patches are constructed for a variety of reasons including utility repairs, correcting grade issues, and addressing a defect in the original pavement. The severity level of patches is determined by the amount of distress (i.e. cracking, depression, weathering/raveling, etc.) occurring within the limits of the patched area.

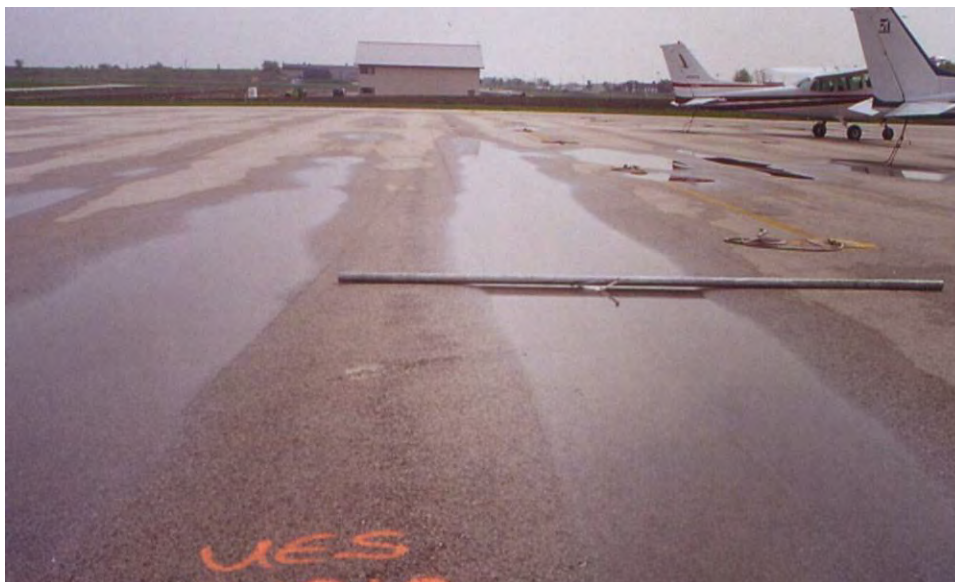
### Example of Rutting

Ruts are localized, load related, areas of pavement having elevations lower than the surrounding sections. Rutting is due to base and subgrade consolidation, caused by excessive wheel loads or poor compactions. Ruts indicate structural failure, and can cause hydroplaning. At low severity, ruts have an

average depth of ¼ to ½ inches. At medium severity, ruts have an average depth of ½ to 1 inch. High severity, ruts have an average depth greater than 1 inch. Full-depth patching is the appropriate repair for ruts.

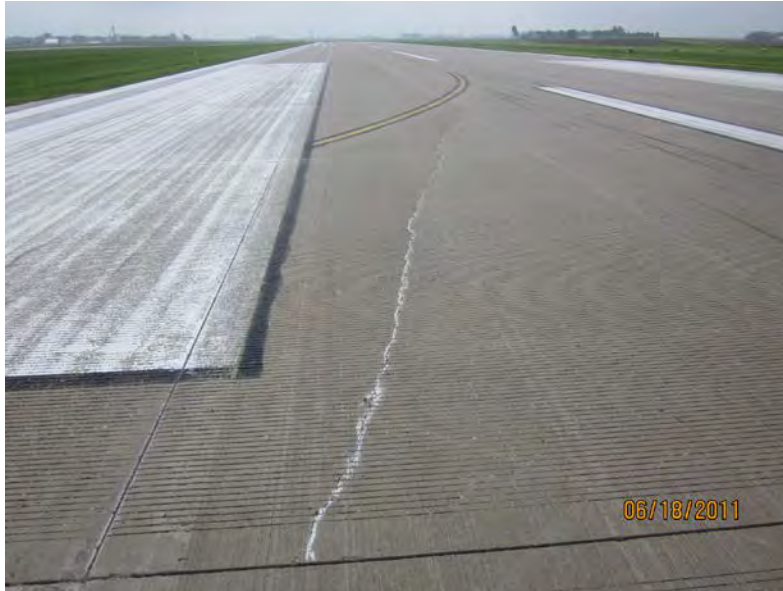
### *Example of Longitudinal, Transverse, and Diagonal Cracking*

LTD cracking is most often a result of externally applied loads and/or constrained temperature deformations. External loads cause LTD cracking through flexure. Temperature changes on restrained slabs will result in stresses due to friction or curling. When any of these stresses exceed the strength of the slab, cracking will occur. LTD cracking is recorded at low, medium, or high severity, depending on the width of crack opening and degree of deterioration. At low severity, the crack is less than 1/8th inch wide with little spalling and no corrective action is indicated. At medium severity, LTD cracks can be up to 1 inch wide with moderate spalling, and should be repaired and sealed using procedures similar to joint sealing. At high severity, cracks exceed 1 inch in width and may be severely spalled. High-severity LTD cracking is evidence of serious load failure of the slab, and correction may require patching or slab replacement. If the distress occurs in several adjacent slabs at medium or high severity, major rehabilitation of that pavement area is indicated.

When a slab is divided by LTD cracks into four or more pieces, the slab is said to be "divided" or "shattered." Shattered slab is a separate distress category and is indicative of significant structural failure as the slab loses its ability to distribute loads to subgrade and further slab deterioration can be expected. Shattered slabs are rated in three severities, with slab replacement recommended for medium and high severities.

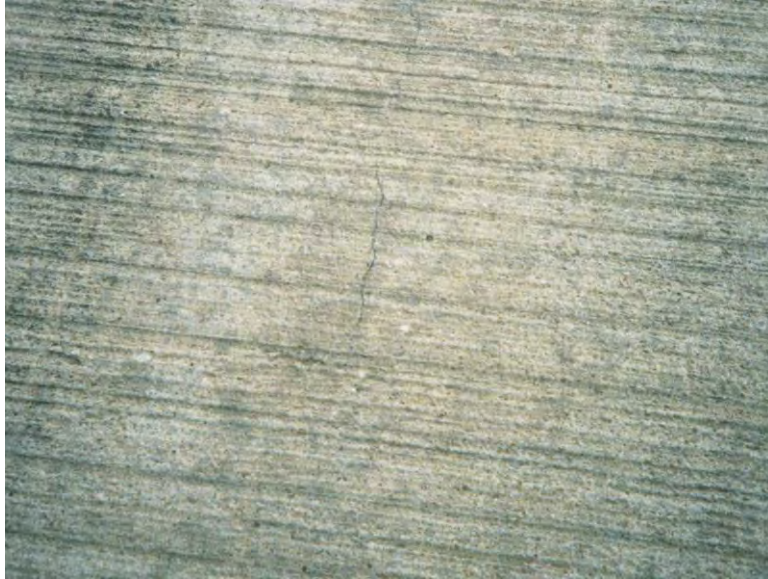
### *Example of Shrinkage Cracking*

Shrinkage cracks are small, nonworking (no spalling along edge) cracks that are visible at the surface but do not penetrate through the full depth of concrete. Shrinkage cracks most commonly occur shortly after construction due to concrete shrinkage during the curing process. Shrinkage cracks are usually so small that they are not visible until staining or material loss at crack edges begins to take place. Shrinkage cracks do not represent a structural weakness, and no corrective action is prescribed.

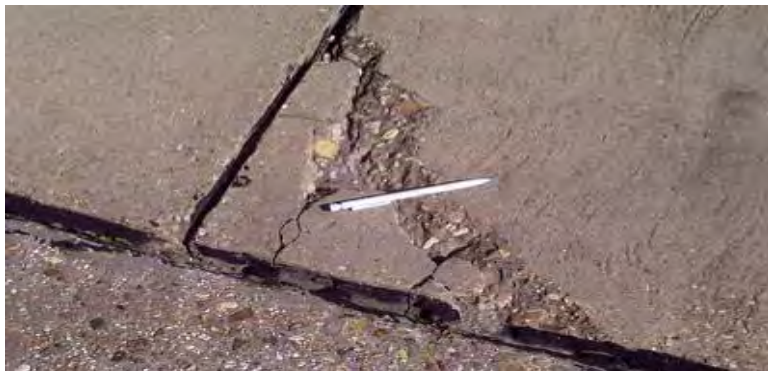
### *Example of Joint and Corner Spalling*

Spalls at slab joints and corners are caused by excessive internal stress in the pavement. Spalls occur when these stresses exceed the shear strength of the concrete. Spalling usually results from thermal expansion during warm or hot weather. As slabs expand, they push against one another at joints. If the joints are filled with incompressibles, such as sand, or if adjacent slabs offset slightly, stresses can become severe, causing spalls. Spalling can be reduced significantly by conscientious maintenance of joint sealant.

Spall repair requires patching. The extent and severity of spalling on a pavement surface suggests appropriate action. For example, at low severity, spalled concrete remains securely in place in the slab. A low-severity spall should be monitored closely for further deterioration and should be patched when

spalled particles become loose in place, or at the next scheduled patching activity in the section. Medium- and high-severity spalls should be repaired immediately to prevent the incidence of FOD. If the pavement can be restored to serviceable condition, spalls should be carefully patched for long-term service. If the pavement is beyond repair, temporary patching should be considered to control FOD.

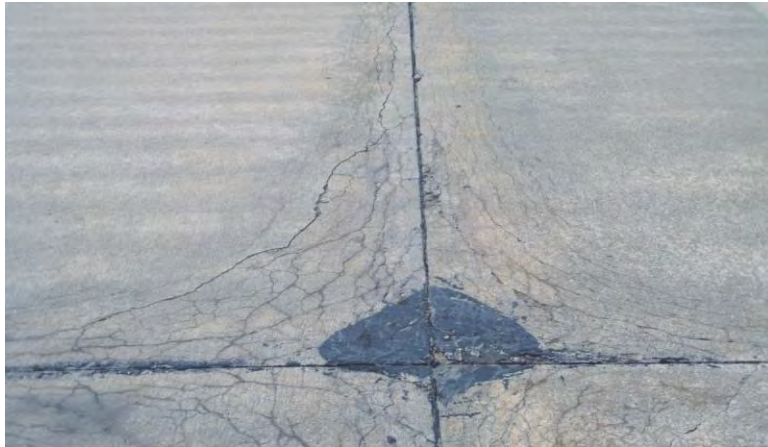
### ***Example of Durability Cracking***

Durability cracking (D-cracking) is caused by environmental factors, the most common of which is freezing/thawing. It usually appears as a pattern of hairline cracks running parallel to a joint or crack, or in a corner, where water tends to collect. This type of cracking eventually leads to disintegration of the pavement, creating FOD potential. At low severity, D-cracking is evident, but no disintegration has occurred. As the distress advances to medium severity, the distress pattern is evident over a significant area of the slab, and some disintegration and FOD potential exists. High severity durability cracking is evidenced by extensive cracking with loose and missing pieces and significant FOD potential.

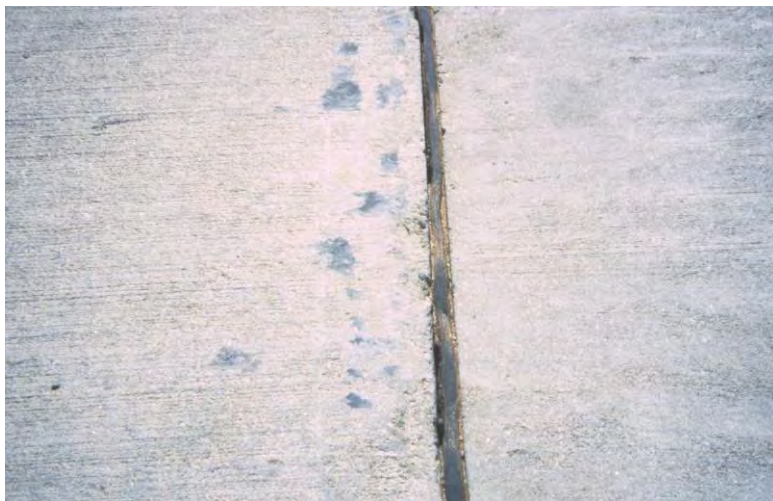
### ***Example of Joint Seal Damage***

Joint seal damage is recorded at three severities: low, medium, and high. When joint sealant is in perfect condition (no damage), it is not a distress. At low severity, at least 10 percent of the sealant is debonded but still in contact with the joint edges (i.e., joint sealant is in serviceable condition but should

be monitored for evidence of more serious failure). Medium-severity joint seal damage is recorded when at least 10 percent of the sealant has visible gaps smaller than 1/8th inch and is an indicator that replacement should be programmed as soon as is practicable. In the meantime, aggressive inspection and sustaining maintenance is recommended to minimize subsurface damage from moisture penetration. At high severity, visible gaps exceed 1/8th inch and the amount and degree of joint seal damage is such that repair is no longer feasible. The only appropriate corrective action is sealant replacement.
