# Minnesota Airport System Pavement Evaluation 2012 Update

St. Cloud Regional Airport (STC)

*Final Report*

Applied Research Associates, Inc.  
100 Trade Centre Dr., Suite 200  
Champaign, IL 61820  
(217) 356-4500

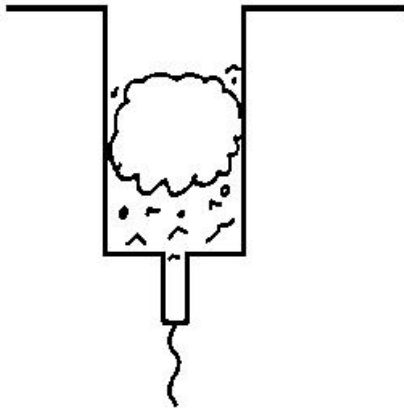
Typical joint with deficient sealant and a collection of debris & incompressibles.
