# Minnesota Airport System Pavement Evaluation 2012 Update

Warren Municipal Airport (D37)

Warren, Minnesota

January 2013

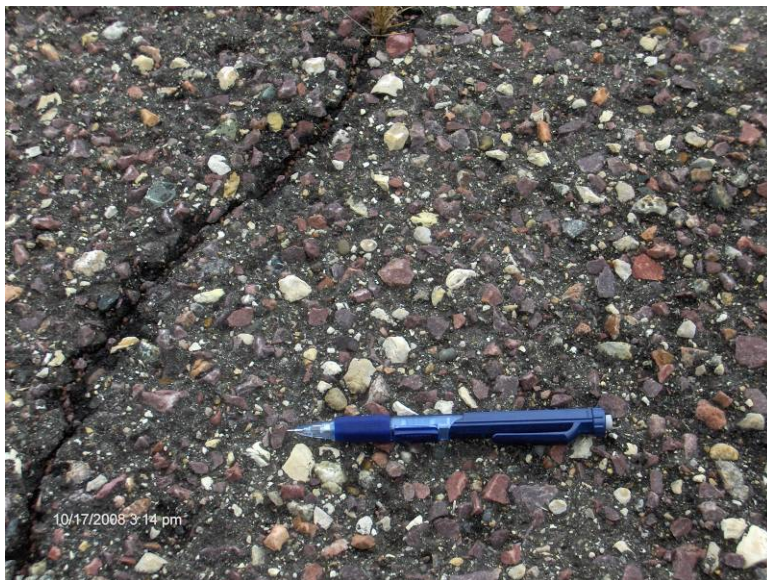
### *Example of Raveling/Weathering*

Raveling and weathering are the wearing away of the pavement surface. Raveling is the condition where the mid- to large size aggregates are becoming dislodged; weathering is when the fine aggregate wears away exposing the edges of the larger aggregate. This distress is usually evident over large areas. Raveling and weathering may indicate that the asphalt binder has hardened significantly. At low severity, the surface has started to wear away with few (if any) loose particles and the coarse surface aggregate is exposed to 1/4 of its diameter. At medium severity, the aggregate and/or binder have worn away with some loose and missing particles, and the surface texture is moderately rough and pitted, but the average depth of erosion is less than ¼ inch. At high severity, the aggregate and/or binder have worn away with a large amount of loose and missing particles, the surface texture is severely rough and pitted, and the top layer of aggregate has eroded away.
