Minnesota Airport System Pavement Evaluation 2012 Update

Worthington Municipal Airport (OTG)

Worthington, Minnesota

Final Report

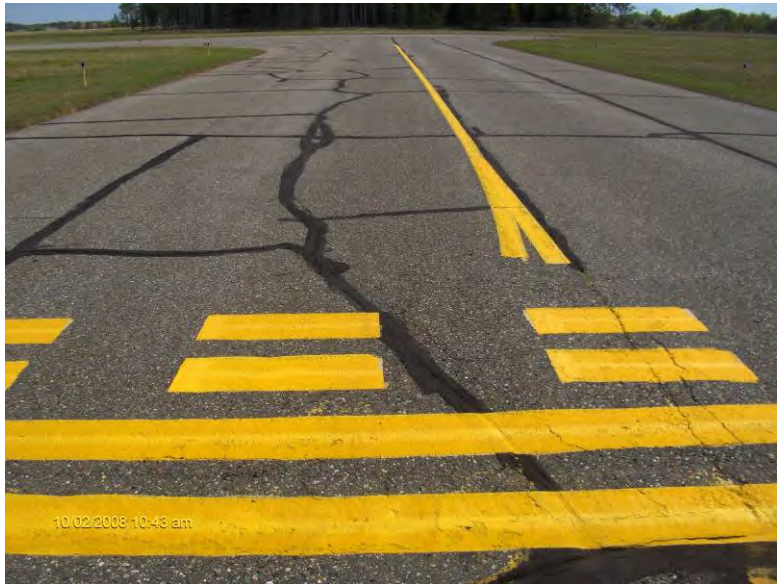
Example of Longitudinal and Transverse Cracking (L&T cracking)

Longitudinal and transverse cracks are caused by pavement aging, by construction, and by subsurface movement. Aging occurs as pavement loses some of its components to the atmosphere and becomes more brittle. Consistent application of pavement sealcoats can help to prevent the occurrence of age related cracks. Cracks will also develop along poorly constructed paving lane joints. Ensuring that joints are made when both sides are still hot, and near the same temperature, is one of the best ways to mitigate this potential problem. Seasonal movement caused by changes in moisture content or temperature differences can also cause pavement cracks. Asphalt pavement placed over a PCC pavement or cement stabilized base course may evidence reflective cracking from the underlying material. Longitudinal and transverse cracks are not caused by wheel loads, although traffic may worsen their condition.

Low severity longitudinal and transverse cracks are less than $\frac{1}{4}$ inch wide, or if sealed with suitable filler material in satisfactory condition can be any width, less than 3 inches, if they are not spalled. Maintenance usually is not indicated for low-severity cracking. Moderately spalled cracks and cracks wider than $\frac{1}{4}$ inch which are not satisfactorily sealed are at medium severity. Medium-severity cracks should be sealed with a high-quality crack filling material. Severely spalled cracks and cracks wider than 3 inches are at high severity. High-severity L&T cracks normally require patching.

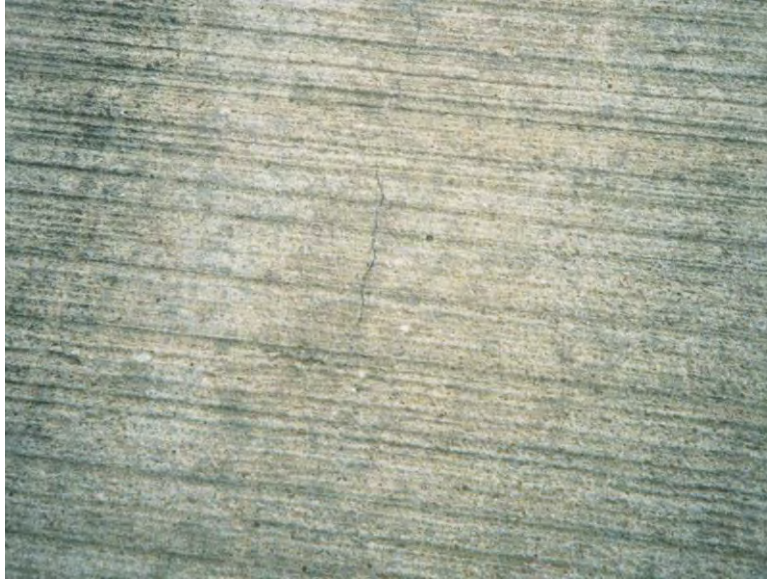
Example of Shrinkage Cracking

Shrinkage cracks are small, nonworking (no spalling along edge) cracks that are visible at the surface but do not penetrate through the full depth of concrete. Shrinkage cracks most commonly occur shortly after construction due to concrete shrinkage during the curing process. Shrinkage cracks are usually so small that they are not visible until staining or material loss at crack edges begins to take place. Shrinkage cracks do not represent a structural weakness, and no corrective action is prescribed.

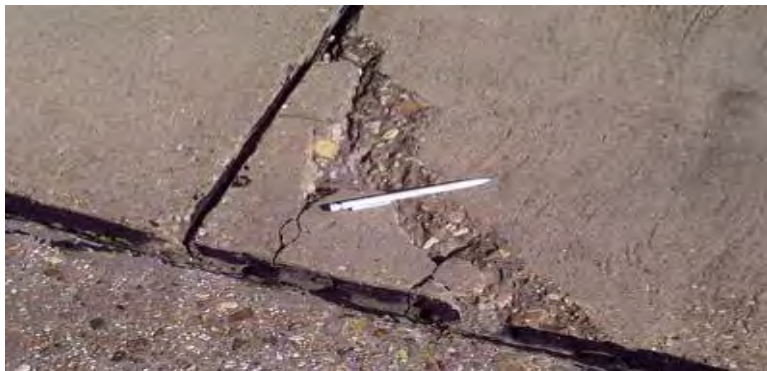
Example of Joint and Corner Spalling

Spalls at slab joints and corners are caused by excessive internal stress in the pavement. Spalls occur when these stresses exceed the shear strength of the concrete. Spalling usually results from thermal expansion during warm or hot weather. As slabs expand, they push against one another at joints. If the joints are filled with incompressibles, such as sand, or if adjacent slabs offset slightly, stresses can become severe, causing spalls. Spalling can be reduced significantly by conscientious maintenance of joint sealant.

Spall repair requires patching. The extent and severity of spalling on a pavement surface suggests appropriate action. For example, at low severity, spalled concrete remains securely in place in the slab. A low-severity spall should be monitored closely for further deterioration and should be patched when

spalled particles become loose in place, or at the next scheduled patching activity in the section. Medium- and high-severity spalls should be repaired immediately to prevent the incidence of FOD. If the pavement can be restored to serviceable condition, spalls should be carefully patched for long-term service. If the pavement is beyond repair, temporary patching should be considered to control FOD.
