# Minnesota Airport System Pavement Evaluation 2013 Update

Long Prairie Municipal Airport (14Y)

Long Prairie, Minnesota

October 2013

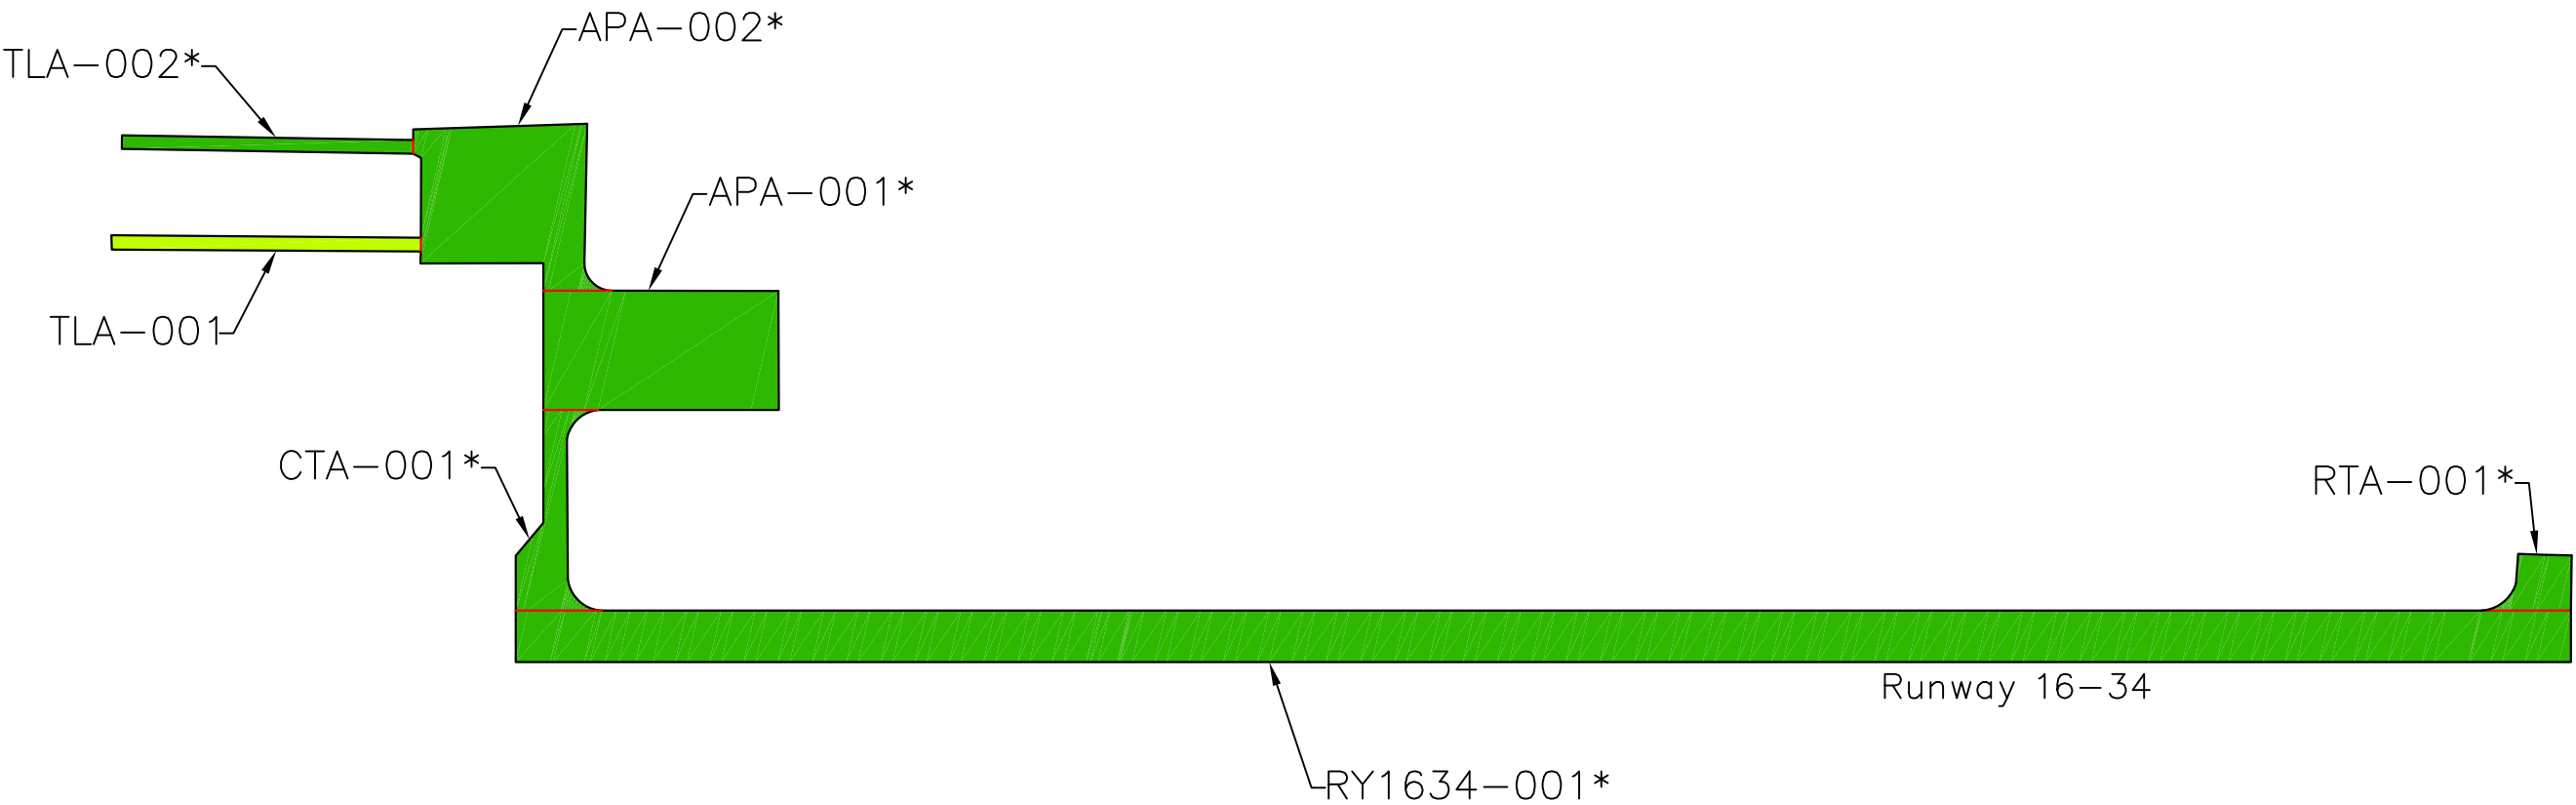
Figure 4. 2013 Pavement Condition Index Rating at Long Prairie Municipal Airport (14Y).

The results of the 2013 PCI inspection are presented in figure 4. The overall area-weighted PCI for 14Y is 99. When summarizing PCI values, an area-weighted calculation is used instead of a straight mathematical average because the area-weighted calculations eliminate the skewing of the PCI due to the disparity of the section sizes.

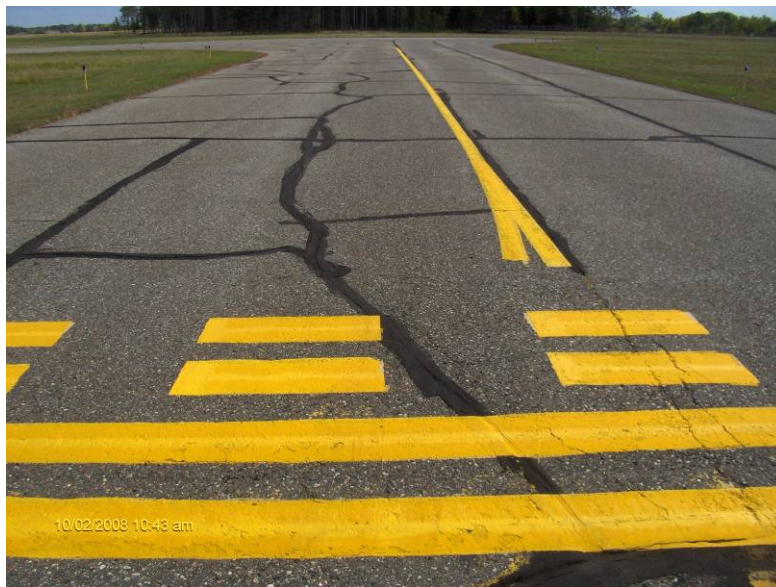
### ***Example of Longitudinal and Transverse Cracking (L&T cracking)***

Longitudinal and transverse cracks are caused by pavement aging, by construction, and by subsurface movement. Aging occurs as pavement loses some of its components to the atmosphere and becomes more brittle. Consistent application of pavement sealcoats can help to prevent the occurrence of age related cracks. Cracks will also develop along poorly constructed paving lane joints. Ensuring that joints are made when both sides are still hot, and near the same temperature, is one of the best ways to mitigate this potential problem. Seasonal movement caused by changes in moisture content or temperature differences can also cause pavement cracks. Asphalt pavement placed over a PCC pavement or cement stabilized base course may evidence reflective cracking from the underlying material. Longitudinal and transverse cracks are not caused by wheel loads, although traffic may worsen their condition.

Low severity longitudinal and transverse cracks are less than ¼ inch wide, or if sealed with suitable filler material in satisfactory condition can be any width, less than 3 inches, if they are not spalled. Maintenance usually is not indicated for low-severity cracking. Moderately spalled cracks and cracks wider than ¼ inch which are not satisfactorily sealed are at medium severity. Medium-severity cracks should be sealed with a high-quality crack filling material. Severely spalled cracks and cracks wider than 3 inches are at high severity. High-severity L&T cracks normally require patching.
