Minnesota Airport System Pavement Evaluation 2013 Update

Bagley Municipal Airport (7Y4)

Final Report

Applied Research Associates, Inc.
100 Trade Centre Dr., Suite 200
Champaign, IL 61820
(217) 356-4500

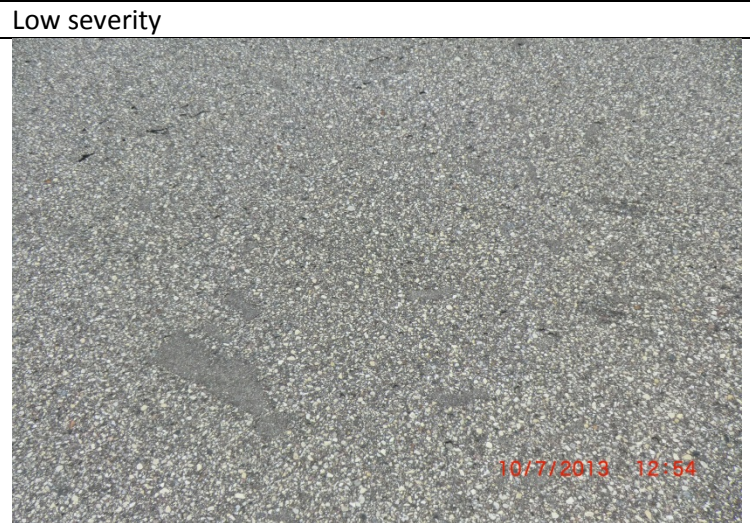
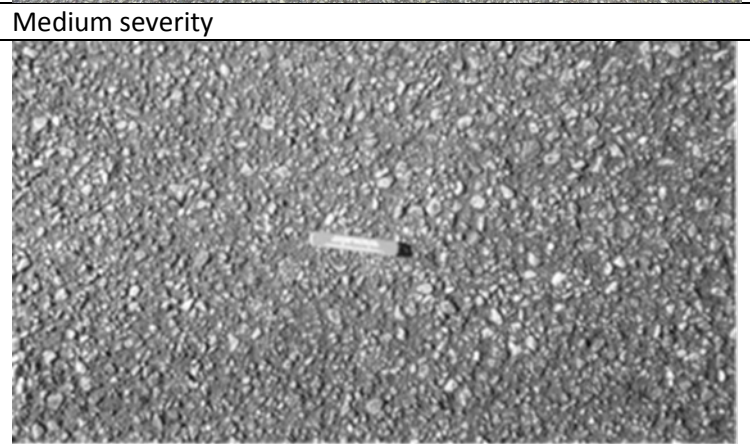
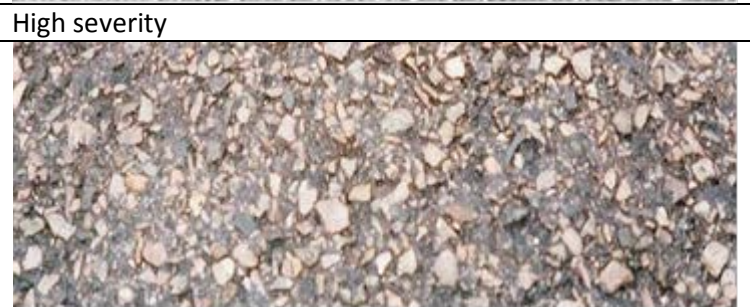
Weathering – At low severity, the coarse aggregate is slightly exposed due to the wearing away of the fine aggregate. At medium severity, the coarse aggregate is exposed up to ¼ the width of the longest side. At high severity, the coarse is exposed greater than ¼ the width of the longest side.
