# Minnesota Airport System Pavement Evaluation 2013 Update

Stephen Municipal Airport (D41)

Stephen, Minnesota

October 2013

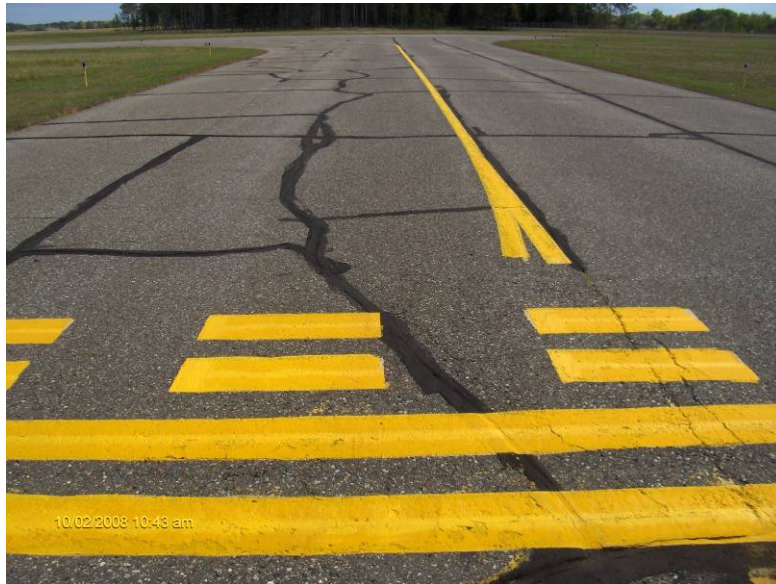
### ***Example of Longitudinal and Transverse Cracking (L&T cracking)***

Longitudinal and transverse cracks are caused by pavement aging, by construction, and by subsurface movement. Aging occurs as pavement loses some of its components to the atmosphere and becomes more brittle. Consistent application of pavement sealcoats can help to prevent the occurrence of age related cracks. Cracks will also develop along poorly constructed paving lane joints. Ensuring that joints are made when both sides are still hot, and near the same temperature, is one of the best ways to mitigate this potential problem. Seasonal movement caused by changes in moisture content or temperature differences can also cause pavement cracks. Asphalt pavement placed over a PCC pavement or cement stabilized base course may evidence reflective cracking from the underlying material. Longitudinal and transverse cracks are not caused by wheel loads, although traffic may worsen their condition.

Low severity longitudinal and transverse cracks are less than ¼ inch wide, or if sealed with suitable filler material in satisfactory condition can be any width, less than 3 inches, if they are not spalled. Maintenance usually is not indicated for low-severity cracking. Moderately spalled cracks and cracks wider than ¼ inch which are not satisfactorily sealed are at medium severity. Medium-severity cracks should be sealed with a high-quality crack filling material. Severely spalled cracks and cracks wider than 3 inches are at high severity. High-severity L&T cracks normally require patching.

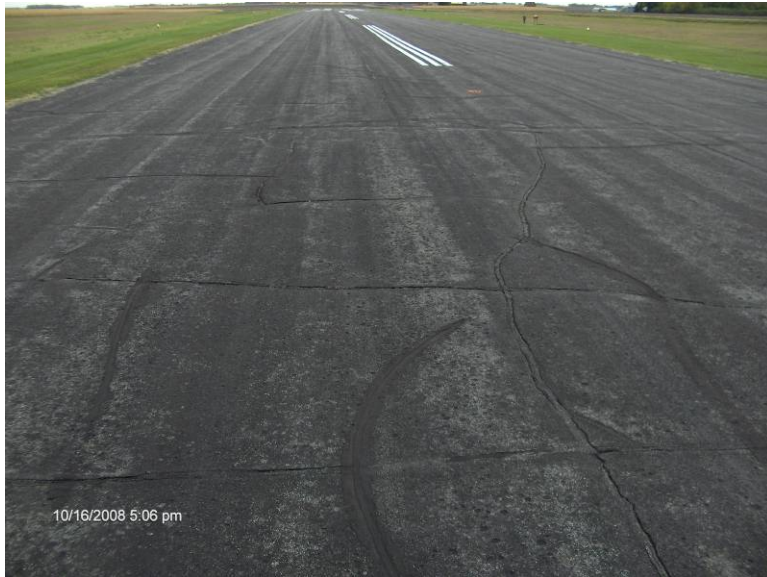
### *Example of Block Cracking*

Block cracking is longitudinal and transverse cracking that has established a pattern of blocks ranging in size from 1ft x 1ft to 10ft x 10ft. This distress typically happens in older asphalt pavements and is an indication that the bituminous binder has lost most of its flexibility. The severity determination is basically determined by the crack width criteria defined for longitudinal and transverse cracking. Crack sealing typically is used to repair block cracking; however, the amount of required sealant can be extensive due to the high density of cracks.

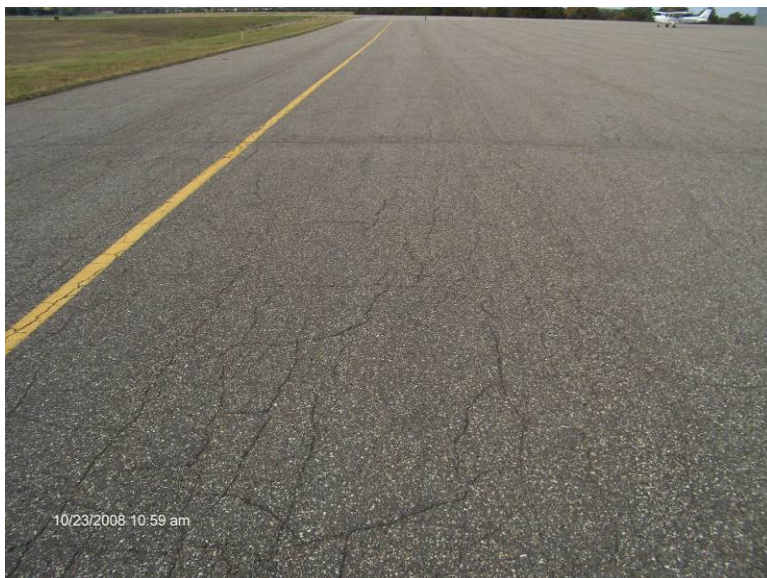
### *Example of Alligator Cracking*

Alligator (or fatigue) cracks are a series of interconnected load-related cracks caused by fatigue of the asphalt surface. Alligator cracking is a significant structural distress and develops only in places subject to traffic loads. These cracks typically initiate at the bottom of the asphalt layer (where tensile strains

are highest) and propagate upward - so once a fatigue crack is visible, significant damage has already occurred.

At low severity, alligator cracks are evidenced by a series of parallel hairline cracks (usually in a wheel path). Further traffic and deterioration leads to the interconnection of these cracks. Medium severity alligator cracking is a well-defined pattern of interconnected cracks, some spalling may be present. High severity alligator cracks have lost aggregate interlock between adjacent pieces, the cracks may be severely spalled with FOD potential, and most likely the pieces will move freely under traffic. Alligator cracking is a structural failure and cannot be repaired with sealant, the proper repair is full-depth patching.

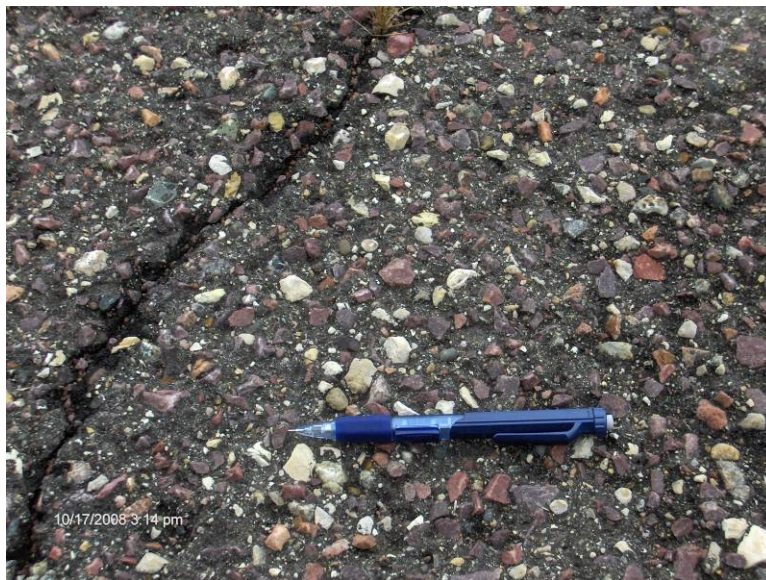
#### *Example of Raveling/Weathering*

Raveling and weathering are the wearing away of the pavement surface. Raveling is the condition where the mid- to large size aggregates are becoming dislodged; weathering is when the fine aggregate wears away exposing the edges of the larger aggregate. These distresses are usually evident over large areas and may occur together (pictured above) or separately. Raveling and weathering may indicate that the asphalt binder has hardened significantly.

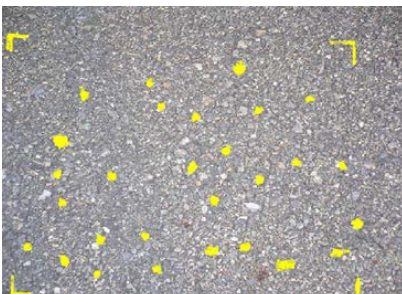
Raveling – At low severity, the number of missing coarse aggregates ( $> 3/8$  inch) is between 5-20 missing/yd<sup>2</sup>, medium severity (pictured below where the missing coarse aggregates have been dotted with yellow paint) is 21-40 missing/yd<sup>2</sup>, and high severity is  $> 40$  missing/yd<sup>2</sup>.

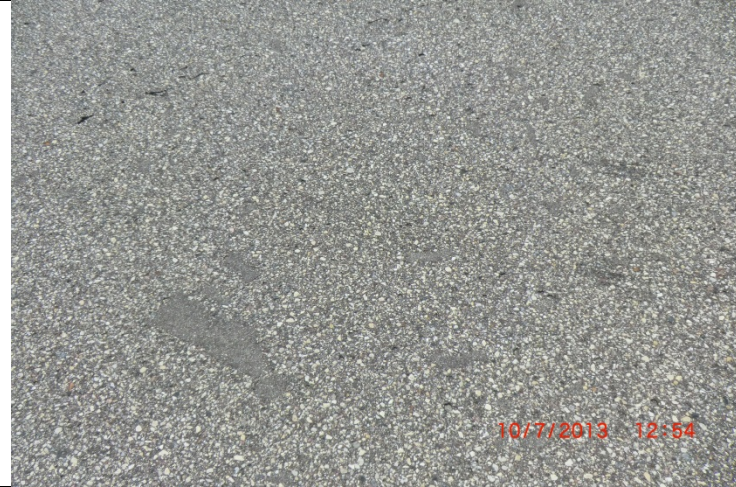
Low severity

Weathering – At low severity, the coarse aggregate is slightly exposed due to the wearing away of the fine aggregate. At medium severity, the coarse aggregate is exposed up to  $\frac{1}{4}$  the width of the longest side. At high severity, the coarse is exposed greater than  $\frac{1}{4}$  the width of the longest side.

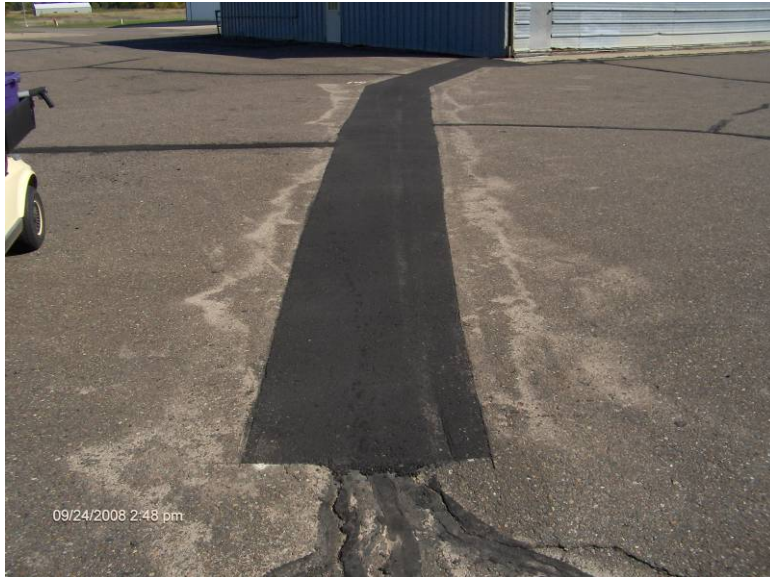
### *Example of Patching*

Patched areas are defined when a portion of the original pavement is replaced with a material intended as a semi-permanent repair. A patch is documented as a defect because it is considered a break in the integrity of the pavement structure. Patches are constructed for a variety of reasons including utility repairs, correcting grade issues, and addressing a defect in the original pavement. The severity level of patches is determined by the amount of distress (i.e. cracking, depression, weathering/raveling, etc.) occurring within the limits of the patched area.

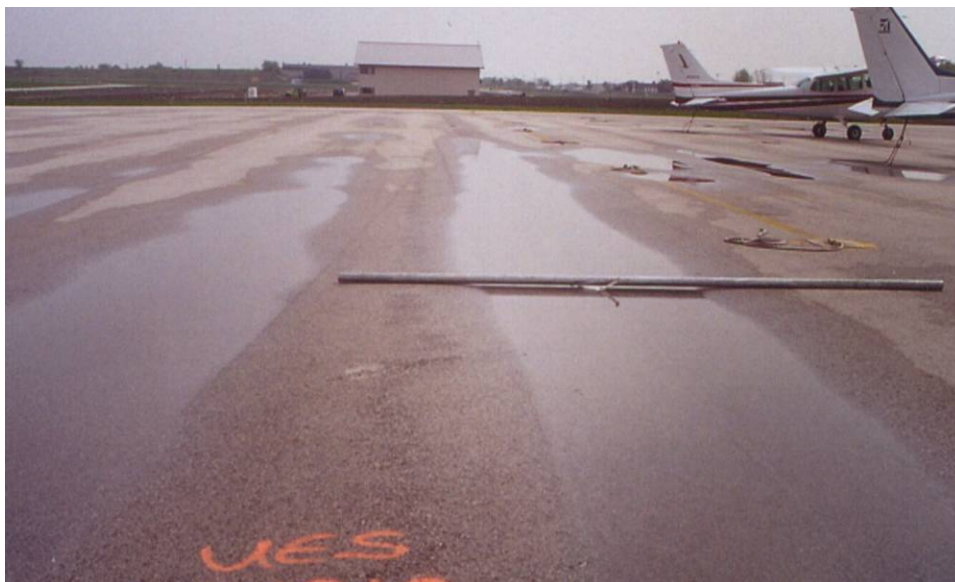
### *Example of Rutting*

Ruts are localized, load related, areas of pavement having elevations lower than the surrounding sections. Rutting is due to base and subgrade consolidation, caused by excessive wheel loads or poor compactions. Ruts indicate structural failure, and can cause hydroplaning. At low severity, ruts have an

average depth of ¼ to ½ inches. At medium severity, ruts have an average depth of ½ to 1 inch. High severity, ruts have an average depth greater than 1 inch. Full-depth patching is the appropriate repair for ruts.

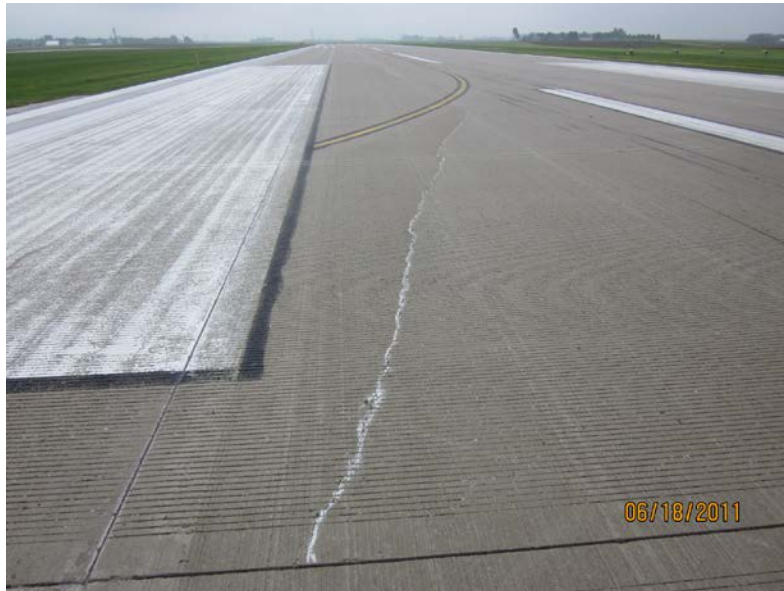
### *Example of Longitudinal, Transverse, and Diagonal Cracking*

LTD cracking is most often a result of externally applied loads and/or constrained temperature deformations. External loads cause LTD cracking through flexure. Temperature changes on restrained slabs will result in stresses due to friction or curling. When any of these stresses exceed the strength of the slab, cracking will occur. LTD cracking is recorded at low, medium, or high severity, depending on the width of crack opening and degree of deterioration. At low severity, the crack is less than 1/8th inch wide with little spalling and no corrective action is indicated. At medium severity, LTD cracks can be up to 1 inch wide with moderate spalling, and should be repaired and sealed using procedures similar to joint sealing. At high severity, cracks exceed 1 inch in width and may be severely spalled. High-severity LTD cracking is evidence of serious load failure of the slab, and correction may require patching or slab replacement. If the distress occurs in several adjacent slabs at medium or high severity, major rehabilitation of that pavement area is indicated.

When a slab is divided by LTD cracks into four or more pieces, the slab is said to be "divided" or "shattered." Shattered slab is a separate distress category and is indicative of significant structural failure as the slab loses its ability to distribute loads to subgrade and further slab deterioration can be expected. Shattered slabs are rated in three severities, with slab replacement recommended for medium and high severities.

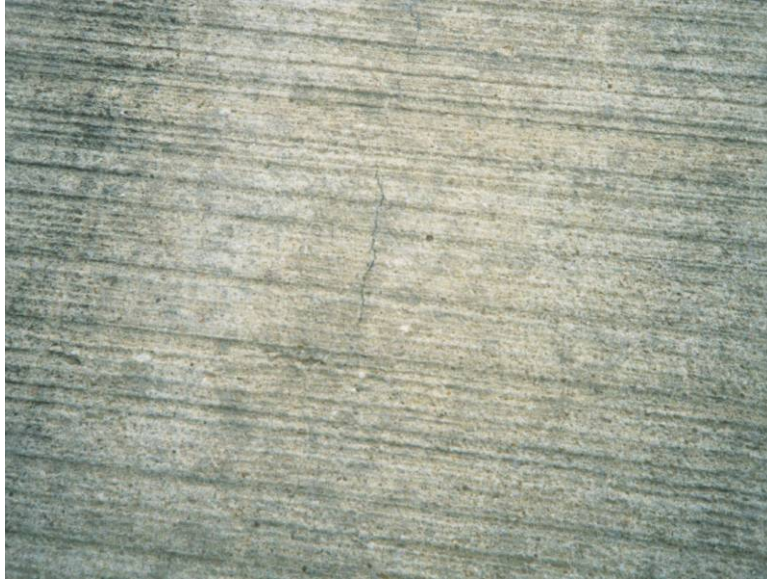
### *Example of Shrinkage Cracking*

Shrinkage cracks are small, nonworking (no spalling along edge) cracks that are visible at the surface but do not penetrate through the full depth of concrete. Shrinkage cracks most commonly occur shortly after construction due to concrete shrinkage during the curing process. Shrinkage cracks are usually so small that they are not visible until staining or material loss at crack edges begins to take place. Shrinkage cracks do not represent a structural weakness, and no corrective action is prescribed.

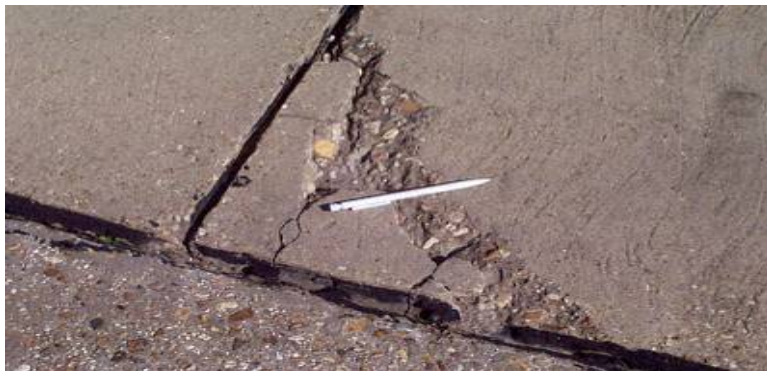
### *Example of Joint and Corner Spalling*

Spalls at slab joints and corners are caused by excessive internal stress in the pavement. Spalls occur when these stresses exceed the shear strength of the concrete. Spalling usually results from thermal expansion during warm or hot weather. As slabs expand, they push against one another at joints. If the joints are filled with incompressibles, such as sand, or if adjacent slabs offset slightly, stresses can become severe, causing spalls. Spalling can be reduced significantly by conscientious maintenance of joint sealant.

Spall repair requires patching. The extent and severity of spalling on a pavement surface suggests appropriate action. For example, at low severity, spalled concrete remains securely in place in the slab. A low-severity spall should be monitored closely for further deterioration and should be patched when

spalled particles become loose in place, or at the next scheduled patching activity in the section. Medium- and high-severity spalls should be repaired immediately to prevent the incidence of FOD. If the pavement can be restored to serviceable condition, spalls should be carefully patched for long-term service. If the pavement is beyond repair, temporary patching should be considered to control FOD.

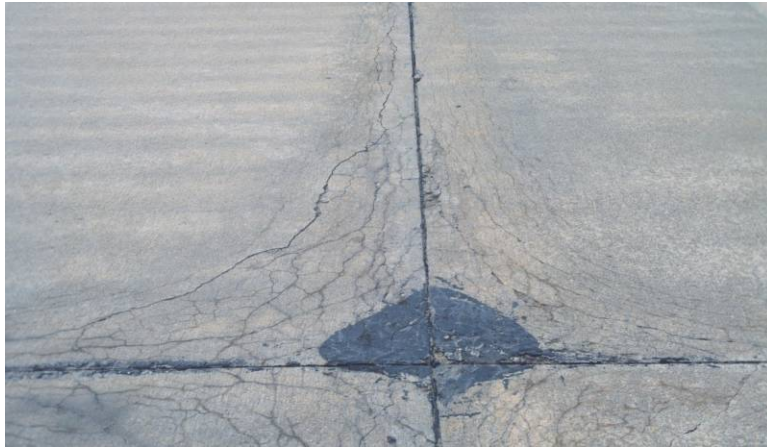
#### *Example of Durability Cracking*

Durability cracking (D-cracking) is caused by environmental factors, the most common of which is freezing/thawing. It usually appears as a pattern of hairline cracks running parallel to a joint or crack, or in a corner, where water tends to collect. This type of cracking eventually leads to disintegration of the pavement, creating FOD potential. At low severity, D-cracking is evident, but no disintegration has occurred. As the distress advances to medium severity, the distress pattern is evident over a significant area of the slab, and some disintegration and FOD potential exists. High severity durability cracking is evidenced by extensive cracking with loose and missing pieces and significant FOD potential.

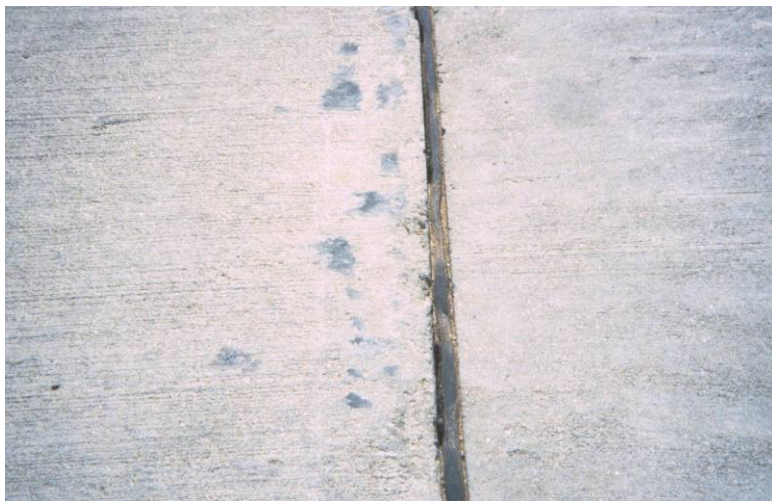
#### *Example of Joint Seal Damage*

Joint seal damage is recorded at three severities: low, medium, and high. When joint sealant is in perfect condition (no damage), it is not a distress. At low severity, at least 10 percent of the sealant is debonded but still in contact with the joint edges (i.e., joint sealant is in serviceable condition but should

be monitored for evidence of more serious failure). Medium-severity joint seal damage is recorded when at least 10 percent of the sealant has visible gaps smaller than 1/8th inch and is an indicator that replacement should be programmed as soon as is practicable. In the meantime, aggressive inspection and sustaining maintenance is recommended to minimize subsurface damage from moisture penetration. At high severity, visible gaps exceed 1/8th inch and the amount and degree of joint seal damage is such that repair is no longer feasible. The only appropriate corrective action is sealant replacement.

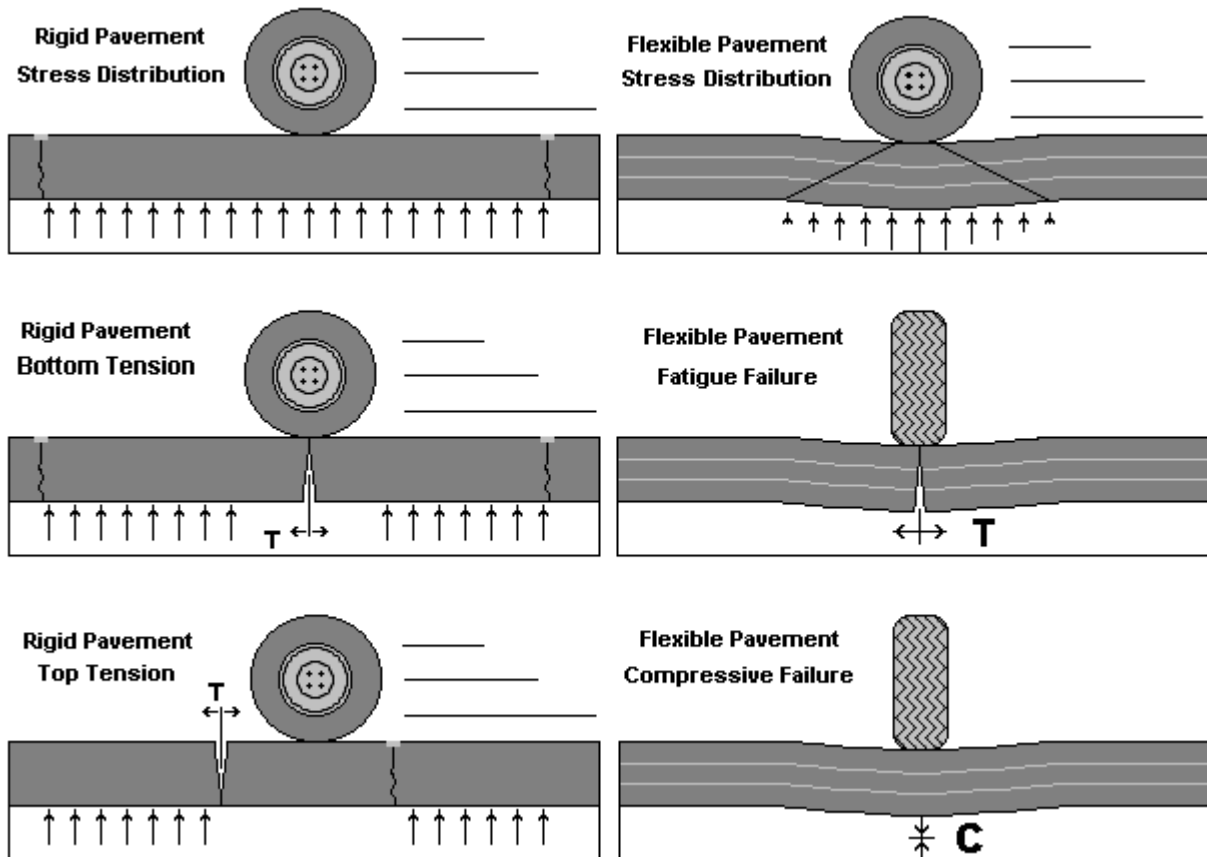
Figure 1. Pavement failure.

Load-related cracks can start at the top or bottom of a pavement section. In asphalt sections, load-related (fatigue) cracks start at the bottom. If a load-related crack reaches the surface, it usually indicates significant structural deficiency. In PCC pavement, corner breaks are caused by top tension, and the crack propagates downward. Mid-slab LTD cracks are examples of bottom tension.

Spalls can be caused by either wheel loads or environmental factors, anytime there is movement between adjacent slabs. If a small rock is allowed into a joint, a differential movement between adjacent slabs can cause a spall. Spalling can be minimized by keeping joint and crack sealant intact.

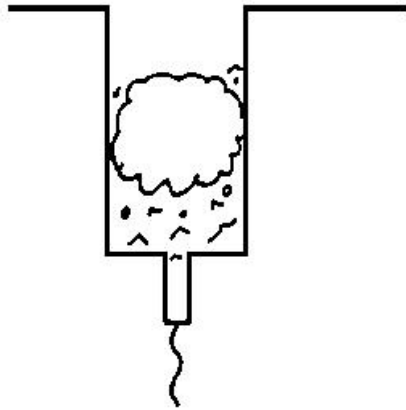
Typical joint with deficient sealant and a collection of debris & incompressibles.
