Minnesota Airport System Pavement Evaluation 2013 Update

Grand Rapids – Itasca County Airport
(GPZ)

Grand Rapids, Minnesota

Final Report

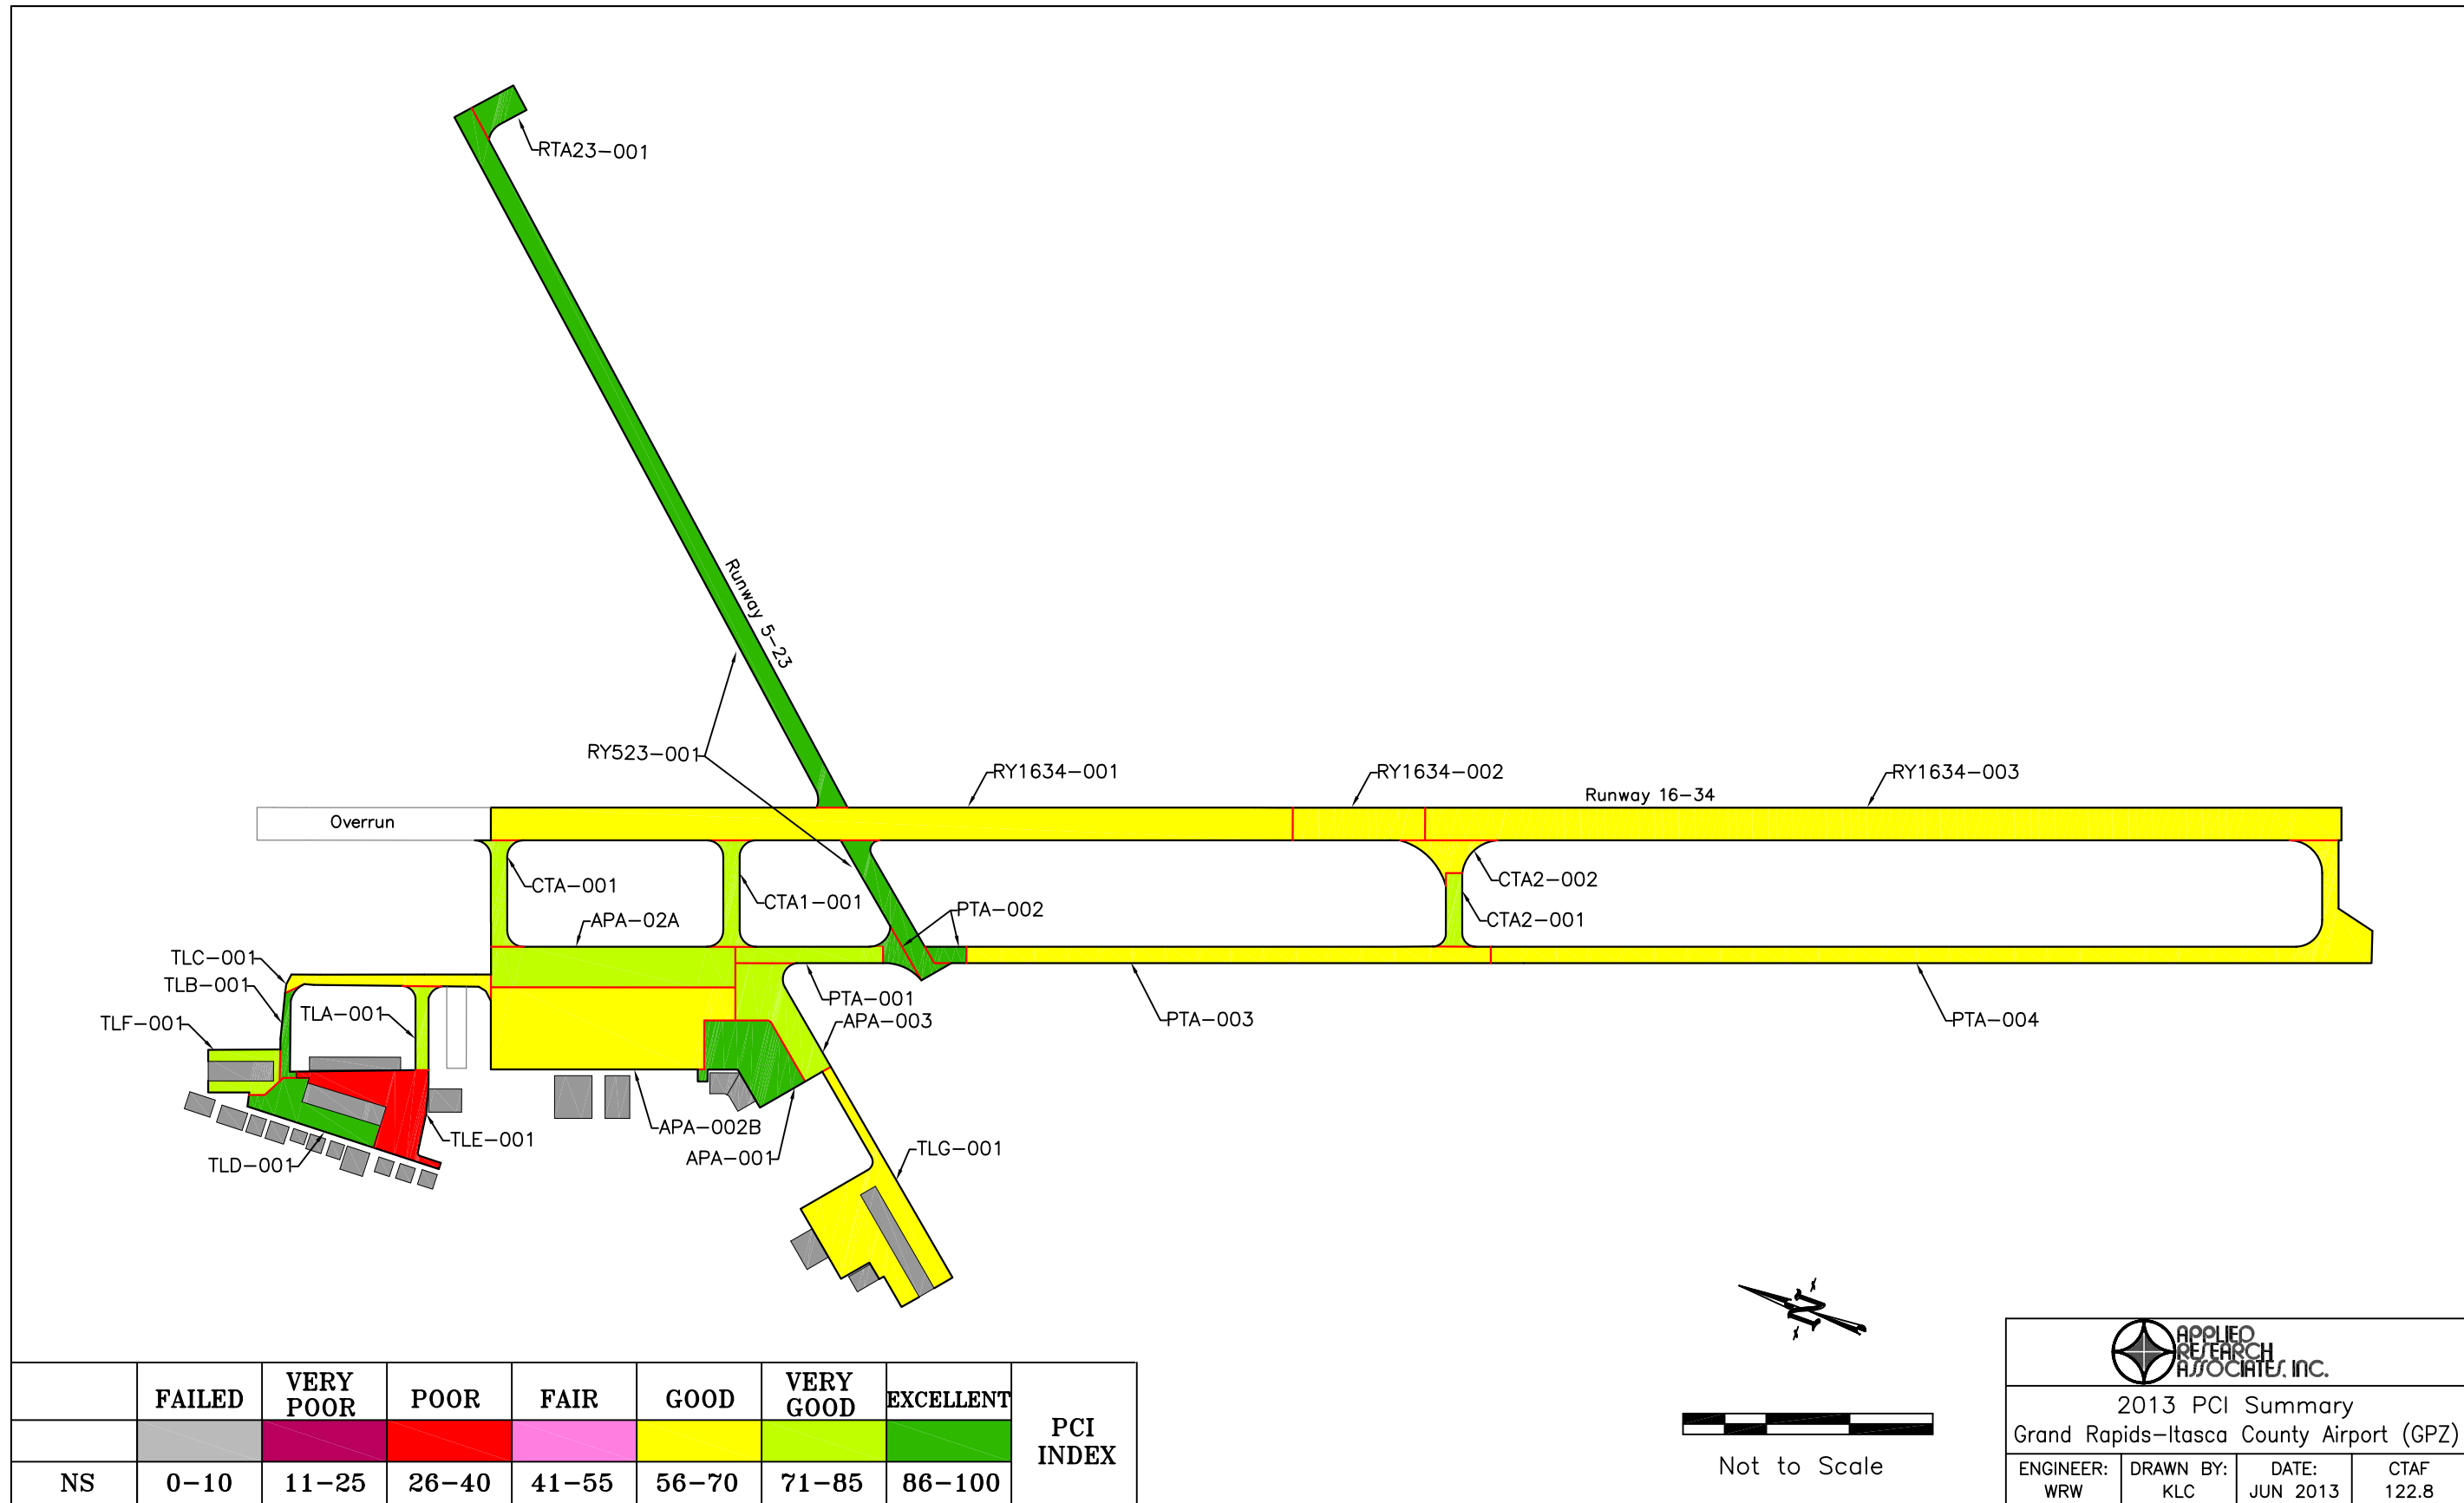
Figure 4. 2013 Pavement Condition Index Rating at Grand Rapids-Itasca County Airport (GPZ).

The results of the 2013 PCI inspection are presented in figure 4. The overall area-weighted PCI for GPZ is 69. When summarizing PCI values, an area-weighted calculation is used instead of a straight mathematical average because the area-weighted calculations eliminate the skewing of the PCI due to the disparity of the section sizes.
