Minnesota Airport System Pavement Evaluation 2013 Update

Glencoe Municipal Airport (GYL)

Glencoe, Minnesota

Final Report

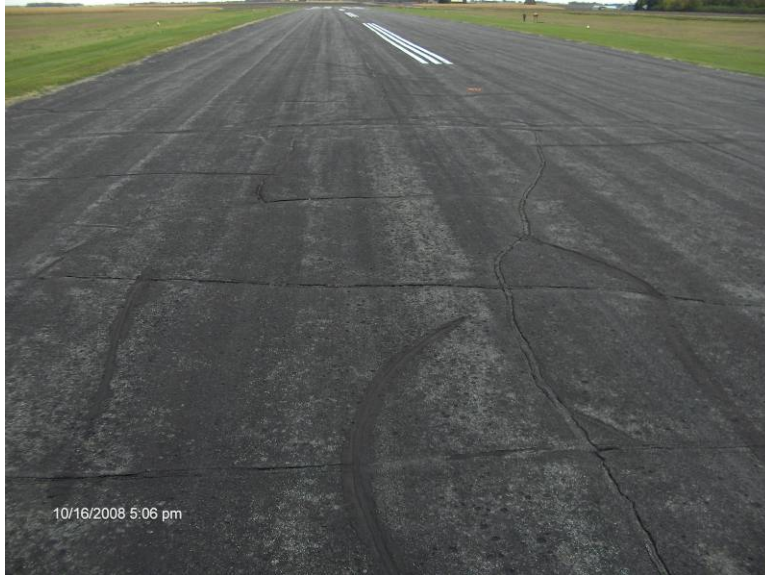
Example of Block Cracking

Block cracking is longitudinal and transverse cracking that has established a pattern of blocks ranging in size from 1ft x 1ft to 10ft x 10ft. This distress typically happens in older asphalt pavements and is an indication that the bituminous binder has lost most of its flexibility. The severity determination is basically determined by the crack width criteria defined for longitudinal and transverse cracking. Crack sealing typically is used to repair block cracking; however, the amount of required sealant can be extensive due to the high density of cracks.

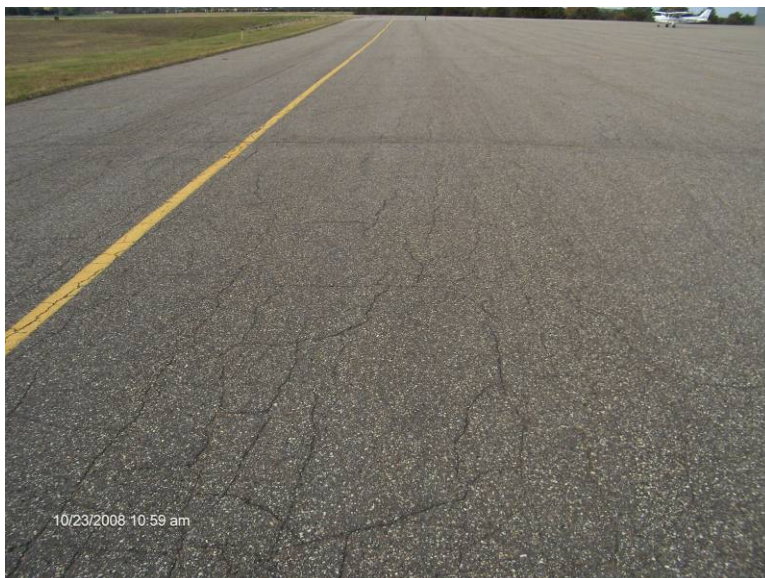
Example of Alligator Cracking

Alligator (or fatigue) cracks are a series of interconnected load-related cracks caused by fatigue of the asphalt surface. Alligator cracking is a significant structural distress and develops only in places subject to traffic loads. These cracks typically initiate at the bottom of the asphalt layer (where tensile strains

are highest) and propagate upward - so once a fatigue crack is visible, significant damage has already occurred.

At low severity, alligator cracks are evidenced by a series of parallel hairline cracks (usually in a wheel path). Further traffic and deterioration leads to the interconnection of these cracks. Medium severity alligator cracking is a well-defined pattern of interconnected cracks, some spalling may be present. High severity alligator cracks have lost aggregate interlock between adjacent pieces, the cracks may be severely spalled with FOD potential, and most likely the pieces will move freely under traffic. Alligator cracking is a structural failure and cannot be repaired with sealant, the proper repair is full-depth patching.

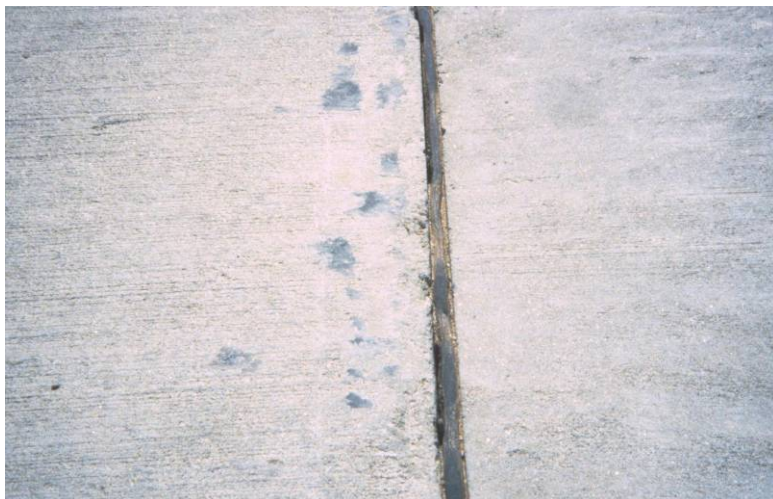
Example of Joint Seal Damage

Joint seal damage is recorded at three severities: low, medium, and high. When joint sealant is in perfect condition (no damage), it is not a distress. At low severity, at least 10 percent of the sealant is debonded but still in contact with the joint edges (i.e., joint sealant is in serviceable condition but should

be monitored for evidence of more serious failure). Medium-severity joint seal damage is recorded when at least 10 percent of the sealant has visible gaps smaller than 1/8th inch and is an indicator that replacement should be programmed as soon as is practicable. In the meantime, aggressive inspection and sustaining maintenance is recommended to minimize subsurface damage from moisture penetration. At high severity, visible gaps exceed 1/8th inch and the amount and degree of joint seal damage is such that repair is no longer feasible. The only appropriate corrective action is sealant replacement.
