Minnesota Airport System Pavement Evaluation 2013 Update

Hutchinson Municipal Airport (HCD)

Final Report

Applied Research Associates, Inc.
100 Trade Centre Dr., Suite 200
Champaign, IL 61820
(217) 356-4500

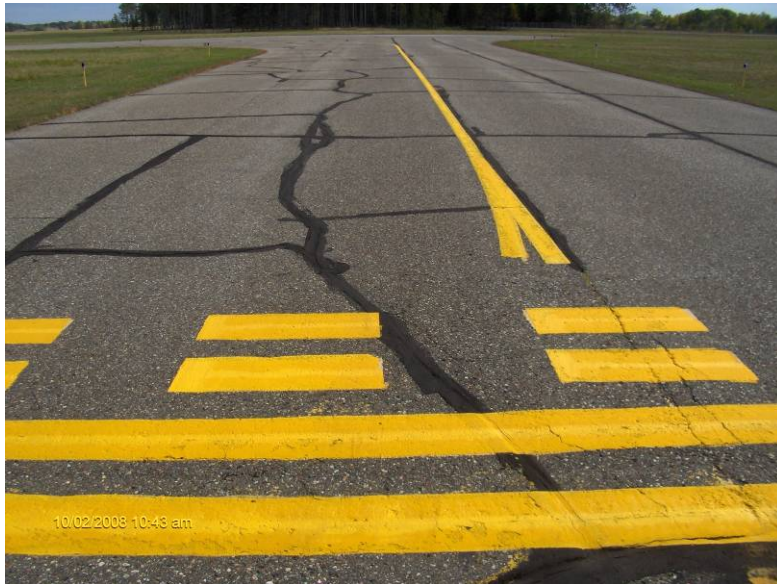
Example of Longitudinal and Transverse Cracking (L&T cracking)

Longitudinal and transverse cracks are caused by pavement aging, by construction, and by subsurface movement. Aging occurs as pavement loses some of its components to the atmosphere and becomes more brittle. Consistent application of pavement sealcoats can help to prevent the occurrence of age related cracks. Cracks will also develop along poorly constructed paving lane joints. Ensuring that joints are made when both sides are still hot, and near the same temperature, is one of the best ways to mitigate this potential problem. Seasonal movement caused by changes in moisture content or temperature differences can also cause pavement cracks. Asphalt pavement placed over a PCC pavement or cement stabilized base course may evidence reflective cracking from the underlying material. Longitudinal and transverse cracks are not caused by wheel loads, although traffic may worsen their condition.

Low severity longitudinal and transverse cracks are less than $\frac{1}{4}$ inch wide, or if sealed with suitable filler material in satisfactory condition can be any width, less than 3 inches, if they are not spalled. Maintenance usually is not indicated for low-severity cracking. Moderately spalled cracks and cracks wider than $\frac{1}{4}$ inch which are not satisfactorily sealed are at medium severity. Medium-severity cracks should be sealed with a high-quality crack filling material. Severely spalled cracks and cracks wider than 3 inches are at high severity. High-severity L&T cracks normally require patching.
