# Minnesota Airport System Pavement Evaluation 2013 Update

Falls International Airport (INL)

International Falls, Minnesota

October 2013

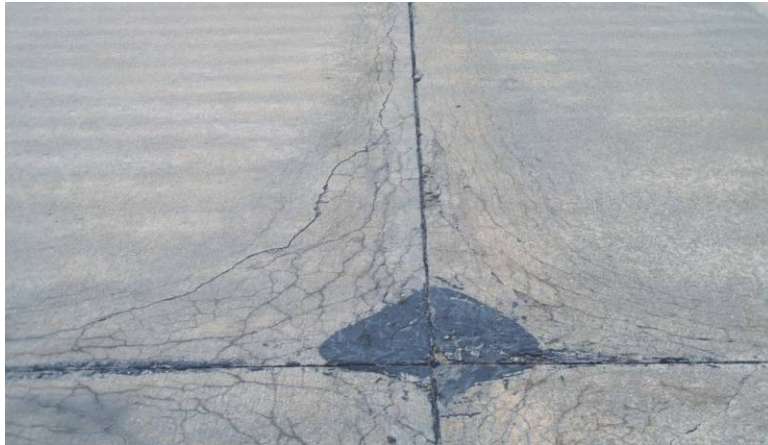
### *Example of Durability Cracking*

Durability cracking (D-cracking) is caused by environmental factors, the most common of which is freezing/thawing. It usually appears as a pattern of hairline cracks running parallel to a joint or crack, or in a corner, where water tends to collect. This type of cracking eventually leads to disintegration of the pavement, creating FOD potential. At low severity, D-cracking is evident, but no disintegration has occurred. As the distress advances to medium severity, the distress pattern is evident over a significant area of the slab, and some disintegration and FOD potential exists. High severity durability cracking is evidenced by extensive cracking with loose and missing pieces and significant FOD potential.
