Minnesota Airport System Pavement Evaluation 2013 Update

St James Municipal Airport (JYG)

St James, Minnesota

Final Report

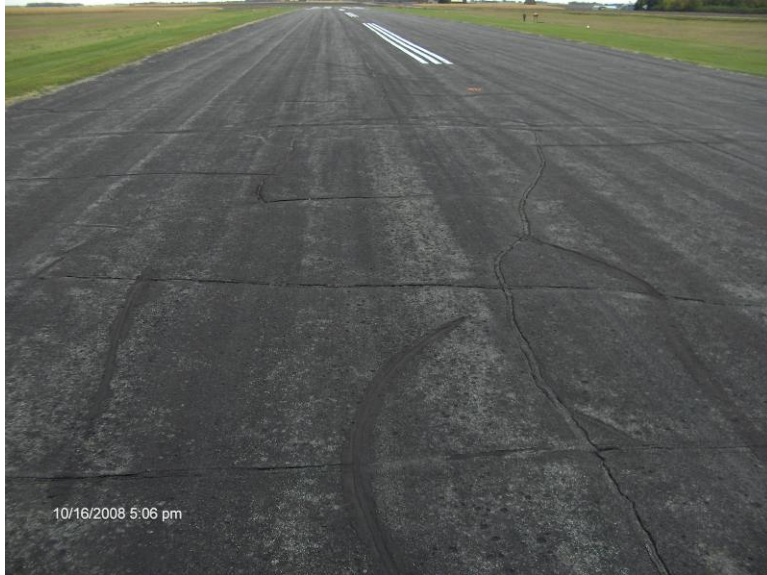
Example of Block Cracking

Block cracking is longitudinal and transverse cracking that has established a pattern of blocks ranging in size from 1ft x 1ft to 10ft x 10ft. This distress typically happens in older asphalt pavements and is an indication that the bituminous binder has lost most of its flexibility. The severity determination is basically determined by the crack width criteria defined for longitudinal and transverse cracking. Crack sealing typically is used to repair block cracking; however, the amount of required sealant can be extensive due to the high density of cracks.
