# Minnesota Airport System Pavement Evaluation 2013 Update

Litchfield Municipal Airport (LJF)

Litchfield, Minnesota

October 2013

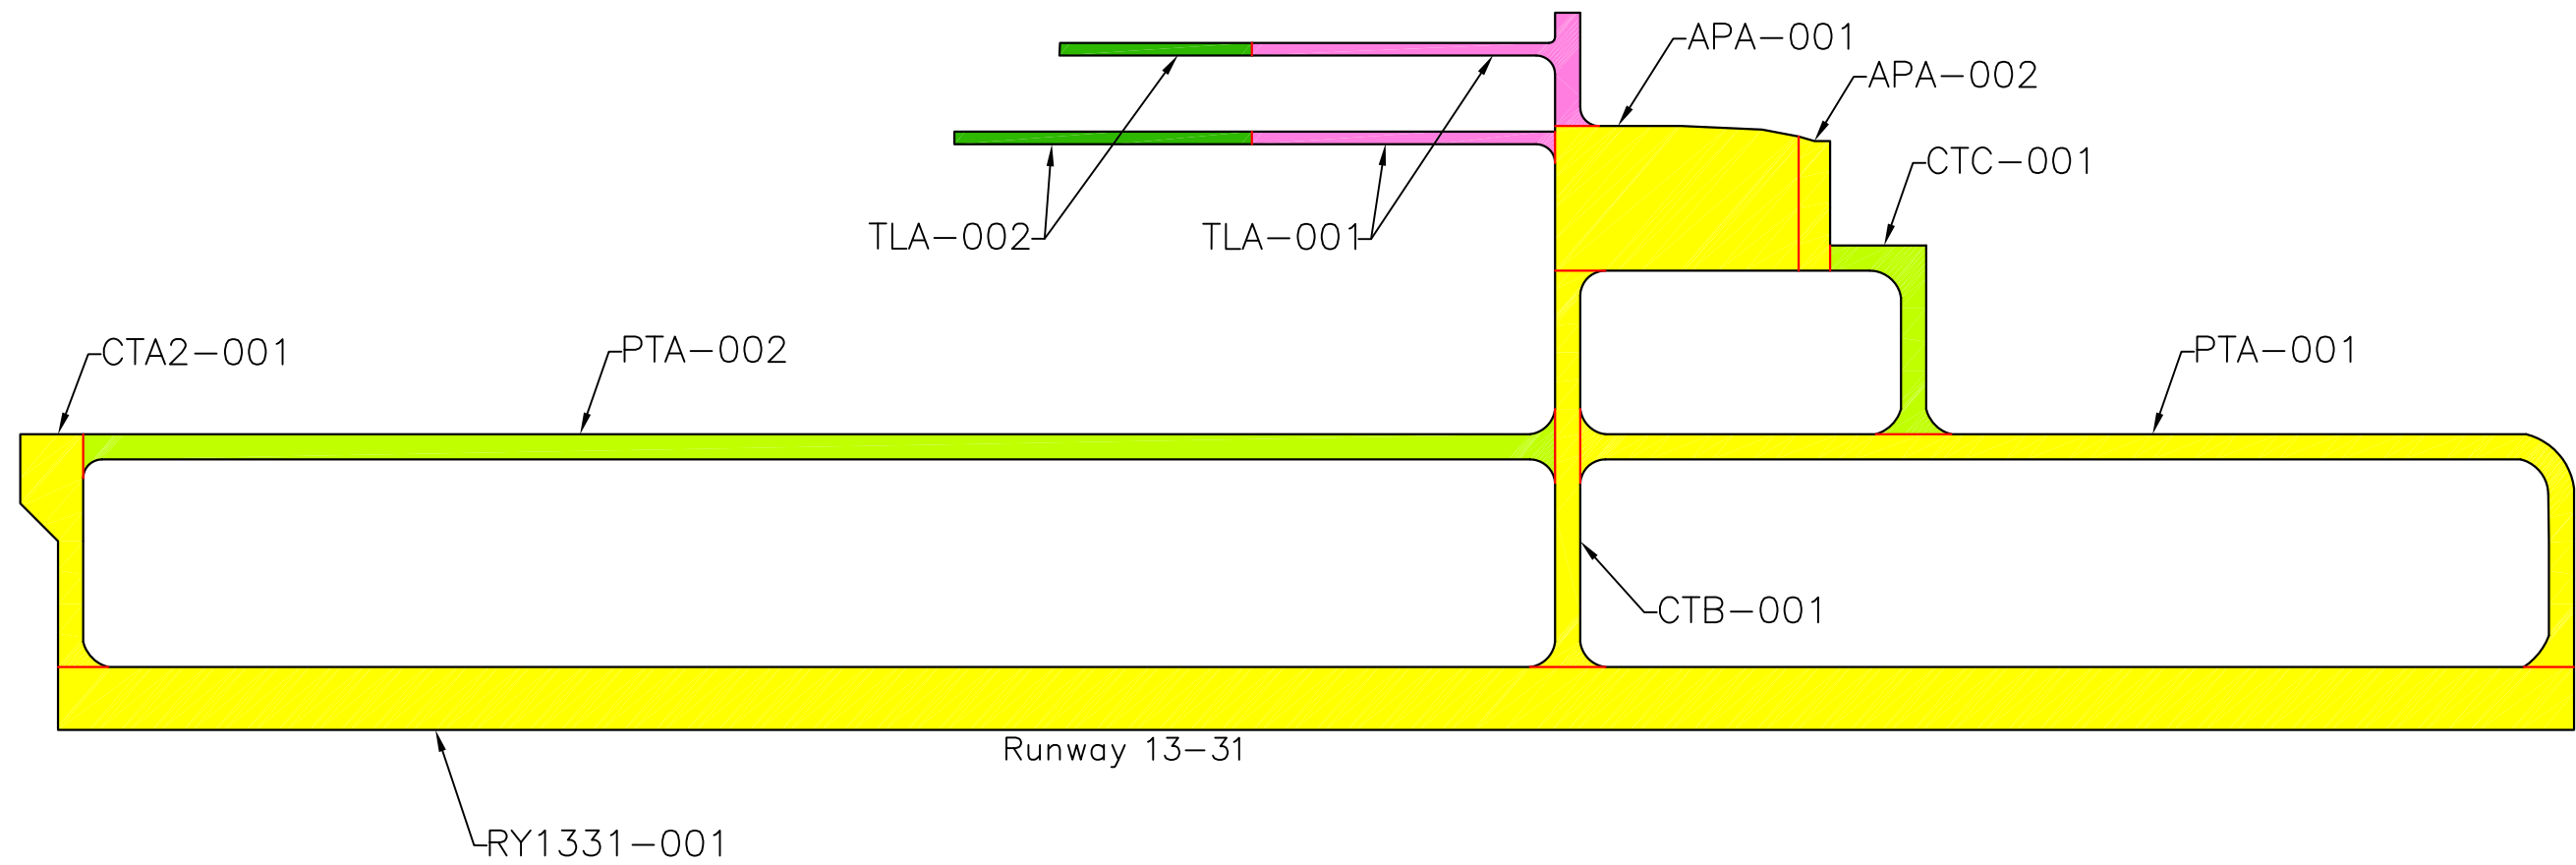
Figure 4. 2013 Pavement Condition Index Rating at Litchfield Municipal Airport (LJF).

The results of the 2013 PCI inspection are presented in figure 4. The overall area-weighted PCI for LJF is 69. When summarizing PCI values, an area-weighted calculation is used instead of a straight mathematical average because the area-weighted calculations eliminate the skewing of the PCI due to the disparity of the section sizes.

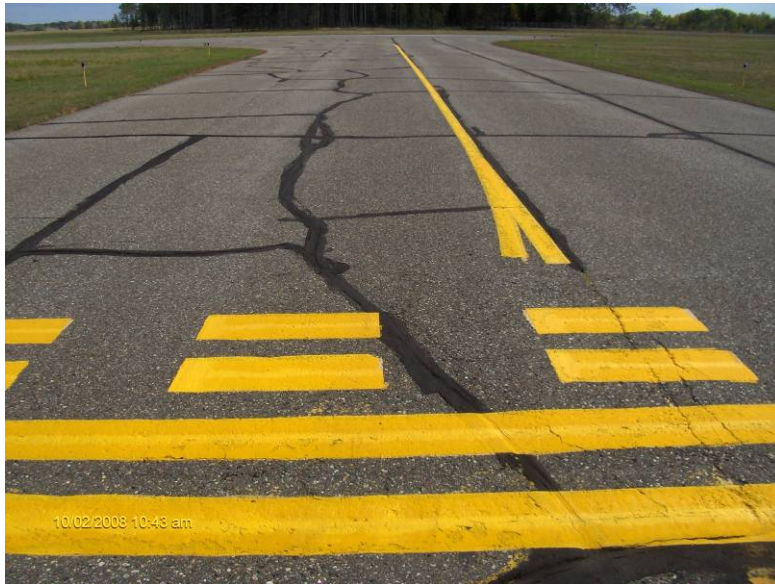
### ***Example of Longitudinal and Transverse Cracking (L&T cracking)***

Longitudinal and transverse cracks are caused by pavement aging, by construction, and by subsurface movement. Aging occurs as pavement loses some of its components to the atmosphere and becomes more brittle. Consistent application of pavement sealcoats can help to prevent the occurrence of age related cracks. Cracks will also develop along poorly constructed paving lane joints. Ensuring that joints are made when both sides are still hot, and near the same temperature, is one of the best ways to mitigate this potential problem. Seasonal movement caused by changes in moisture content or temperature differences can also cause pavement cracks. Asphalt pavement placed over a PCC pavement or cement stabilized base course may evidence reflective cracking from the underlying material. Longitudinal and transverse cracks are not caused by wheel loads, although traffic may worsen their condition.

Low severity longitudinal and transverse cracks are less than ¼ inch wide, or if sealed with suitable filler material in satisfactory condition can be any width, less than 3 inches, if they are not spalled. Maintenance usually is not indicated for low-severity cracking. Moderately spalled cracks and cracks wider than ¼ inch which are not satisfactorily sealed are at medium severity. Medium-severity cracks should be sealed with a high-quality crack filling material. Severely spalled cracks and cracks wider than 3 inches are at high severity. High-severity L&T cracks normally require patching.

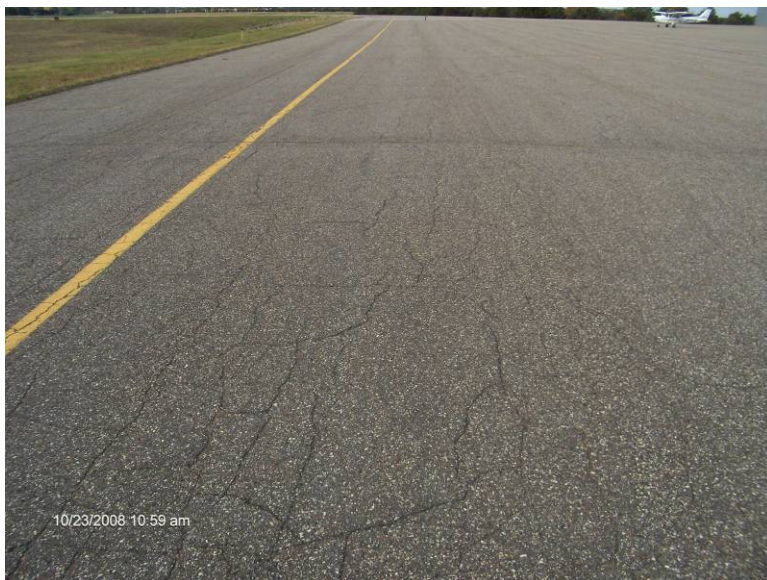
### *Example of Alligator Cracking*

Alligator (or fatigue) cracks are a series of interconnected load-related cracks caused by fatigue of the asphalt surface. Alligator cracking is a significant structural distress and develops only in places subject to traffic loads. These cracks typically initiate at the bottom of the asphalt layer (where tensile strains

are highest) and propagate upward - so once a fatigue crack is visible, significant damage has already occurred.

At low severity, alligator cracks are evidenced by a series of parallel hairline cracks (usually in a wheel path). Further traffic and deterioration leads to the interconnection of these cracks. Medium severity alligator cracking is a well-defined pattern of interconnected cracks, some spalling may be present. High severity alligator cracks have lost aggregate interlock between adjacent pieces, the cracks may be severely spalled with FOD potential, and most likely the pieces will move freely under traffic. Alligator cracking is a structural failure and cannot be repaired with sealant, the proper repair is full-depth patching.
