Minnesota Airport System Pavement Evaluation 2013 Update

Morris Municipal Airport (MOX)

Morris, Minnesota

Final Report

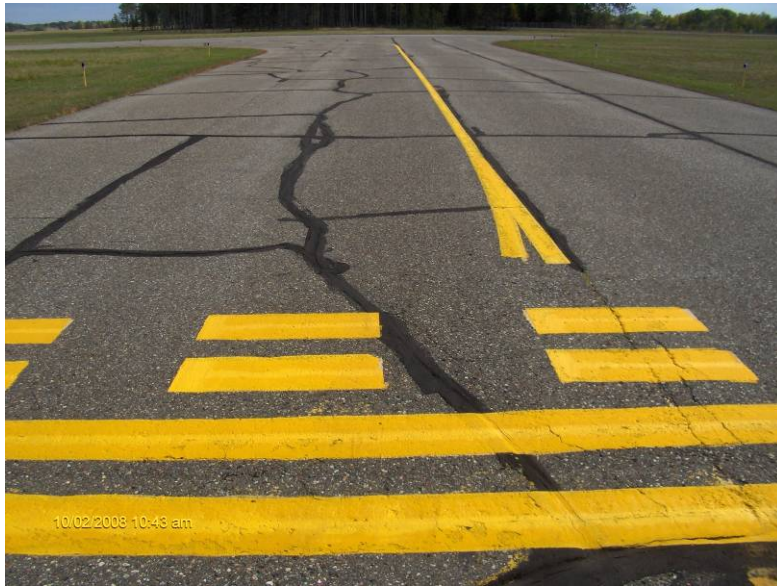
Example of Longitudinal and Transverse Cracking (L&T cracking)

Longitudinal and transverse cracks are caused by pavement aging, by construction, and by subsurface movement. Aging occurs as pavement loses some of its components to the atmosphere and becomes more brittle. Consistent application of pavement sealcoats can help to prevent the occurrence of age related cracks. Cracks will also develop along poorly constructed paving lane joints. Ensuring that joints are made when both sides are still hot, and near the same temperature, is one of the best ways to mitigate this potential problem. Seasonal movement caused by changes in moisture content or temperature differences can also cause pavement cracks. Asphalt pavement placed over a PCC pavement or cement stabilized base course may evidence reflective cracking from the underlying material. Longitudinal and transverse cracks are not caused by wheel loads, although traffic may worsen their condition.

Low severity longitudinal and transverse cracks are less than $\frac{1}{4}$ inch wide, or if sealed with suitable filler material in satisfactory condition can be any width, less than 3 inches, if they are not spalled. Maintenance usually is not indicated for low-severity cracking. Moderately spalled cracks and cracks wider than $\frac{1}{4}$ inch which are not satisfactorily sealed are at medium severity. Medium-severity cracks should be sealed with a high-quality crack filling material. Severely spalled cracks and cracks wider than 3 inches are at high severity. High-severity L&T cracks normally require patching.

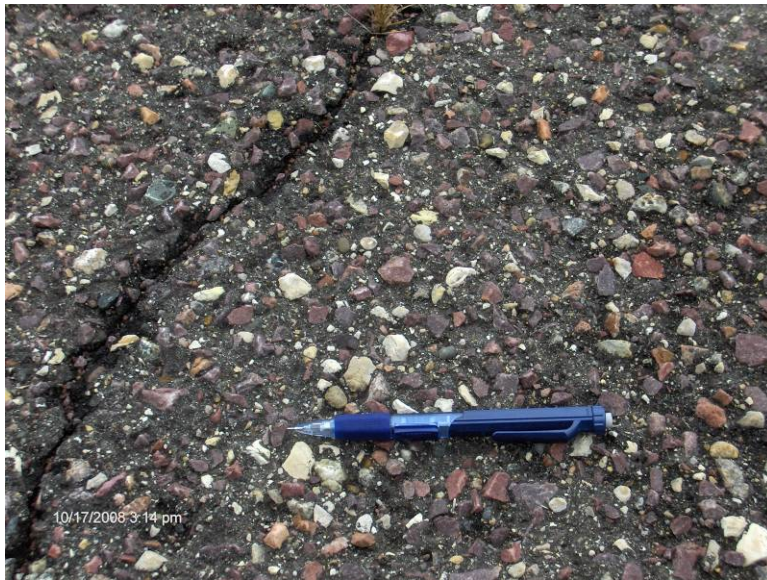
Example of Raveling/Weathering

Raveling and weathering are the wearing away of the pavement surface. Raveling is the condition where the mid- to large size aggregates are becoming dislodged; weathering is when the fine aggregate wears away exposing the edges of the larger aggregate. These distresses are usually evident over large areas and may occur together (pictured above) or separately. Raveling and weathering may indicate that the asphalt binder has hardened significantly.

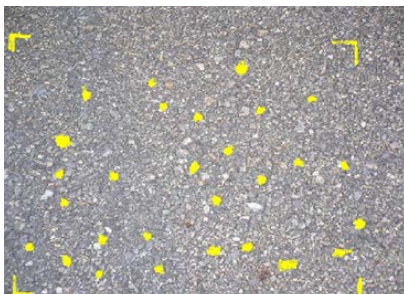
Raveling – At low severity, the number of missing coarse aggregates (> 3/8 inch) is between 5-20 missing/yd², medium severity (pictured below where the missing coarse aggregates have been dotted with yellow paint) is 21-40 missing/yd², and high severity is > 40 missing/yd².

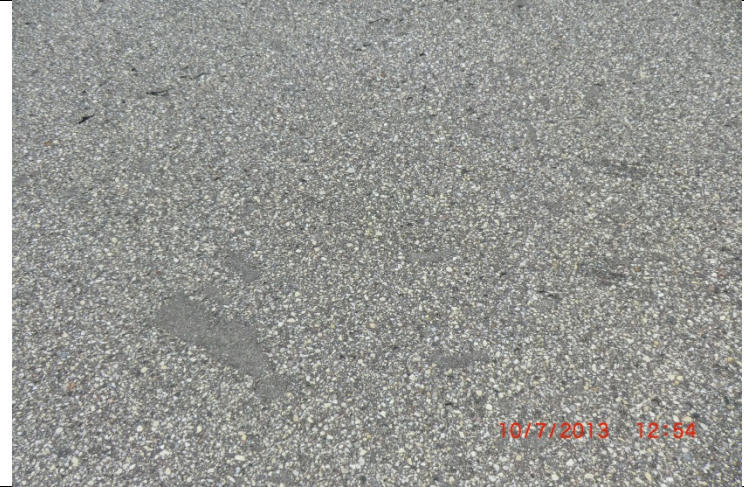
Low severity

Weathering – At low severity, the coarse aggregate is slightly exposed due to the wearing away of the fine aggregate. At medium severity, the coarse aggregate is exposed up to ¼ the width of the longest side. At high severity, the coarse is exposed greater than ¼ the width of the longest side.

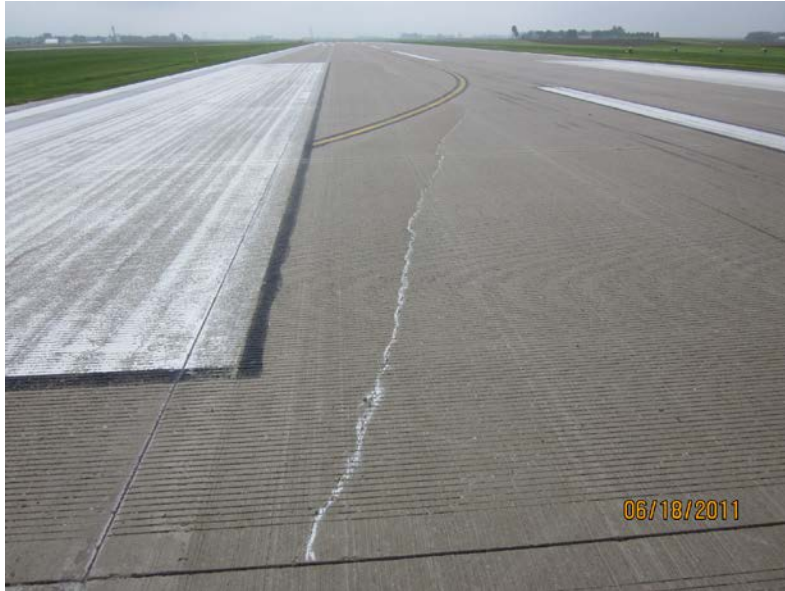
Example of Longitudinal, Transverse, and Diagonal Cracking

LTD cracking is most often a result of externally applied loads and/or constrained temperature deformations. External loads cause LTD cracking through flexure. Temperature changes on restrained slabs will result in stresses due to friction or curling. When any of these stresses exceed the strength of the slab, cracking will occur. LTD cracking is recorded at low, medium, or high severity, depending on the width of crack opening and degree of deterioration. At low severity, the crack is less than 1/8th inch wide with little spalling and no corrective action is indicated. At medium severity, LTD cracks can be up to 1 inch wide with moderate spalling, and should be repaired and sealed using procedures similar to joint sealing. At high severity, cracks exceed 1 inch in width and may be severely spalled. High-severity LTD cracking is evidence of serious load failure of the slab, and correction may require patching or slab replacement. If the distress occurs in several adjacent slabs at medium or high severity, major rehabilitation of that pavement area is indicated.

When a slab is divided by LTD cracks into four or more pieces, the slab is said to be "divided" or "shattered." Shattered slab is a separate distress category and is indicative of significant structural failure as the slab loses its ability to distribute loads to subgrade and further slab deterioration can be expected. Shattered slabs are rated in three severities, with slab replacement recommended for medium and high severities.

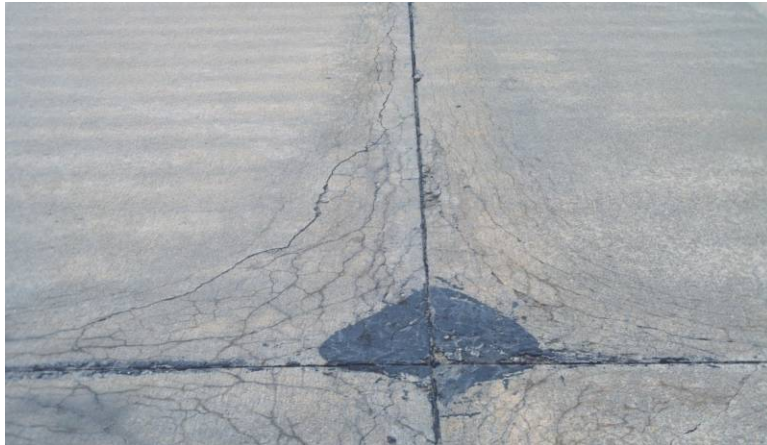
Example of Durability Cracking

Durability cracking (D-cracking) is caused by environmental factors, the most common of which is freezing/thawing. It usually appears as a pattern of hairline cracks running parallel to a joint or crack, or in a corner, where water tends to collect. This type of cracking eventually leads to disintegration of the pavement, creating FOD potential. At low severity, D-cracking is evident, but no disintegration has occurred. As the distress advances to medium severity, the distress pattern is evident over a significant area of the slab, and some disintegration and FOD potential exists. High severity durability cracking is evidenced by extensive cracking with loose and missing pieces and significant FOD potential.
