Minnesota Airport System Pavement Evaluation 2013 Update

Owatonna – Degner Regional Airport
(OWA)

Final Report

Applied Research Associates, Inc.
100 Trade Centre Dr., Suite 200
Champaign, IL 61820
(217) 356-4500

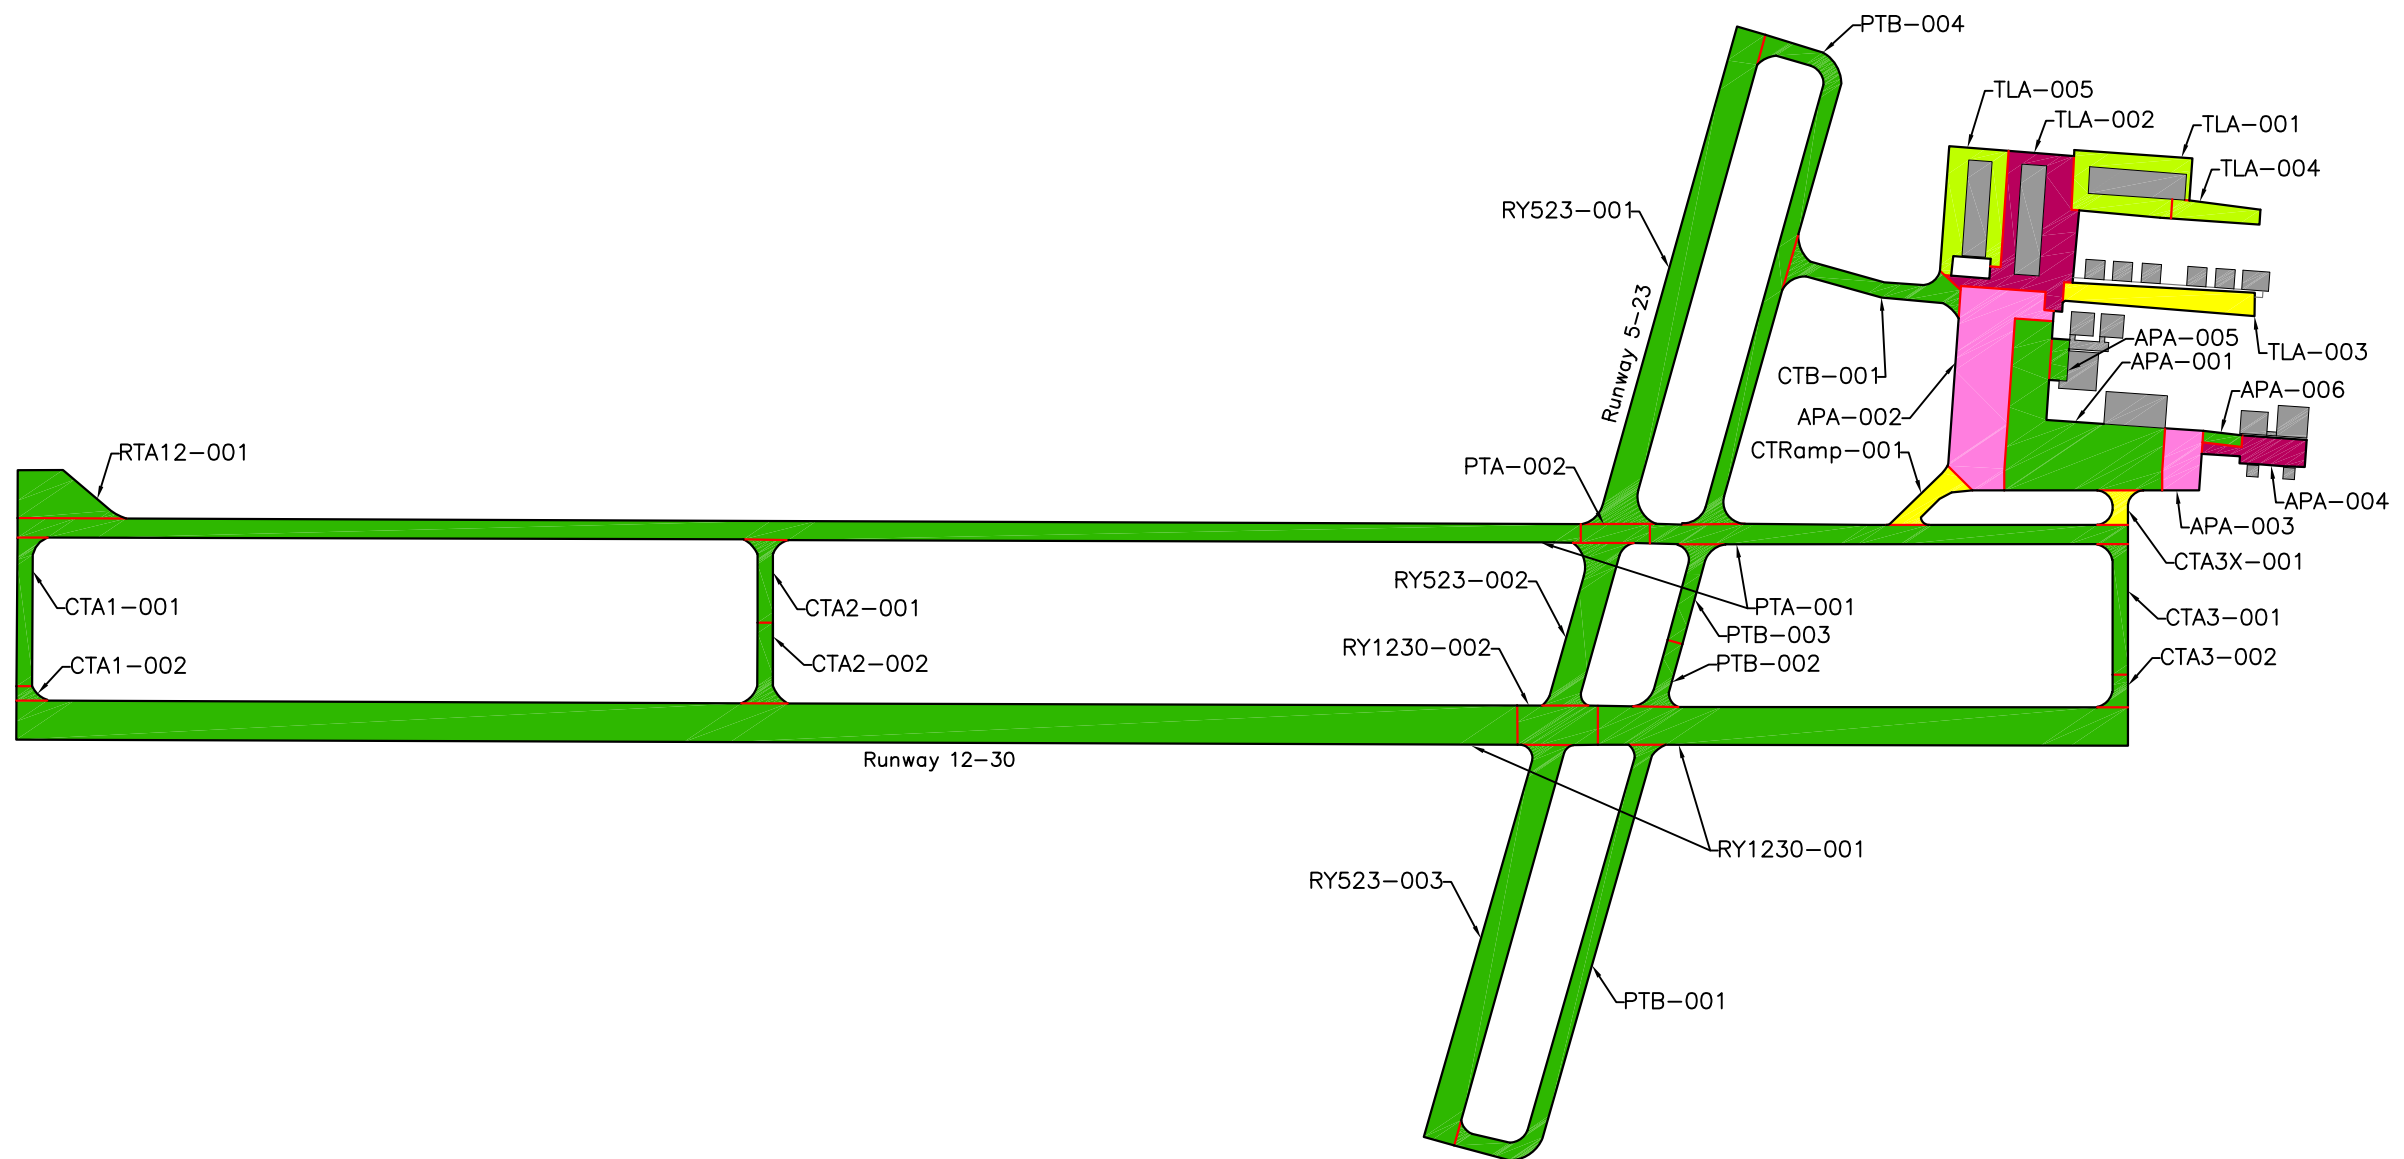
Figure 4. 2013 Pavement Condition Index Rating at Owatonna-Degner Regional Airport (OWA).

The results of the 2013 PCI inspection are presented in figure 4. The overall area-weighted PCI for OWA is 90. When summarizing PCI values, an area-weighted calculation is used instead of a straight mathematical average because the area-weighted calculations eliminate the skewing of the PCI due to the disparity of the section sizes.
