# Minnesota Airport System Pavement Evaluation 2013 Update

Pine River Regional Airport (PWC)

Pine River, Minnesota

*Final Report*

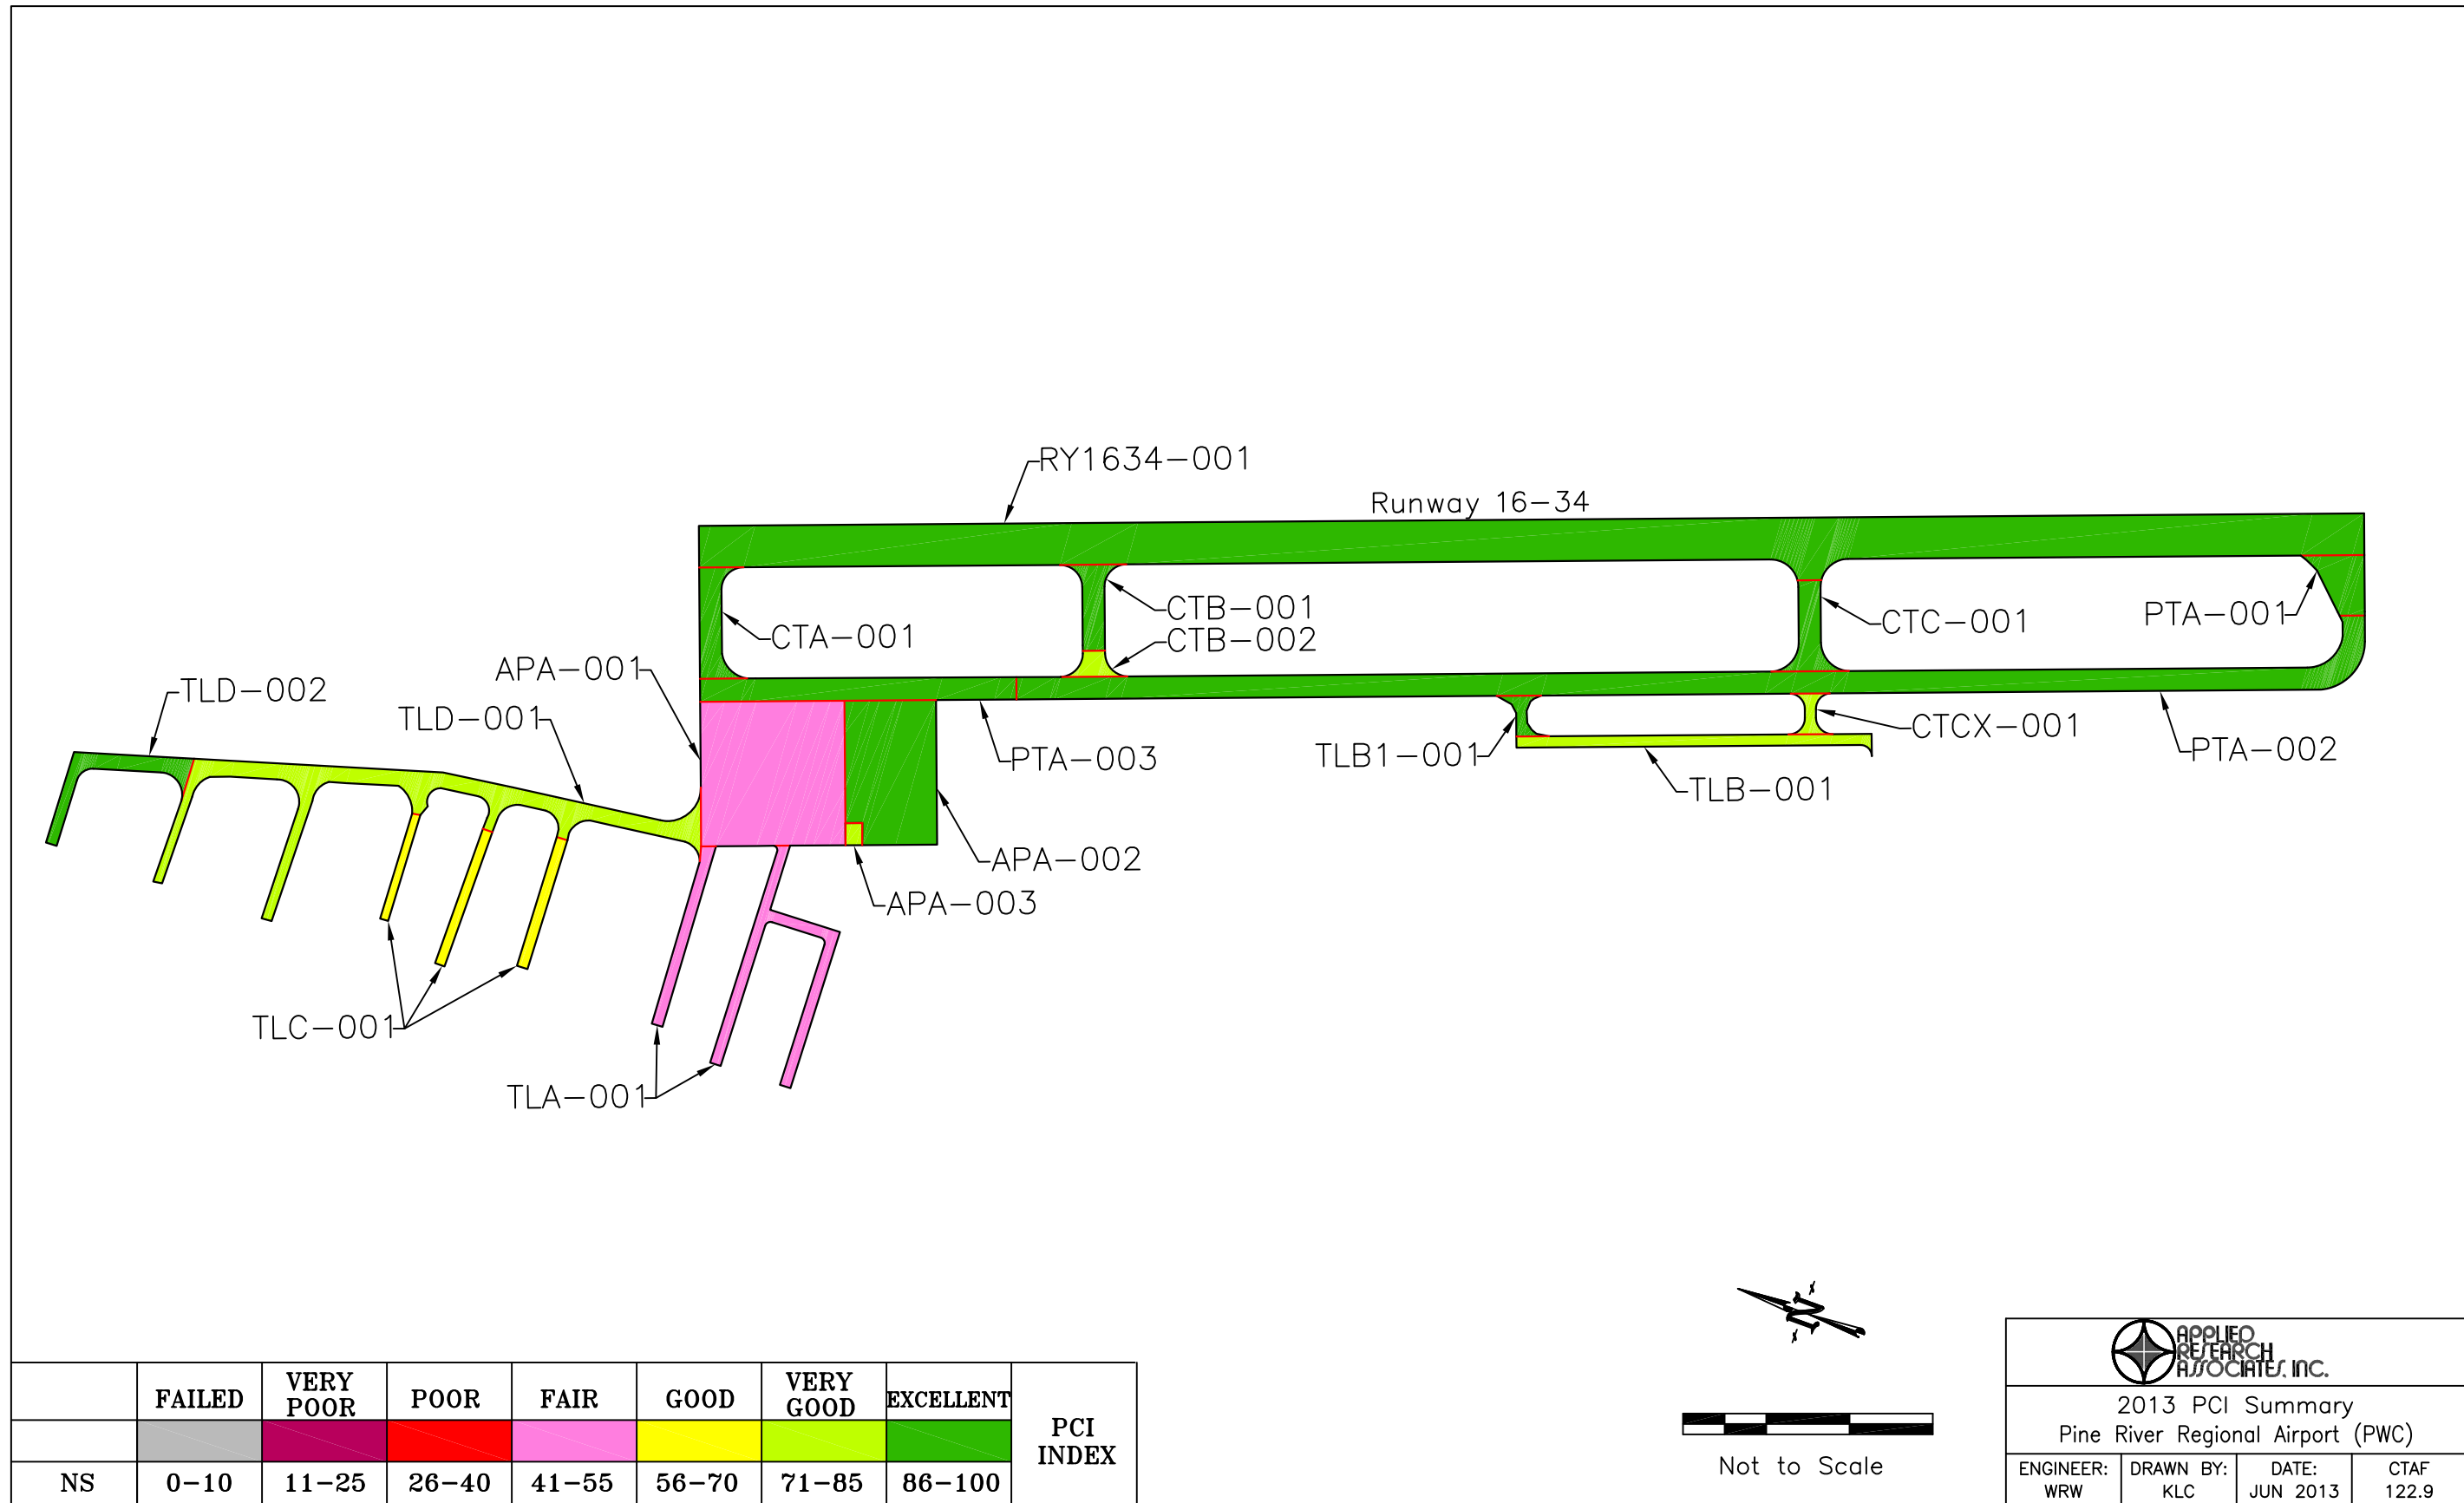
Figure 4. 2013 Pavement Condition Index Rating at Pine River Regional Airport (PWC).

The results of the 2013 PCI inspection are presented in figure 4. The overall area-weighted PCI for PWC is 86. When summarizing PCI values, an area-weighted calculation is used instead of a straight mathematical average because the area-weighted calculations eliminate the skewing of the PCI due to the disparity of the section sizes.

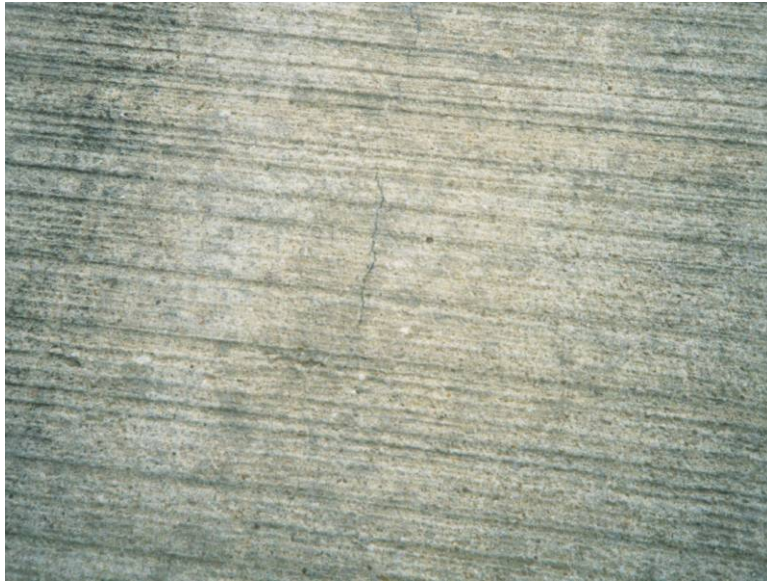
### *Example of Shrinkage Cracking*

Shrinkage cracks are small, nonworking (no spalling along edge) cracks that are visible at the surface but do not penetrate through the full depth of concrete. Shrinkage cracks most commonly occur shortly after construction due to concrete shrinkage during the curing process. Shrinkage cracks are usually so small that they are not visible until staining or material loss at crack edges begins to take place. Shrinkage cracks do not represent a structural weakness, and no corrective action is prescribed.
