Minnesota Airport System Pavement Evaluation 2013 Update

Longville Municipal Airport (XVG)

Longville, Minnesota

Final Report

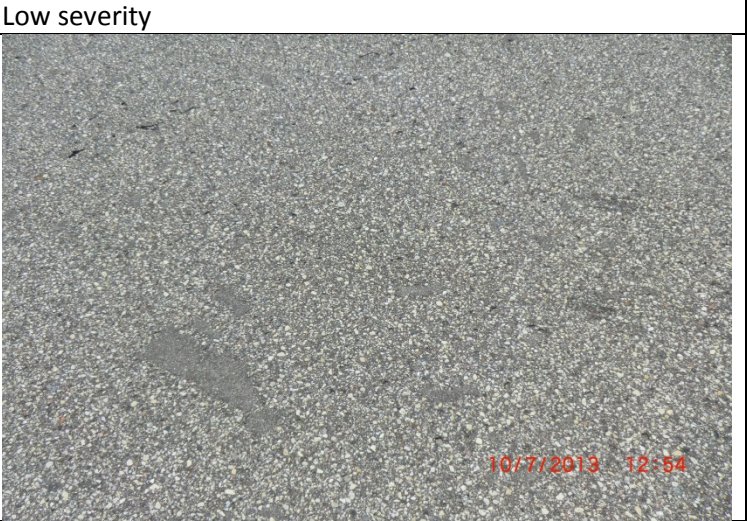
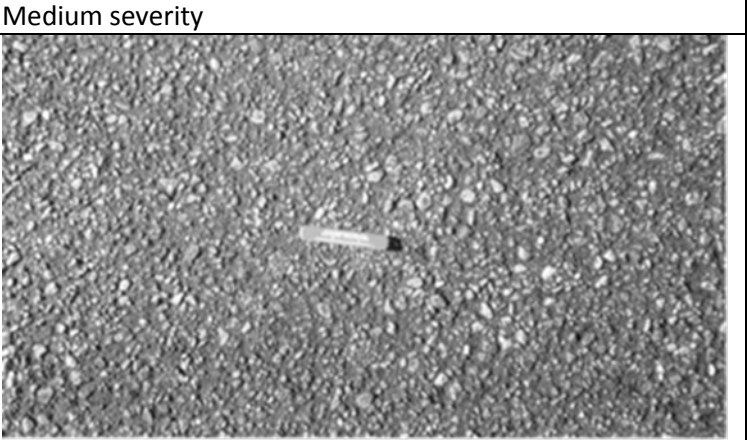
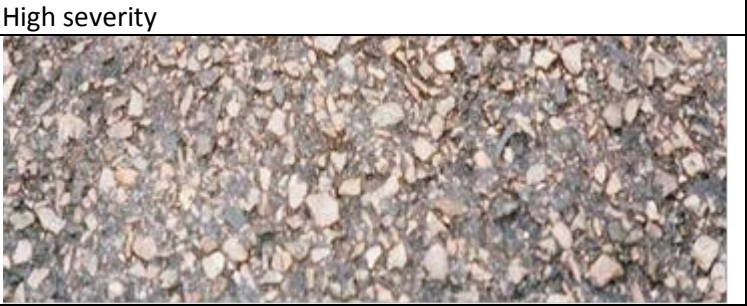
Weathering – At low severity, the coarse aggregate is slightly exposed due to the wearing away of the fine aggregate. At medium severity, the coarse aggregate is exposed up to ¼ the width of the longest side. At high severity, the coarse is exposed greater than ¼ the width of the longest side.
