Minnesota Airport System Pavement Evaluation 2013 Update

Walker Municipal Airport (Y49)

Walker, Minnesota

Final Report

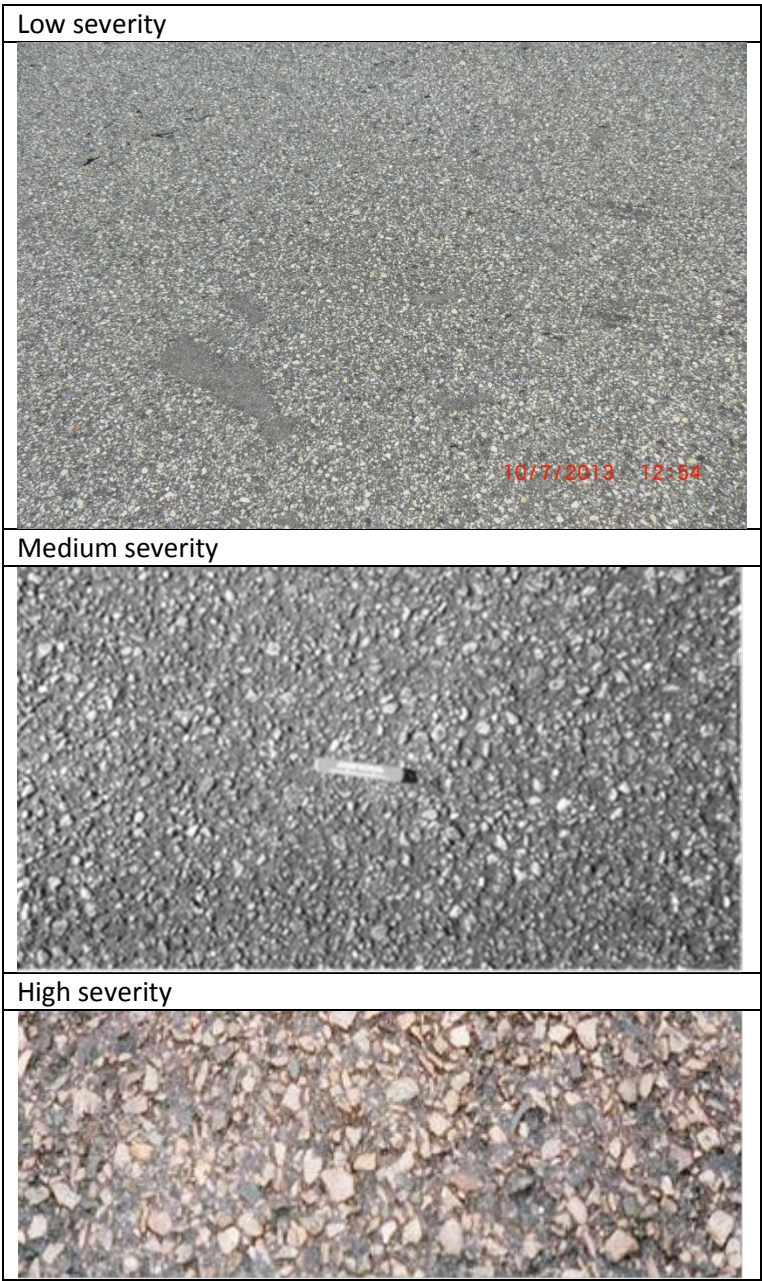
Weathering – At low severity, the coarse aggregate is slightly exposed due to the wearing away of the fine aggregate. At medium severity, the coarse aggregate is exposed up to ¼ the width of the longest side. At high severity, the coarse is exposed greater than ¼ the width of the longest side.
