*Final Report*

# Pavement Condition Report

Baudette International Airport (BDE)

**December 2014**

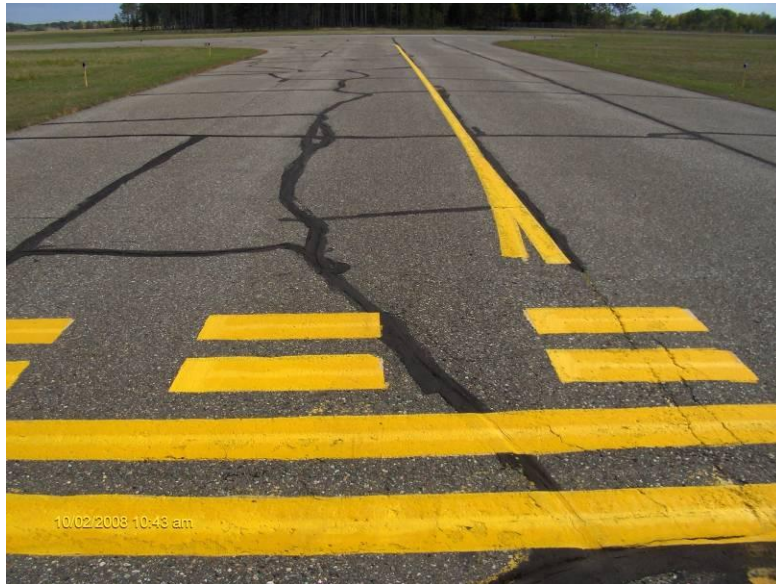
### ***Example of Longitudinal and Transverse Cracking (L&T cracking)***

Longitudinal and transverse cracks are caused by pavement aging, by construction, and by subsurface movement. Aging occurs as pavement loses some of its components to the atmosphere and becomes more brittle. Consistent application of pavement sealcoats can help to prevent the occurrence of age related cracks. Cracks will also develop along poorly constructed paving lane joints. Ensuring that joints are made when both sides are still hot, and near the same temperature, is one of the best ways to mitigate this potential problem. Seasonal movement caused by changes in moisture content or temperature differences can also cause pavement cracks. Asphalt pavement placed over a PCC pavement or cement stabilized base course may evidence reflective cracking from the underlying material. Longitudinal and transverse cracks are not caused by wheel loads, although traffic may worsen their condition.

Low severity longitudinal and transverse cracks are less than ¼ inch wide, or if sealed with suitable filler material in satisfactory condition can be any width, less than 3 inches, if they are not spalled. Maintenance usually is not indicated for low-severity cracking. Moderately spalled cracks and cracks wider than ¼ inch which are not satisfactorily sealed are at medium severity. Medium-severity cracks should be sealed with a high-quality crack filling material. Severely spalled cracks and cracks wider than 3 inches are at high severity. High-severity L&T cracks normally require patching.

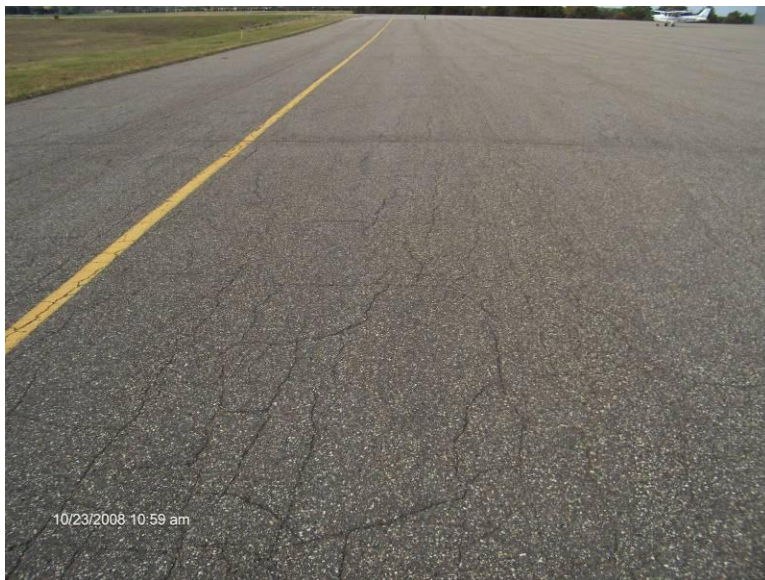
### *Example of Alligator Cracking*

Alligator (or fatigue) cracks are a series of interconnected load-related cracks caused by fatigue of the asphalt surface. Alligator cracking is a significant structural distress and develops only in places subject to traffic loads. These cracks typically initiate at the bottom of the asphalt layer (where tensile strains

are highest) and propagate upward - so once a fatigue crack is visible, significant damage has already occurred.

At low severity, alligator cracks are evidenced by a series of parallel hairline cracks (usually in a wheel path). Further traffic and deterioration leads to the interconnection of these cracks. Medium severity alligator cracking is a well-defined pattern of interconnected cracks, some spalling may be present. High severity alligator cracks have lost aggregate interlock between adjacent pieces, the cracks may be severely spalled with FOD potential, and most likely the pieces will move freely under traffic. Alligator cracking is a structural failure and cannot be repaired with sealant, the proper repair is full-depth patching.

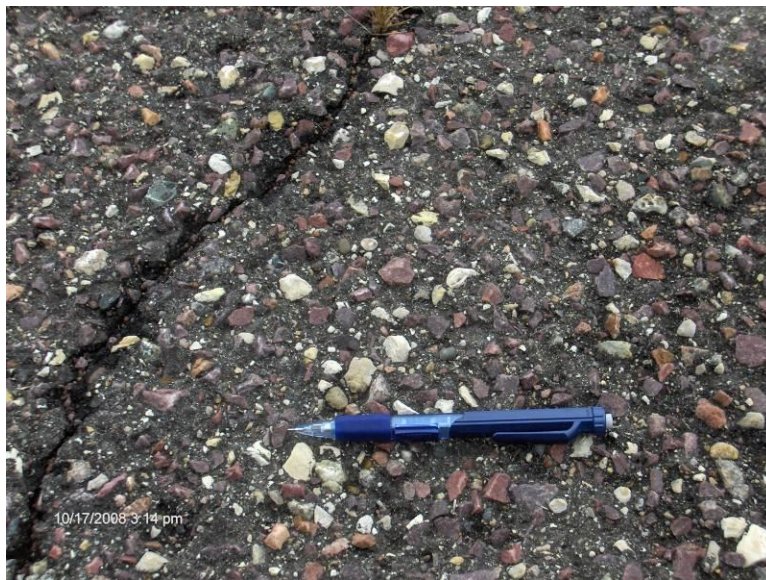
#### *Example of Raveling/Weathering*

Raveling and weathering are the wearing away of the pavement surface. Raveling is the condition where the mid- to large size aggregates are becoming dislodged; weathering is when the fine aggregate wears away exposing the edges of the larger aggregate. These distresses are usually evident over large areas and may occur together (pictured above) or separately. Raveling and weathering may indicate that the asphalt binder has hardened significantly.

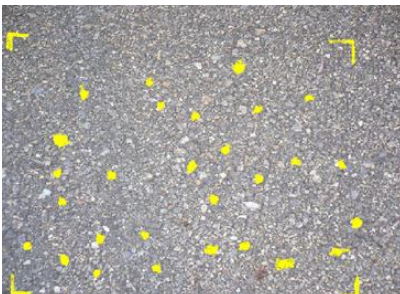
Raveling – At low severity, the number of missing coarse aggregates ( $> 3/8$  inch) is between 5-20 missing/yd<sup>2</sup>, medium severity (pictured below where the missing coarse aggregates have been dotted with yellow paint) is 21-40 missing/yd<sup>2</sup>, and high severity is  $> 40$  missing/yd<sup>2</sup>.

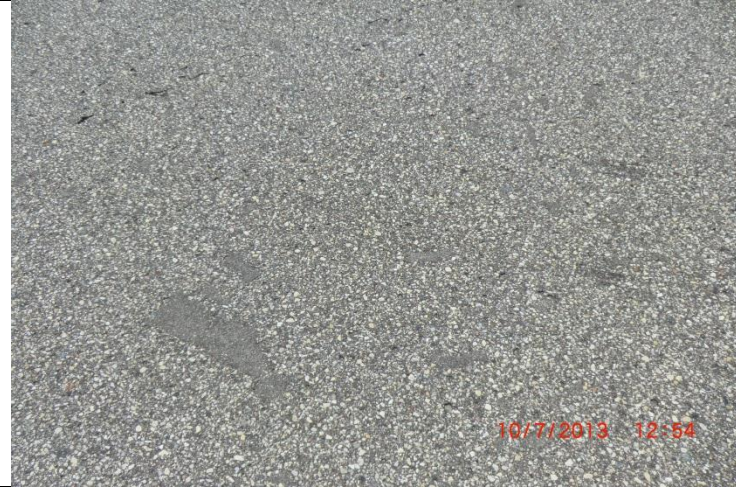
Low severity

Weathering – At low severity, the coarse aggregate is slightly exposed due to the wearing away of the fine aggregate. At medium severity, the coarse aggregate is exposed up to  $\frac{1}{4}$  the width of the longest side. At high severity, the coarse is exposed greater than  $\frac{1}{4}$  the width of the longest side.

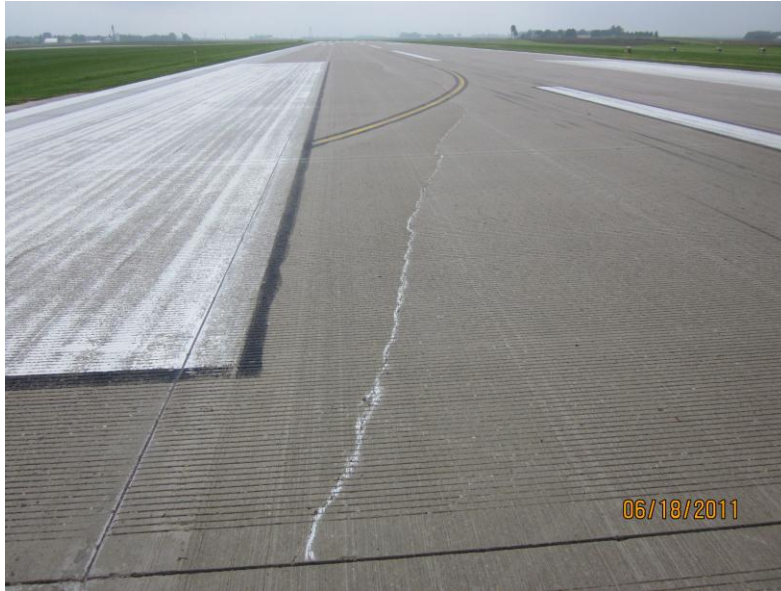
#### ***Example of Longitudinal, Transverse, and Diagonal Cracking***

LTD cracking is most often a result of externally applied loads and/or constrained temperature deformations. External loads cause LTD cracking through flexure. Temperature changes on restrained slabs will result in stresses due to friction or curling. When any of these stresses exceed the strength of the slab, cracking will occur. LTD cracking is recorded at low, medium, or high severity, depending on the width of crack opening and degree of deterioration. At low severity, the crack is less than 1/8th inch wide with little spalling and no corrective action is indicated. At medium severity, LTD cracks can be up to 1 inch wide with moderate spalling, and should be repaired and sealed using procedures similar to joint sealing. At high severity, cracks exceed 1 inch in width and may be severely spalled. High-severity LTD cracking is evidence of serious load failure of the slab, and correction may require patching or slab replacement. If the distress occurs in several adjacent slabs at medium or high severity, major rehabilitation of that pavement area is indicated.

When a slab is divided by LTD cracks into four or more pieces, the slab is said to be "divided" or "shattered." Shattered slab is a separate distress category and is indicative of significant structural failure as the slab loses its ability to distribute loads to subgrade and further slab deterioration can be expected. Shattered slabs are rated in three severities, with slab replacement recommended for medium and high severities.

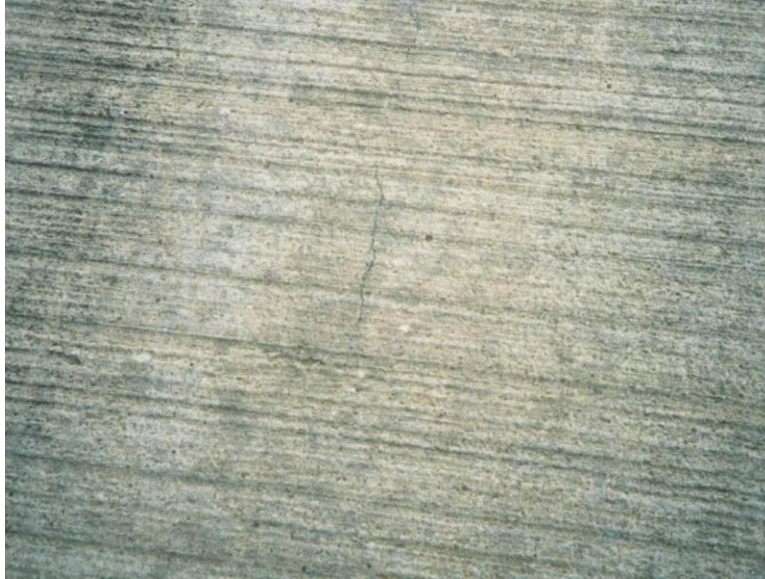
### *Example of Shrinkage Cracking*

Shrinkage cracks are small, nonworking (no spalling along edge) cracks that are visible at the surface but do not penetrate through the full depth of concrete. Shrinkage cracks most commonly occur shortly after construction due to concrete shrinkage during the curing process. Shrinkage cracks are usually so small that they are not visible until staining or material loss at crack edges begins to take place. Shrinkage cracks do not represent a structural weakness, and no corrective action is prescribed.

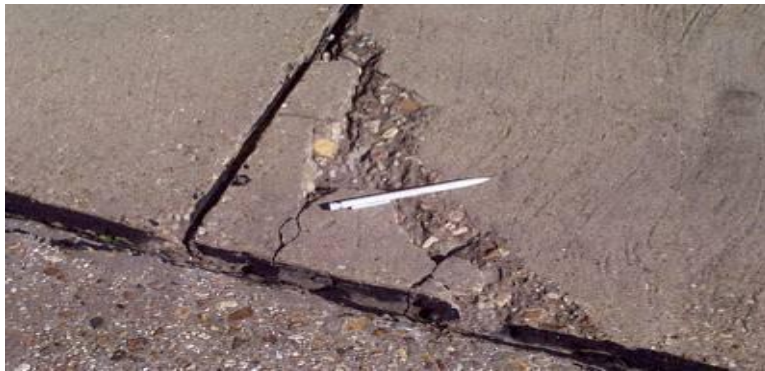
### *Example of Joint and Corner Spalling*

Spalls at slab joints and corners are caused by excessive internal stress in the pavement. Spalls occur when these stresses exceed the shear strength of the concrete. Spalling usually results from thermal expansion during warm or hot weather. As slabs expand, they push against one another at joints. If the joints are filled with incompressibles, such as sand, or if adjacent slabs offset slightly, stresses can become severe, causing spalls. Spalling can be reduced significantly by conscientious maintenance of joint sealant.

Spall repair requires patching. The extent and severity of spalling on a pavement surface suggests appropriate action. For example, at low severity, spalled concrete remains securely in place in the slab. A low-severity spall should be monitored closely for further deterioration and should be patched when

spalled particles become loose in place, or at the next scheduled patching activity in the section. Medium- and high-severity spalls should be repaired immediately to prevent the incidence of FOD. If the pavement can be restored to serviceable condition, spalls should be carefully patched for long-term service. If the pavement is beyond repair, temporary patching should be considered to control FOD.

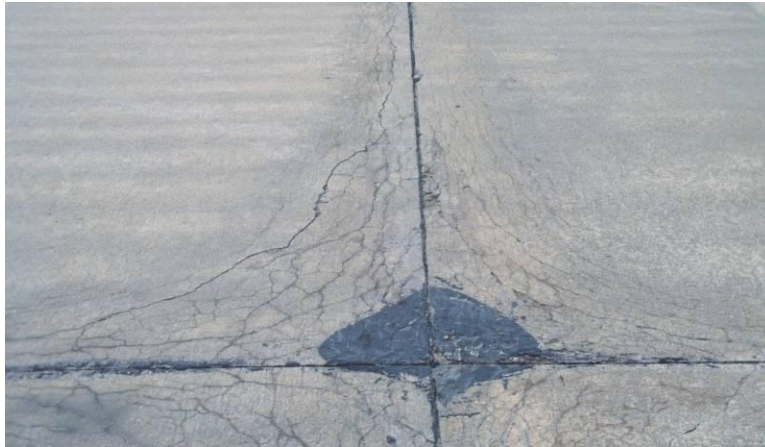
#### *Example of Durability Cracking*

Durability cracking (D-cracking) is caused by environmental factors, the most common of which is freezing/thawing. It usually appears as a pattern of hairline cracks running parallel to a joint or crack, or in a corner, where water tends to collect. This type of cracking eventually leads to disintegration of the pavement, creating FOD potential. At low severity, D-cracking is evident, but no disintegration has occurred. As the distress advances to medium severity, the distress pattern is evident over a significant area of the slab, and some disintegration and FOD potential exists. High severity durability cracking is evidenced by extensive cracking with loose and missing pieces and significant FOD potential.
