Final Report

Pavement Condition Report

Willmar Municipal Airport (BDH)

December 2014

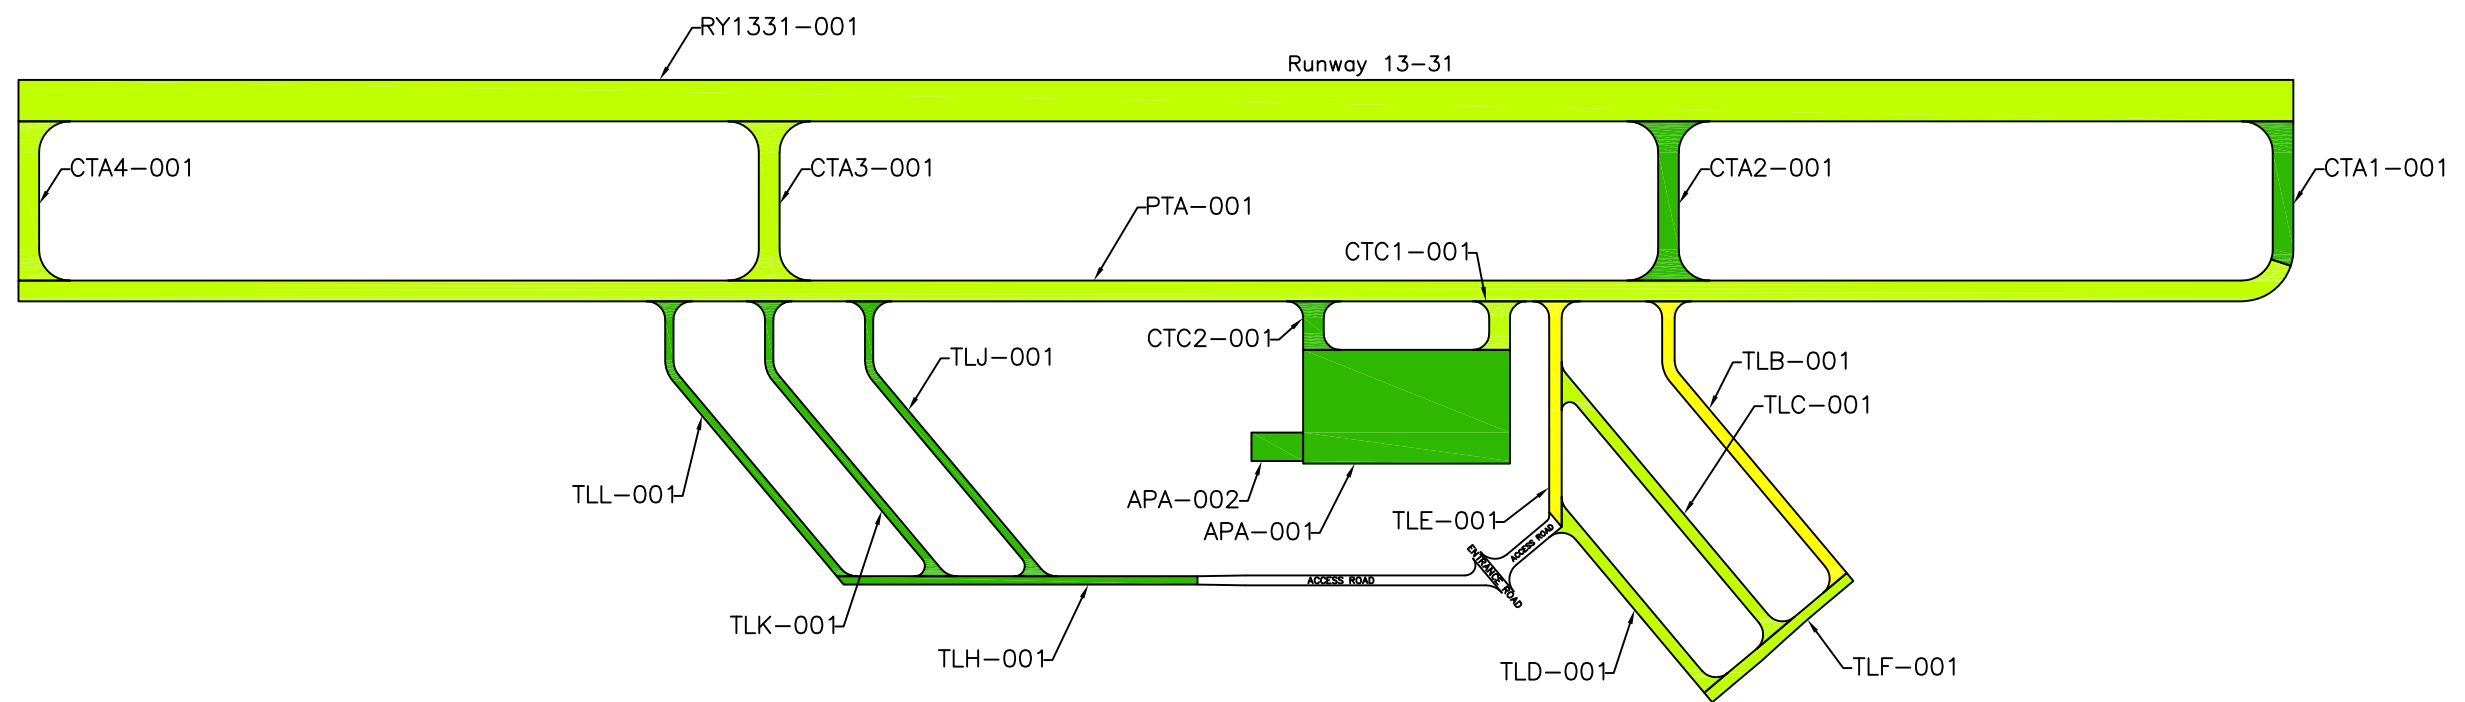
Figure 4. 2014 Pavement Condition Index Rating at Willmar Municipal Airport (BDH).

The results of the 2014 PCI inspection are presented in figure 4. The overall area-weighted PCI for BDH is 83. When summarizing PCI values, an area-weighted calculation is used instead of a straight mathematical average because the area-weighted calculations eliminate the skewing of the PCI due to the disparity of the section sizes.
