Final Report

Pavement Condition Report

Brainerd Lakes Regional Airport (BRD)

December 2014

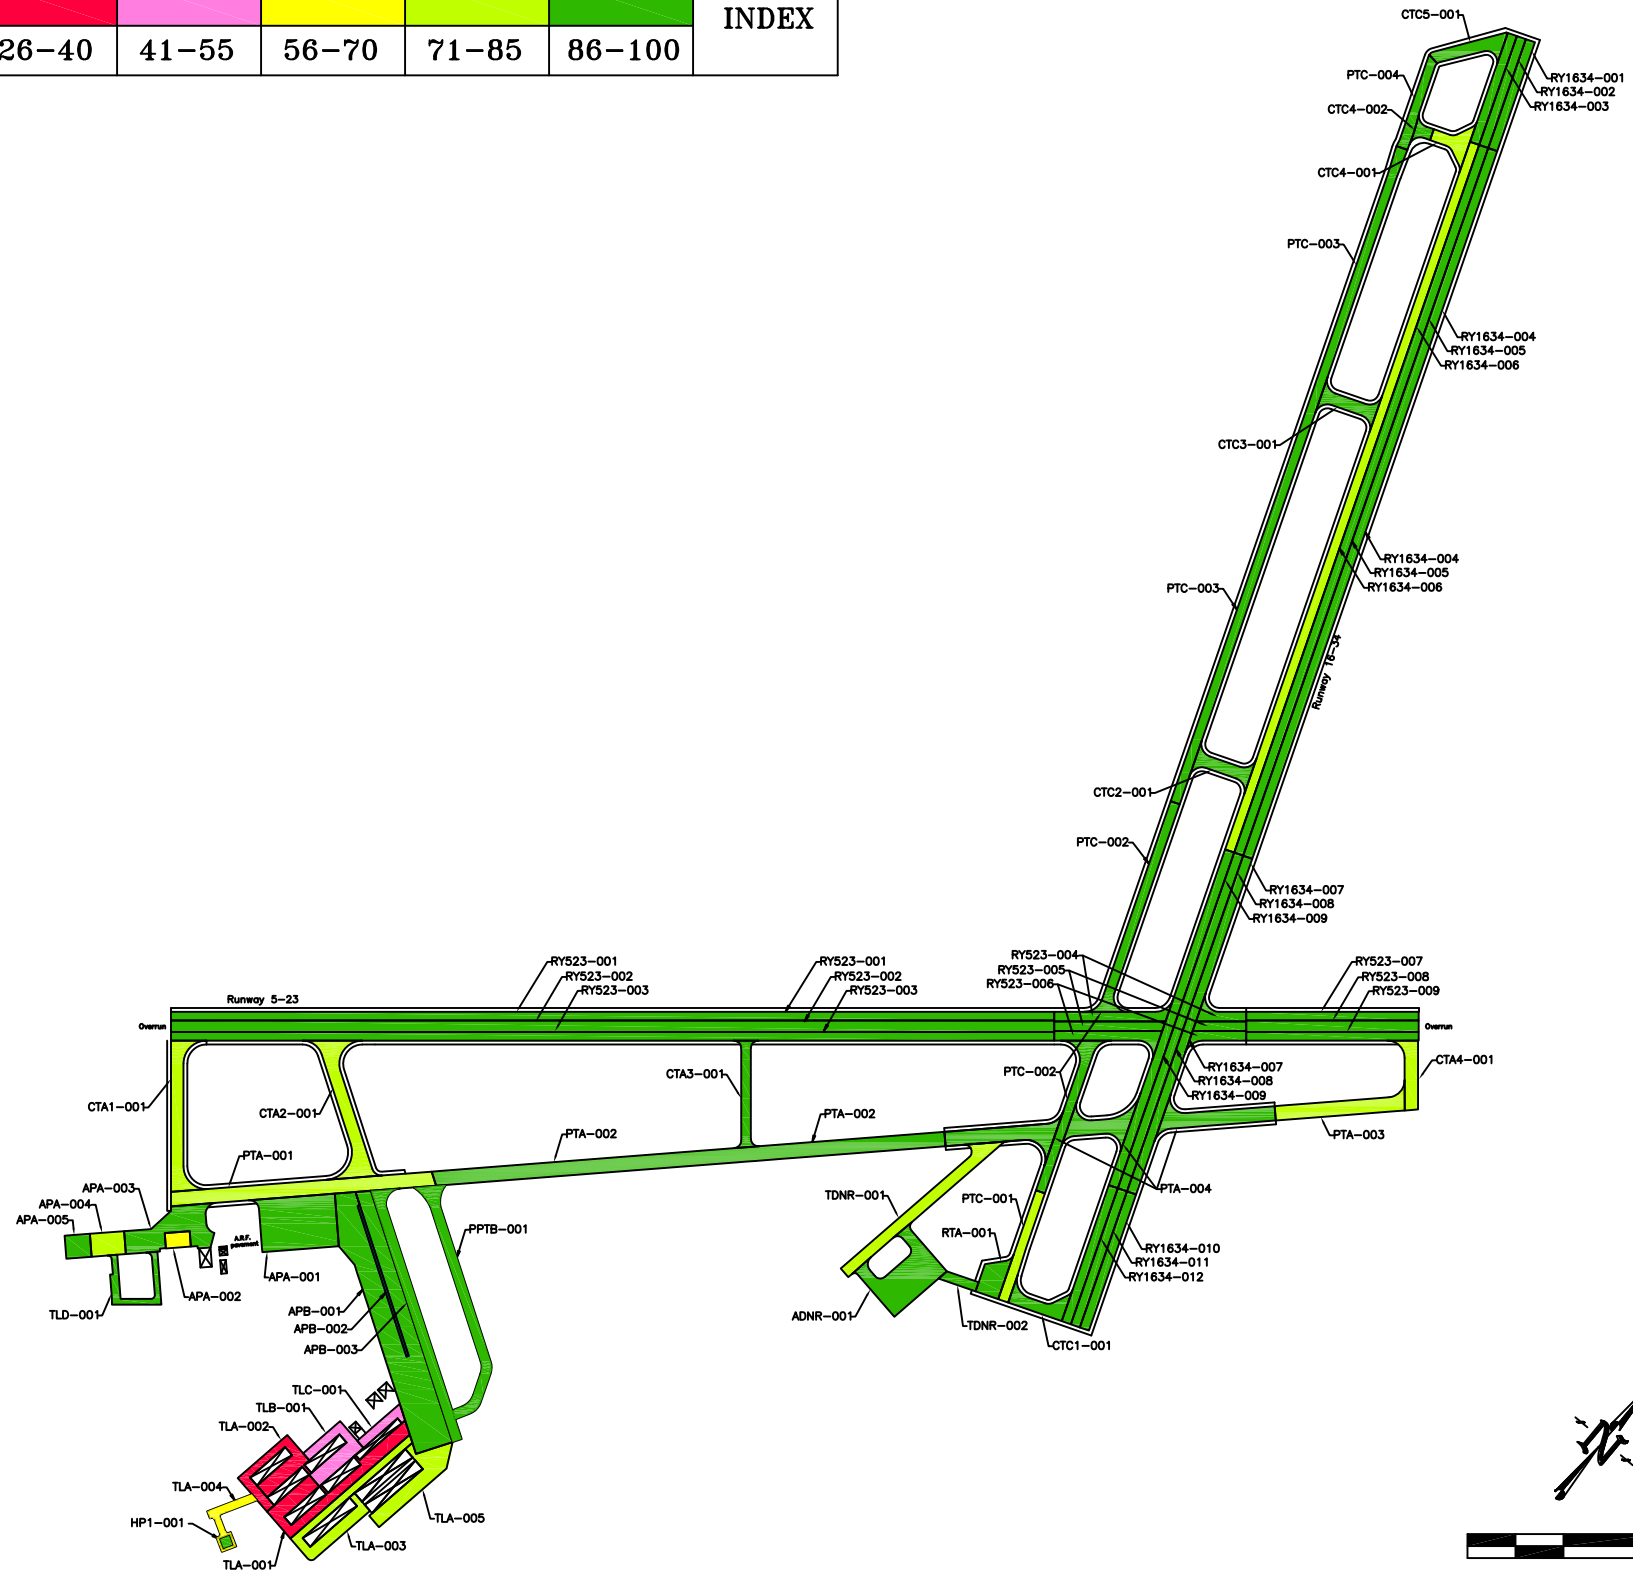
Figure 4. 2014 Pavement Condition Index Rating at Brainerd Lakes Regional Airport (BRD).

The results of the 2014 PCI inspection are presented in figure 4. The overall area-weighted PCI for BRD is 89. When summarizing PCI values, an area-weighted calculation is used instead of a straight mathematical average because the area-weighted calculations eliminate the skewing of the PCI due to the disparity of the section sizes.

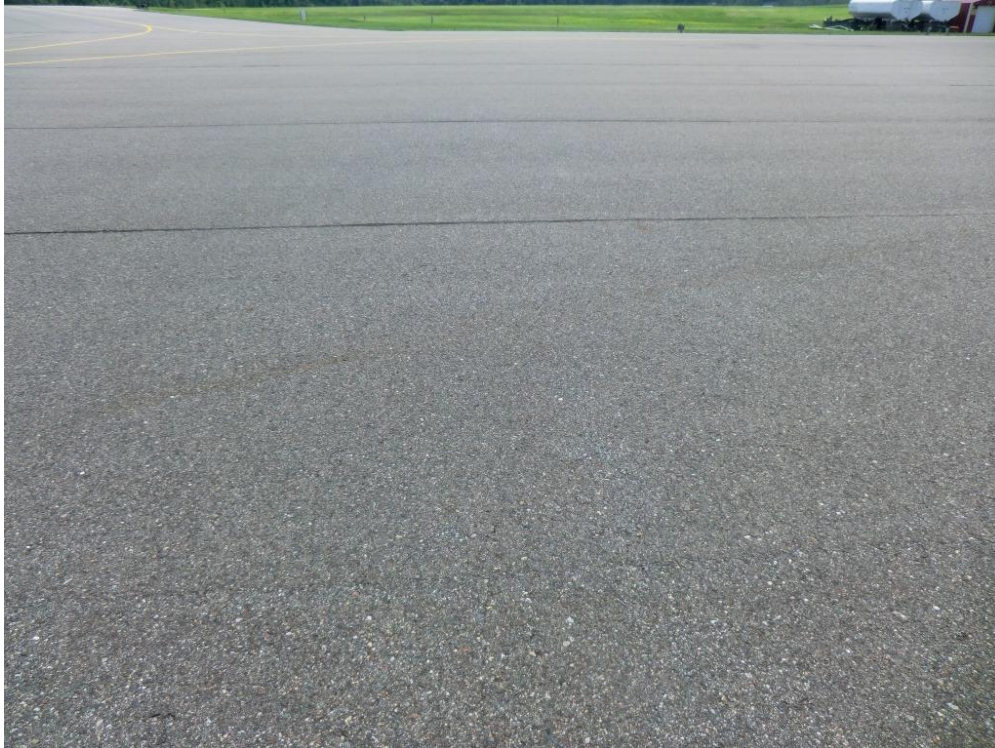
BRD ADNR 001 (PCI = 88)

Branch ID	Section ID	Surface type ¹	Section area (SF)	LCD ²	2011 PCI	2014 PCI	Drop in PCI/Yr ³	% Deduct due to		Distress types
								Load ⁴	Climate ⁵	
ADNR	1	AC	83,400	2004	95	88	1.2	0	100	L&T cracking, weathering
APA	1	PCC	110,000	1980	96	94	0.2	21	31	multiple
APA	2	PCC	10,400	2007	69	56	6.3	92	0	multiple and extensive
APA	3	AC	66,200	2007	99	90	1.4	0	100	L&T cracking
APA	4	AC	21,360	2007	80	77	3.3	0	100	L&T cracking, patching
APA	5	AC	15,840	2007	97	97	0.4	0	100	L&T cracking
APB	1	AC	272,430	2010	97	89	2.8	0	88	L&T cracking, oil spillage
APB	2	PCC	10,313	2010	100	98	0.5	0	0	corner spall
APB	3	AC	68,500	2010	98	91	2.3	0	100	L&T cracking
CTA1	1	AAC	55,400	2007	82	83	2.4	0	100	L&T cracking
CTA2	1	AAC	70,575	2007	81	78	3.1	0	100	L&T cracking
CTA3	1	AAC	28,850	2008	100	99	0.2	0	100	L&T cracking
CTA4	1	AC	27,000	2008	90	84	2.7	0	100	L&T cracking
CTC1	1	AC	23,700	2005	100	94	0.7	0	100	L&T cracking
CTC2	1	AC	21,600	2005	100	94	0.7	0	100	L&T cracking

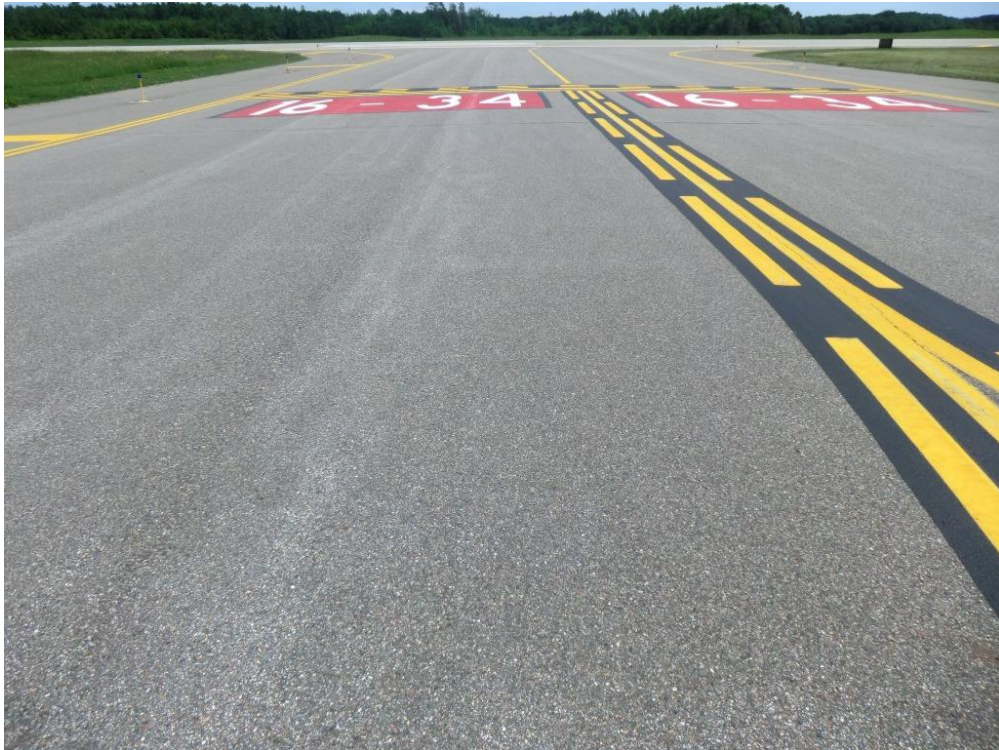
BRD CTC3 001 (PCI = 89)

CTC3	1	AC	21,600	2005	100	89	1.2	0	100	L&T cracking
CTC4	1	AC	20,300	2005	94	85	1.7	0	100	L&T cracking
CTC4	2	AAC	7,080	2010	100	100	0.0	0	0	no distress
CTC5	1	AC	25,950	2010	100	100	0.0	0	0	no distress
HP1	1	PCC	3,600	1990	100	100	0.0	0	0	no distress
PPTB	1	AC	70,805	2012	100	100	0.0	0	0	no distress
PTA	1	AC	103,125	2007	83	84	2.3	0	100	L&T cracking
PTA	2	AC	199,875	2008	85	87	2.2	0	100	L&T cracking
PTA	3	AC	53,075	2008	86	84	2.7	0	100	L&T cracking
PTA	4	AC	142,250	2006	100	98	0.3	0	100	L&T cracking
PTC	1	AC	30,000	2005	90	82	2.0	0	100	L&T cracking
PTC	2	AC	108,000	2006	96	92	1.0	0	100	L&T cracking
PTC	3	AC	187,250	2005	93	86	1.6	0	100	L&T cracking
PTC	4	AC	23,750	2010	100	95	1.3	0	100	L&T cracking
