Final Report

Pavement Condition Report

Cambridge Municipal Airport (CBG)

December 2014

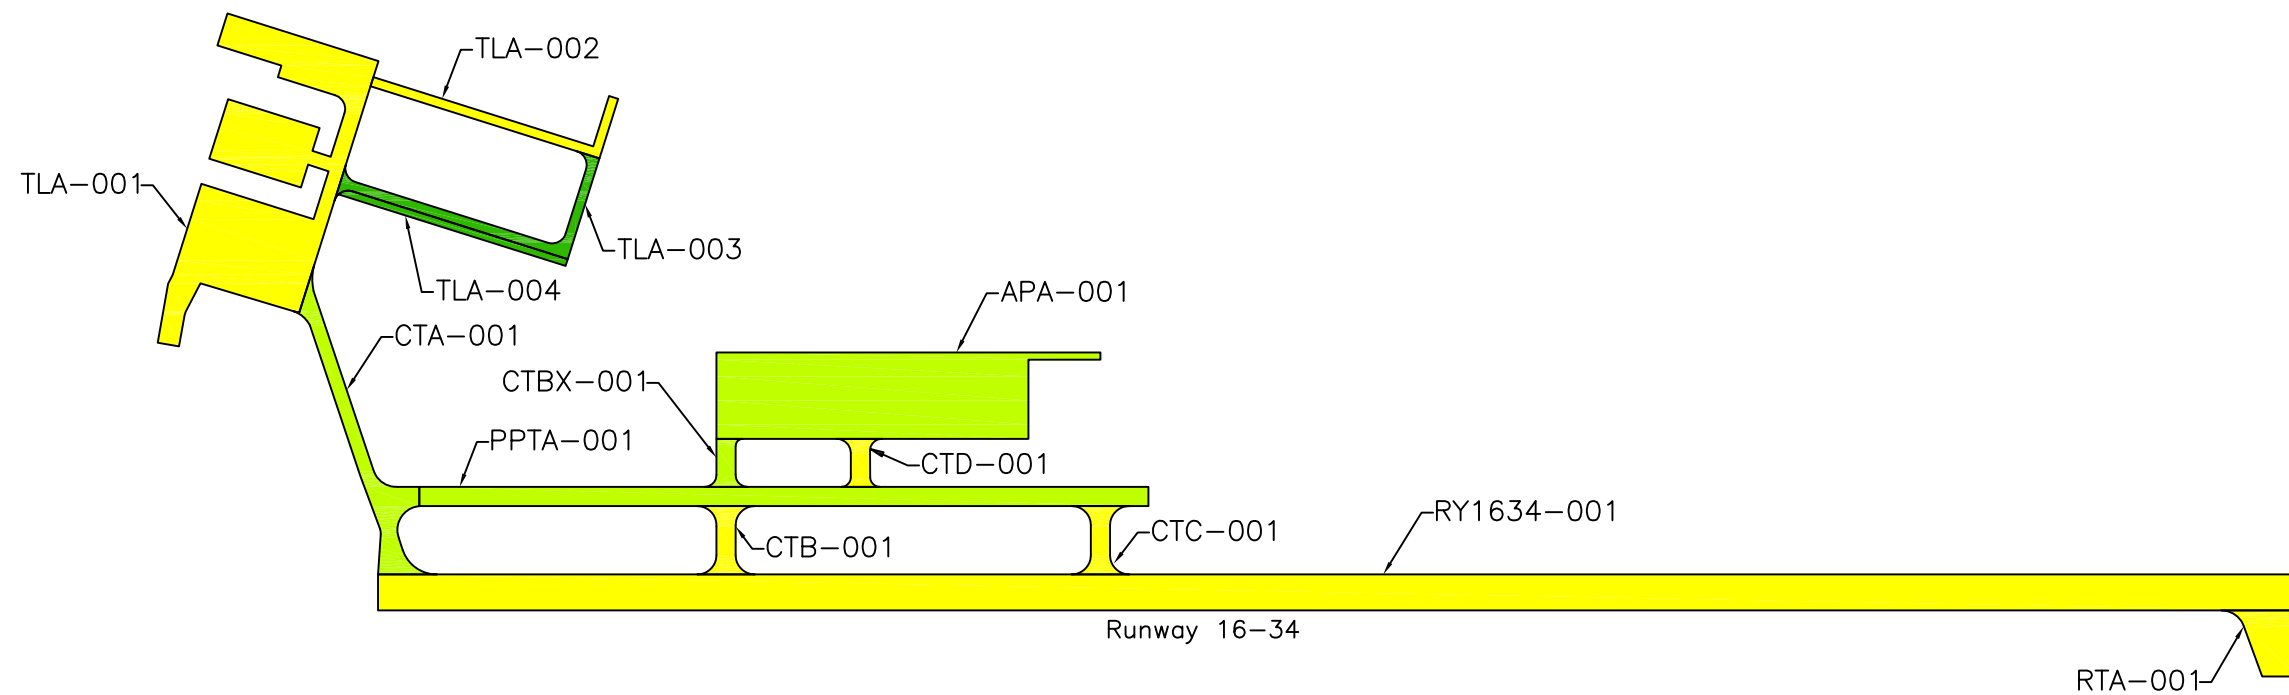
Figure 4. 2014 Pavement Condition Index Rating at Cambridge Municipal Airport (CBG).

The results of the 2014 PCI inspection are presented in figure 4. The overall area-weighted PCI for CBG is 70. When summarizing PCI values, an area-weighted calculation is used instead of a straight mathematical average because the area-weighted calculations eliminate the skewing of the PCI due to the disparity of the section sizes.
