# Pavement Condition Report

## Houston County Airport (CHU)

**December 2014**

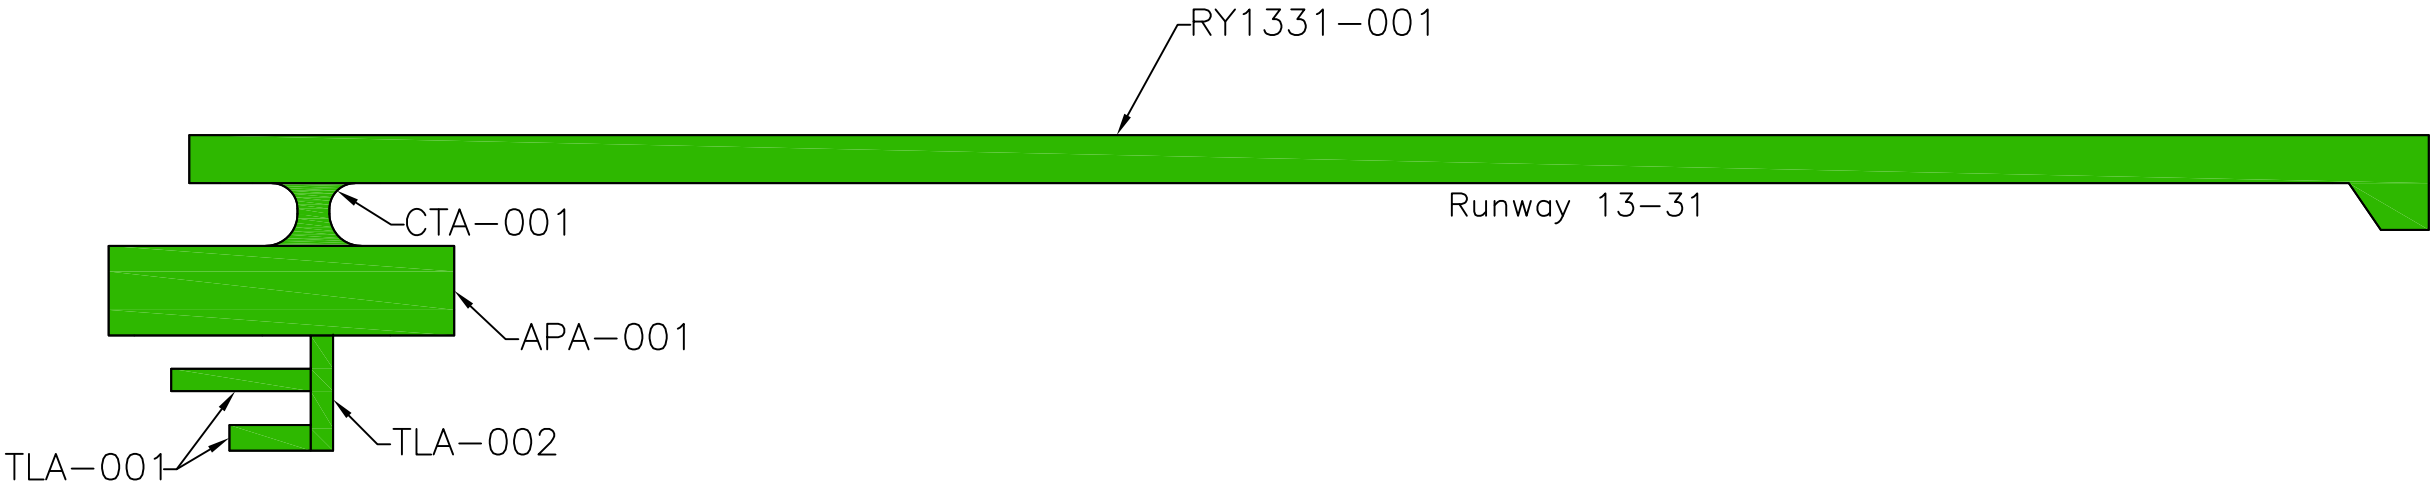
Figure 4. 2014 Pavement Condition Index Rating at Caledonia-Houston County Airport (CHU).

The results of the 2014 PCI inspection are presented in figure 4. The overall area-weighted PCI for CHU is 93. When summarizing PCI values, an area-weighted calculation is used instead of a straight mathematical average because the area-weighted calculations eliminate the skewing of the PCI due to the disparity of the section sizes.

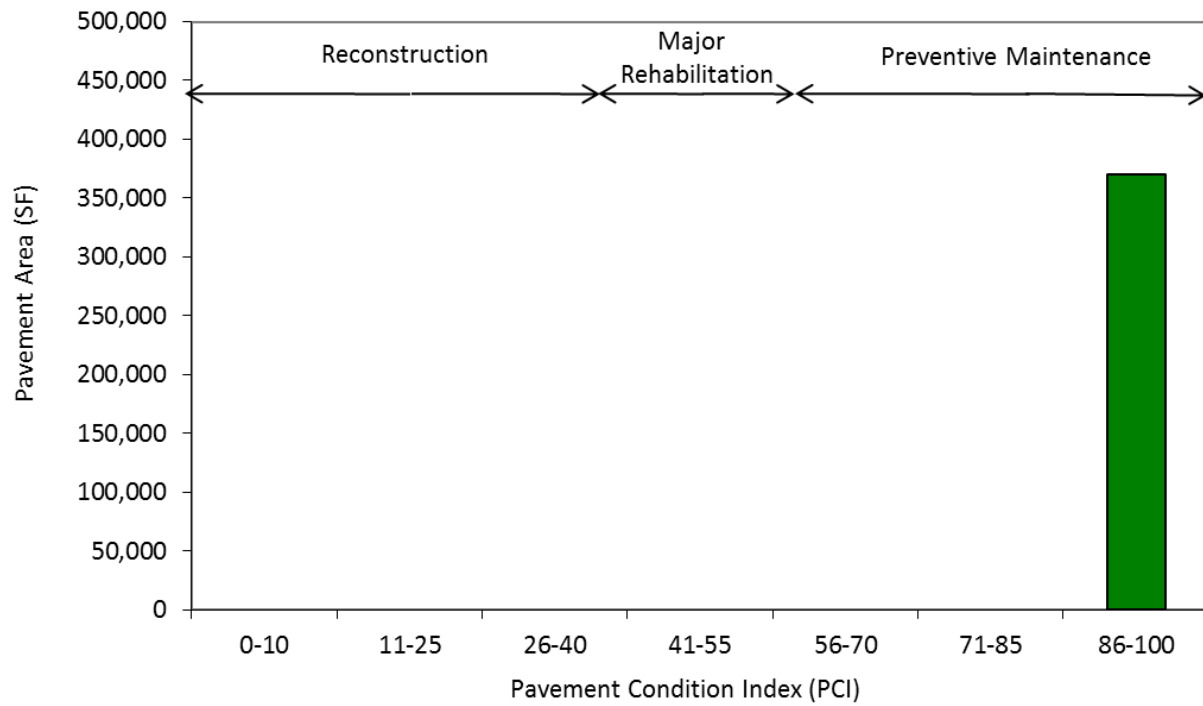
Figure 5. Condition distribution.

Figures 5 and 6 present the overall PCI for CHU by area distribution and pavement use, respectively. Table 3 presents the PCI summary for each section at CHU, including the drop in PCI per year. Generally, pavement sections will deteriorate between 1 and 3 PCI points per year. Sections deteriorating at higher rates may need maintenance above the normal application rates and should be closely monitored in case major repairs become necessary earlier than expected.

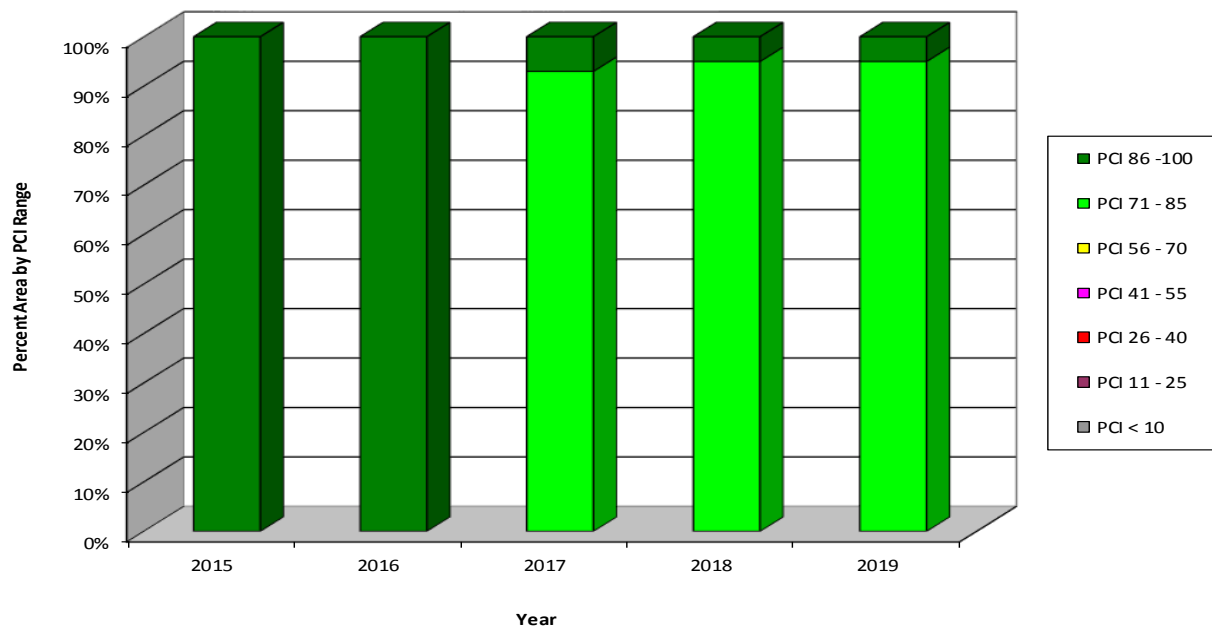
Figure 7. Projected PCI by percent area.

Figure 7 shows the projected PCI at CHU by percent area for the next 5 years assuming no major repairs (overlays, reconstruction, etc.) are performed during that period. It shows how quickly a pavement network can deteriorate when no capital improvements are made.
