Final Report

Pavement Condition Report

Cloquet-Carlton County Airport (COQ)

December 2014

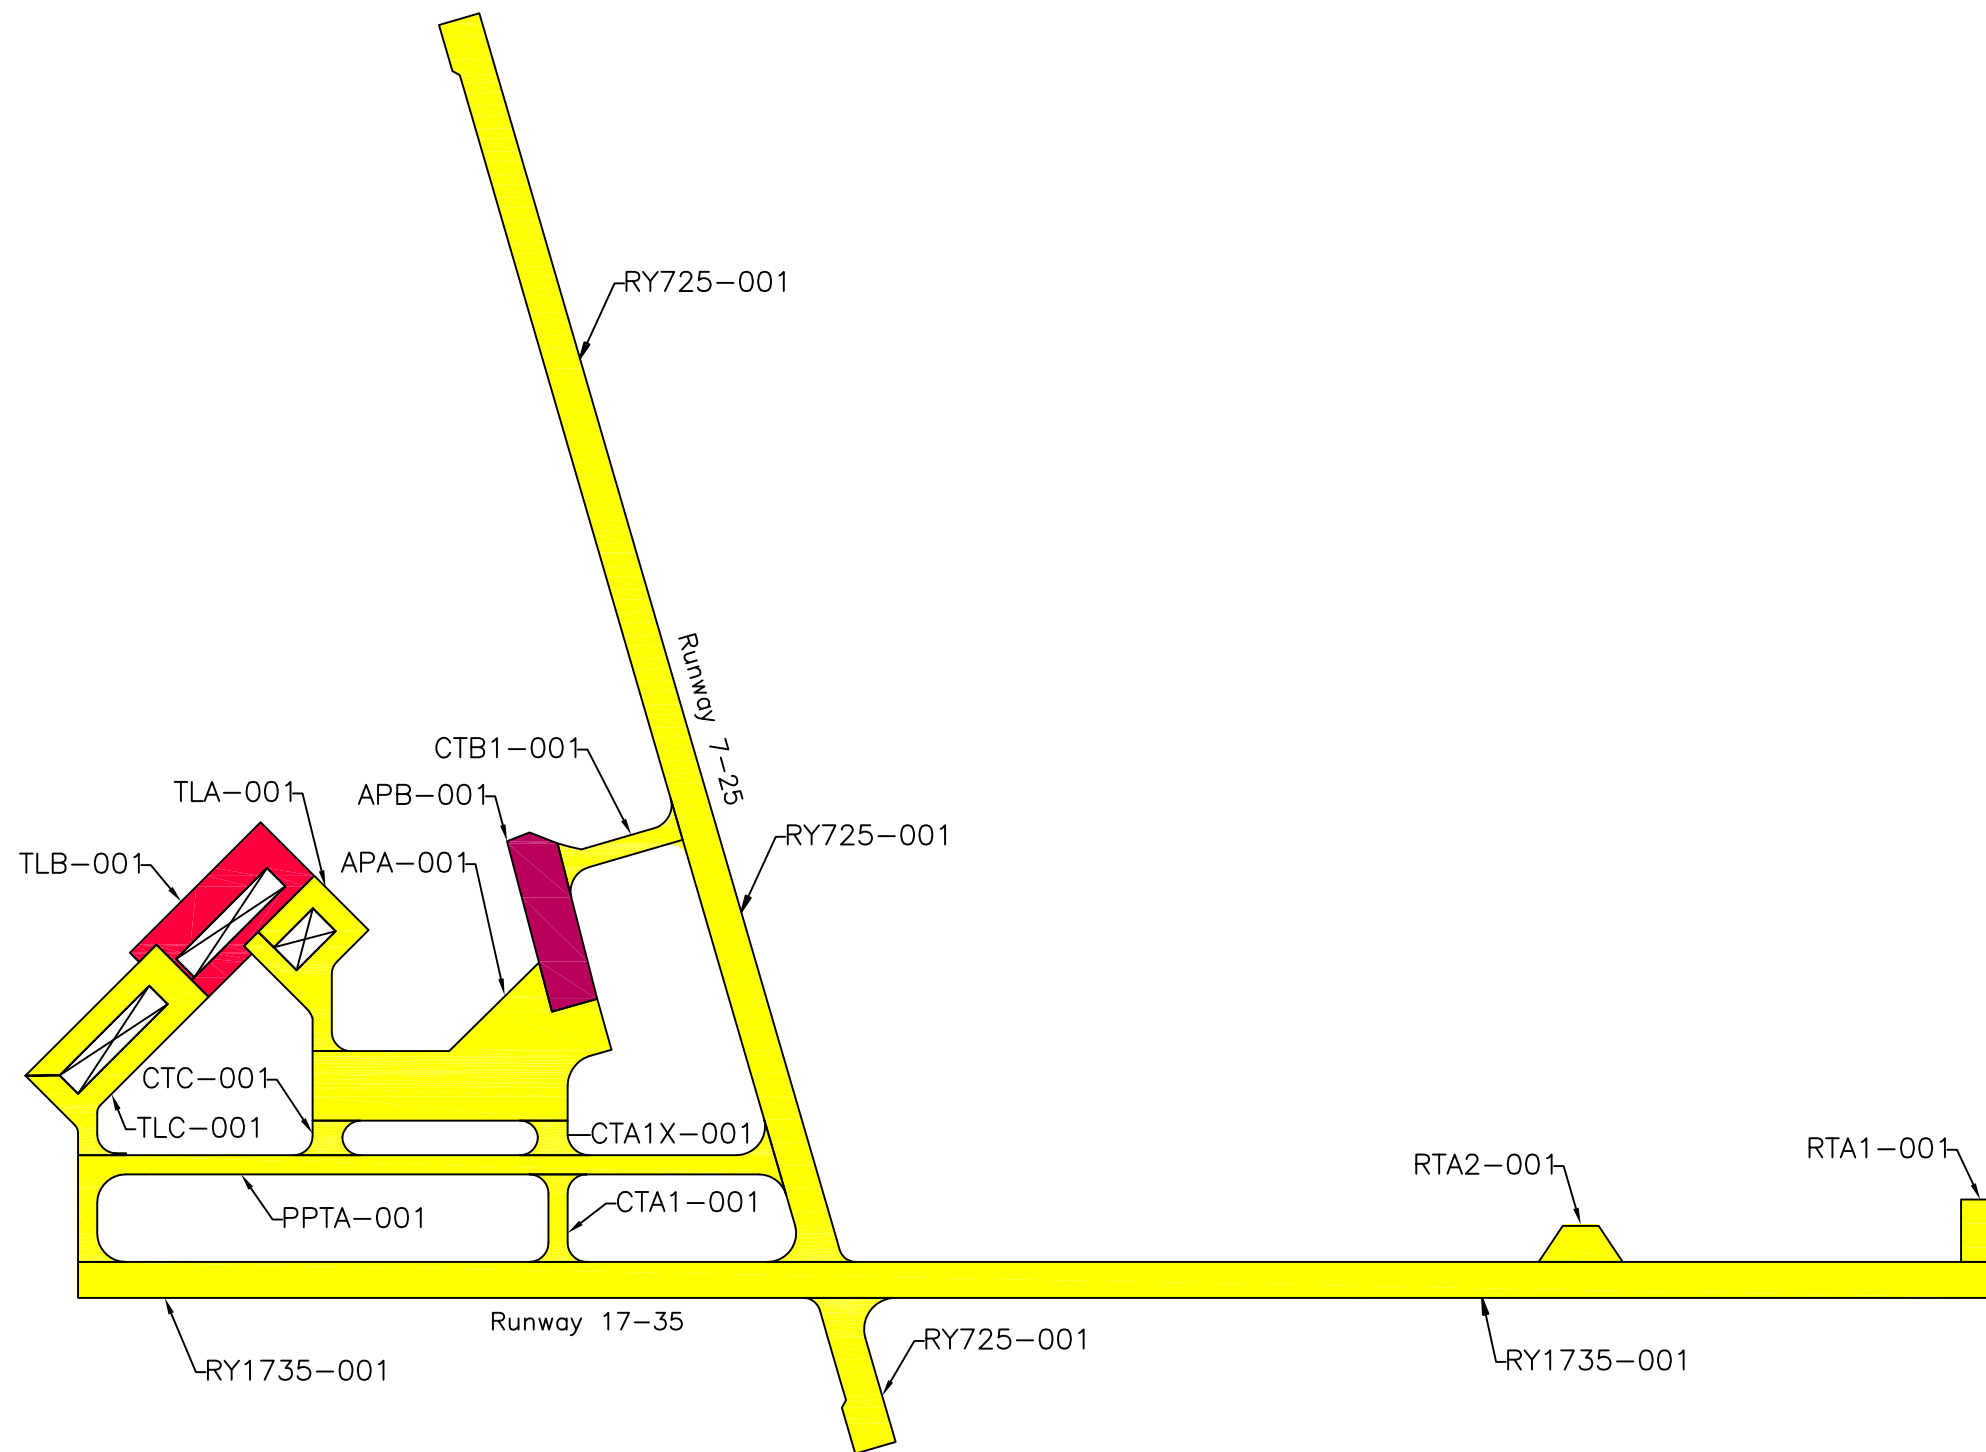
Figure 4. 2014 Pavement Condition Index Rating at Cloquet-Carlton County Airport (COQ).

The results of the 2014 PCI inspection are presented in figure 4. The overall area-weighted PCI for COQ is 57. When summarizing PCI values, an area-weighted calculation is used instead of a straight mathematical average because the area-weighted calculations eliminate the skewing of the PCI due to the disparity of the section sizes.

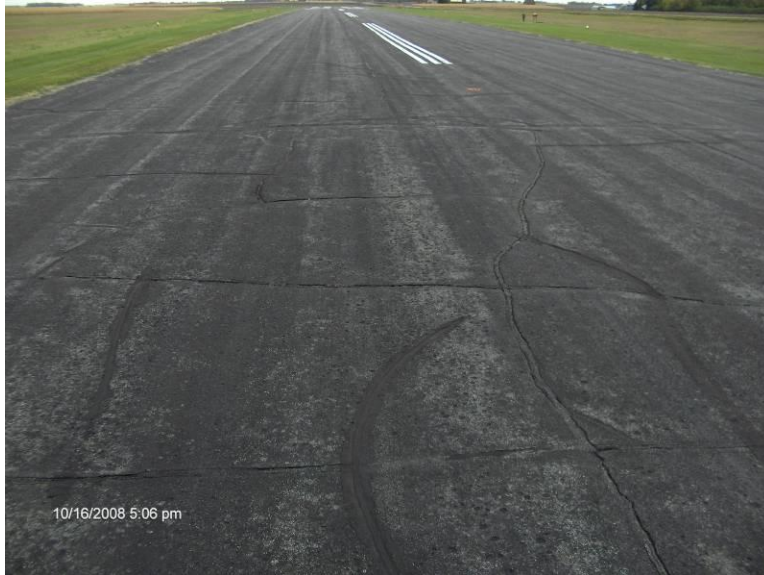
Example of Block Cracking

Block cracking is longitudinal and transverse cracking that has established a pattern of blocks ranging in size from 1ft x 1ft to 10ft x 10ft. This distress typically happens in older asphalt pavements and is an indication that the bituminous binder has lost most of its flexibility. The severity determination is basically determined by the crack width criteria defined for longitudinal and transverse cracking. Crack sealing typically is used to repair block cracking; however, the amount of required sealant can be extensive due to the high density of cracks.

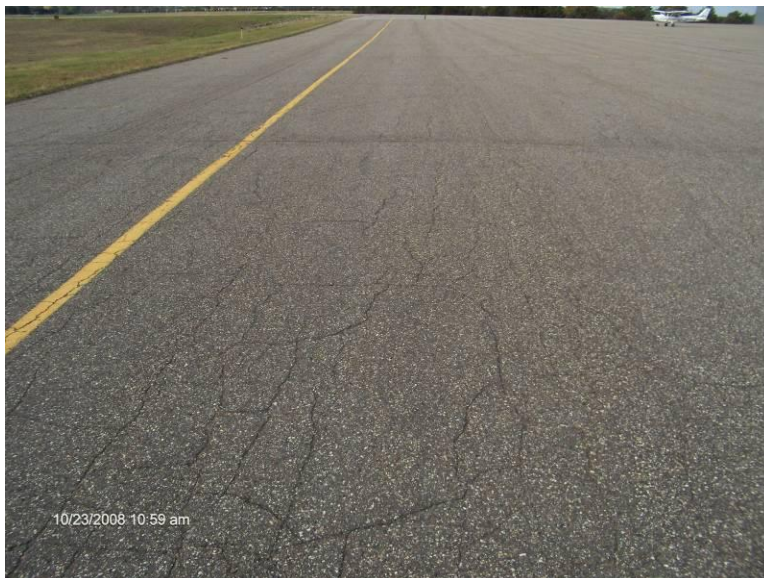
Example of Alligator Cracking

Alligator (or fatigue) cracks are a series of interconnected load-related cracks caused by fatigue of the asphalt surface. Alligator cracking is a significant structural distress and develops only in places subject to traffic loads. These cracks typically initiate at the bottom of the asphalt layer (where tensile strains

are highest) and propagate upward - so once a fatigue crack is visible, significant damage has already occurred.
