Pavement Condition Report

Sauk Centre Municipal Airport (D39)

December 2014

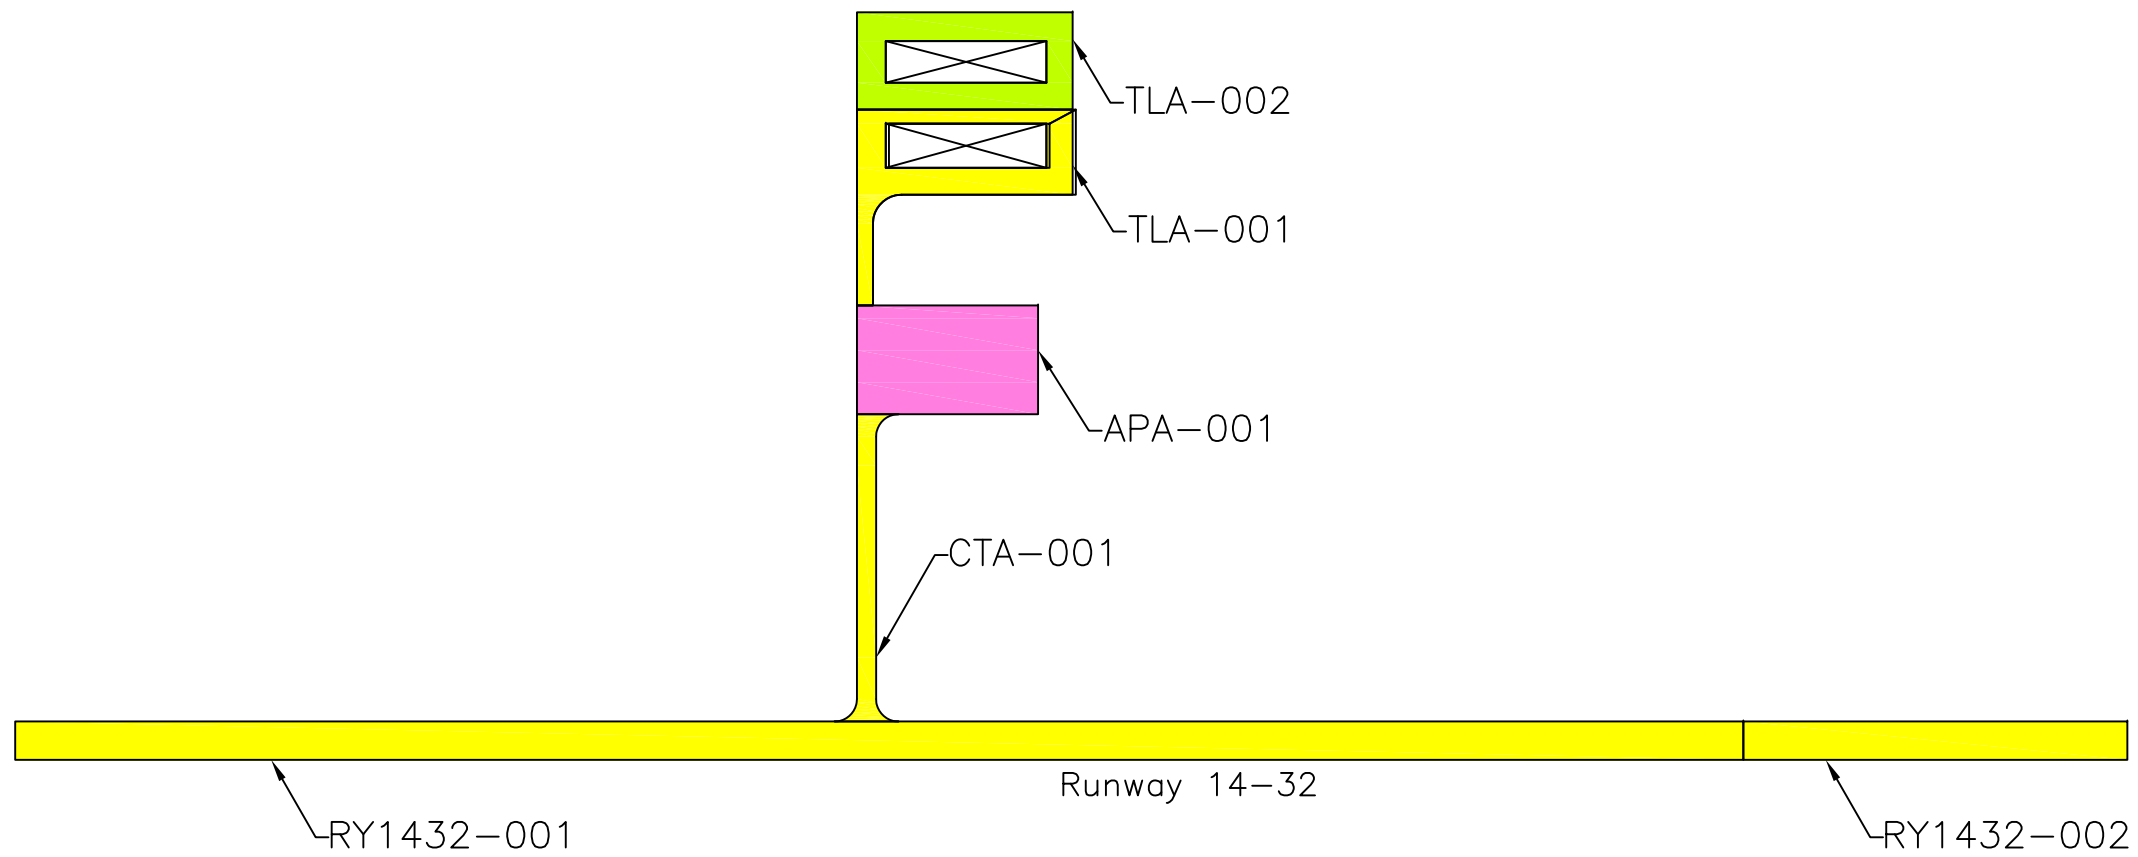
Figure 4. 2014 Pavement Condition Index Rating at Sauk Centre Municipal Airport (D39).

The results of the 2014 PCI inspection are presented in figure 4. The overall area-weighted PCI for D39 is 62. When summarizing PCI values, an area-weighted calculation is used instead of a straight mathematical average because the area-weighted calculations eliminate the skewing of the PCI due to the disparity of the section sizes.
