Final Report

Pavement Condition Report

Detroit Lakes Airport (DTL)

December 2014

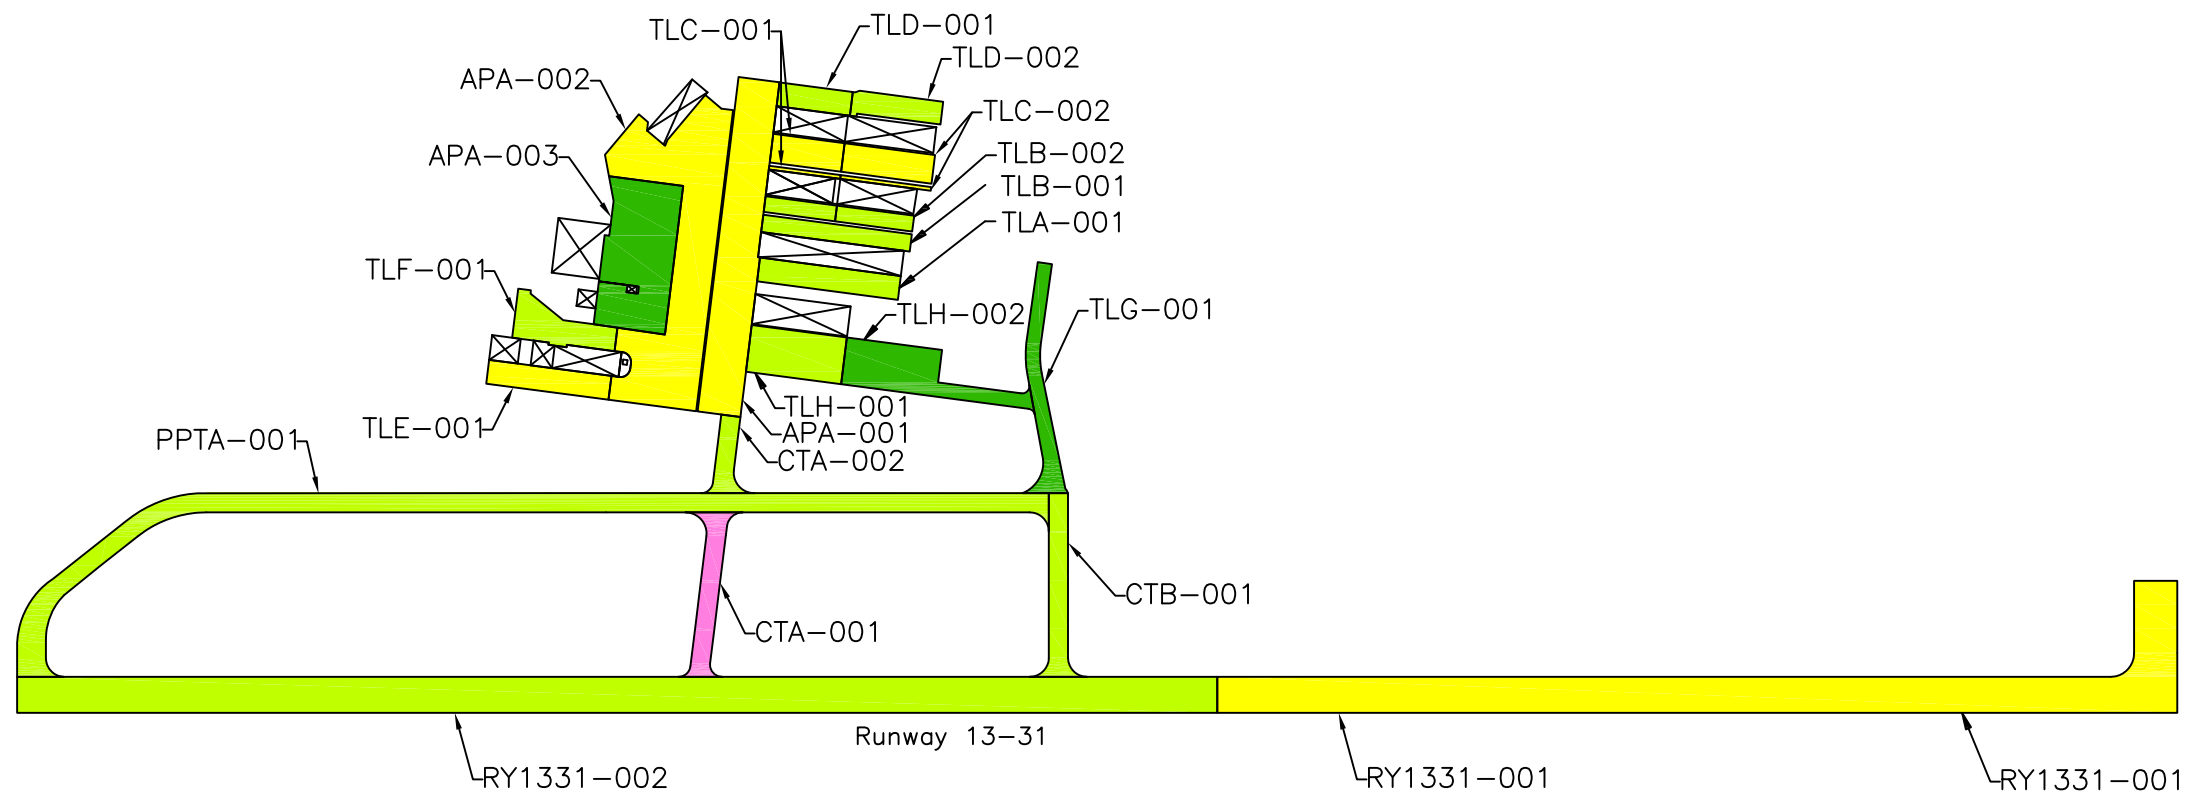
Figure 4. 2014 Pavement Condition Index Rating at Detroit Lakes Airport (DTL).

The results of the 2014 PCI inspection are presented in figure 4. The overall area-weighted PCI for DTL is 72. When summarizing PCI values, an area-weighted calculation is used instead of a straight mathematical average because the area-weighted calculations eliminate the skewing of the PCI due to the disparity of the section sizes.

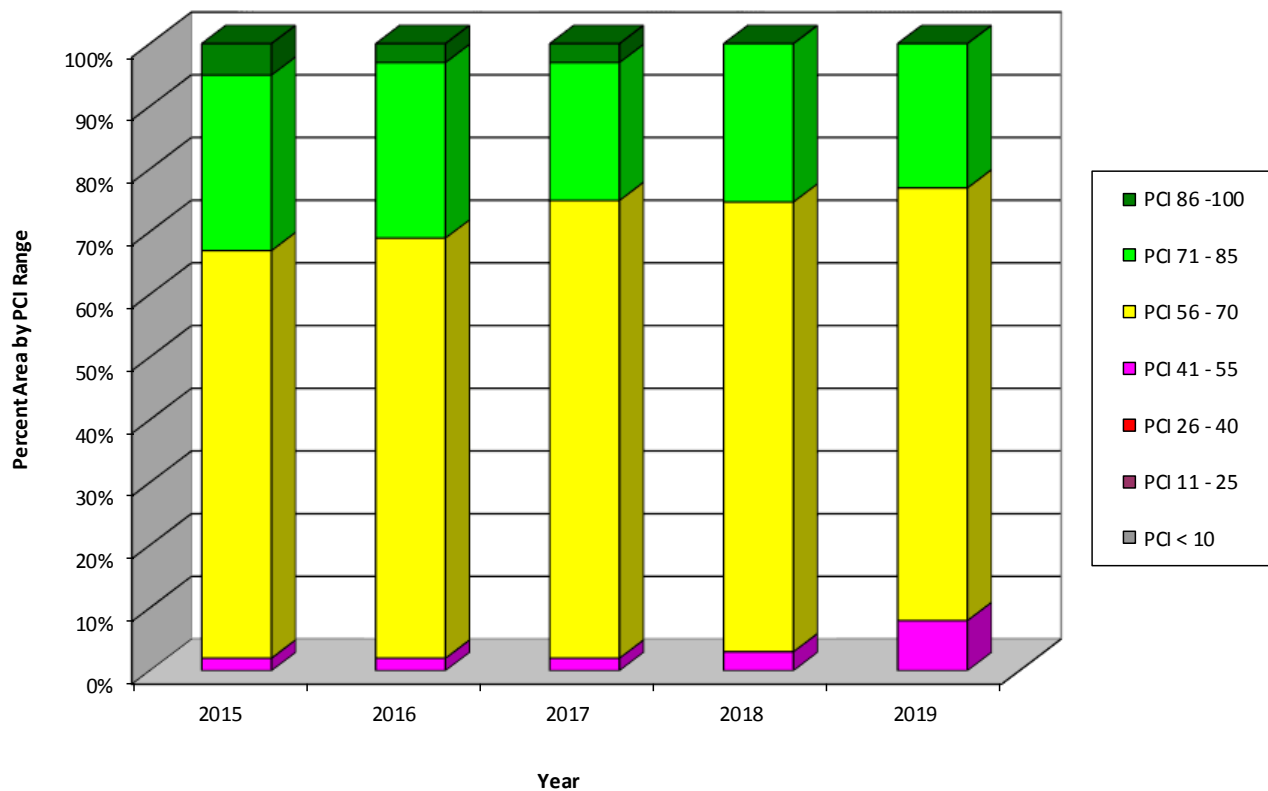
Figure 7. Projected PCI by percent area.

Figure 7 shows the projected PCI at DTL by percent area for the next 5 years assuming no major repairs (overlays, reconstruction, etc.) are performed during that period. It shows how quickly a pavement network can deteriorate when no capital improvements are made.
