Final Report

Pavement Condition Report

Sky Harbor Airport (DYT)

December 2014

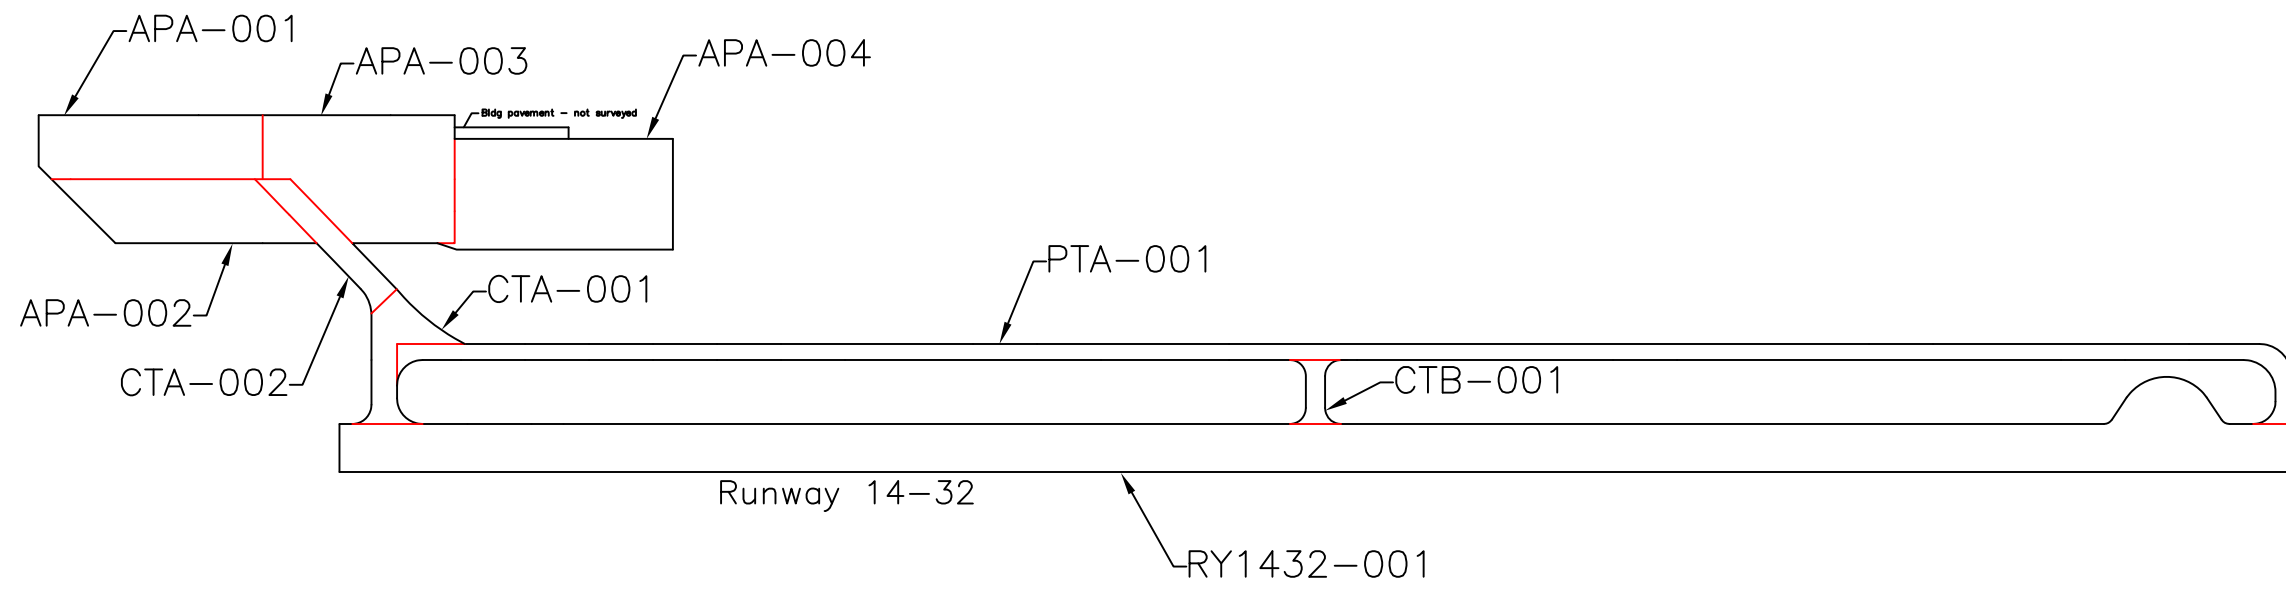
Figure 2. Network Definition at Duluth Sky Harbor Airport (DYT).

Figure 2 presents the network definition for DYT and represents the pavements included in the APMS. Some privately built/maintained pavements and “driveways” leading into hangars may not be included here because they are considered outside the scope of work.

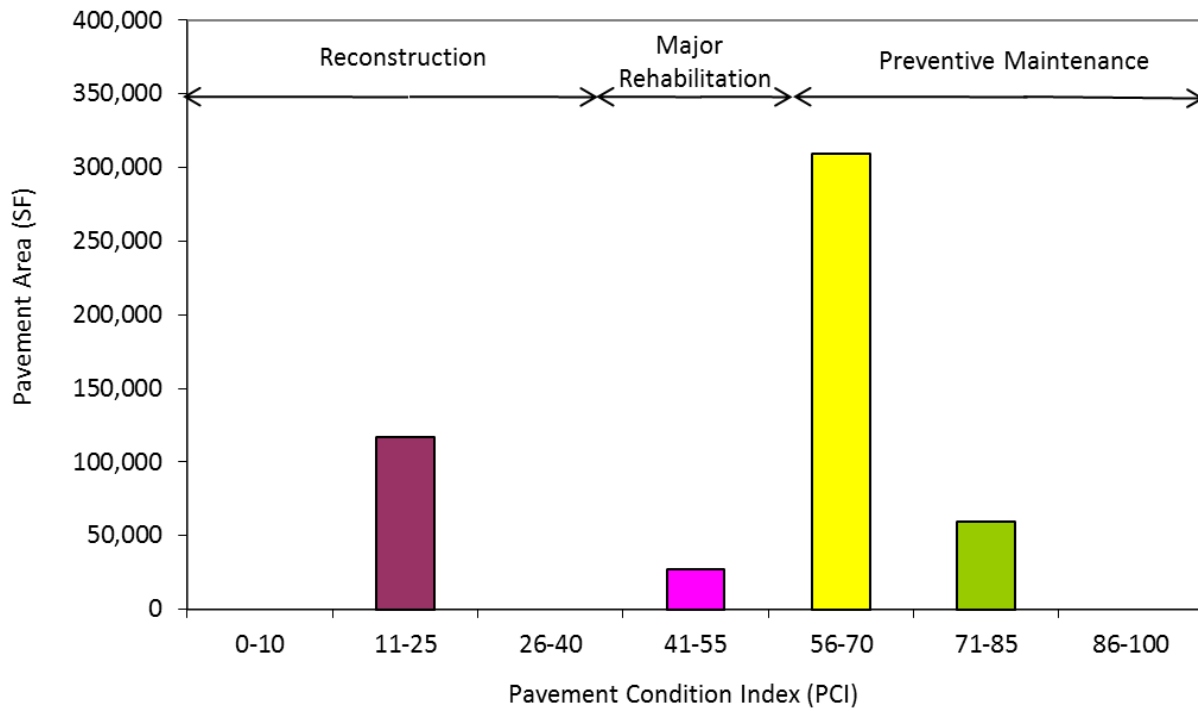
Figure 5. Condition distribution.

Figures 5 and 6 present the overall PCI for DYT by area distribution and pavement use, respectively. Table 3 presents the PCI summary for each section at DYT, including the drop in PCI per year. Generally, pavement sections will deteriorate between 1 and 3 PCI points per year. Sections deteriorating at higher rates may need maintenance above the normal application rates and should be closely monitored in case major repairs become necessary earlier than expected.

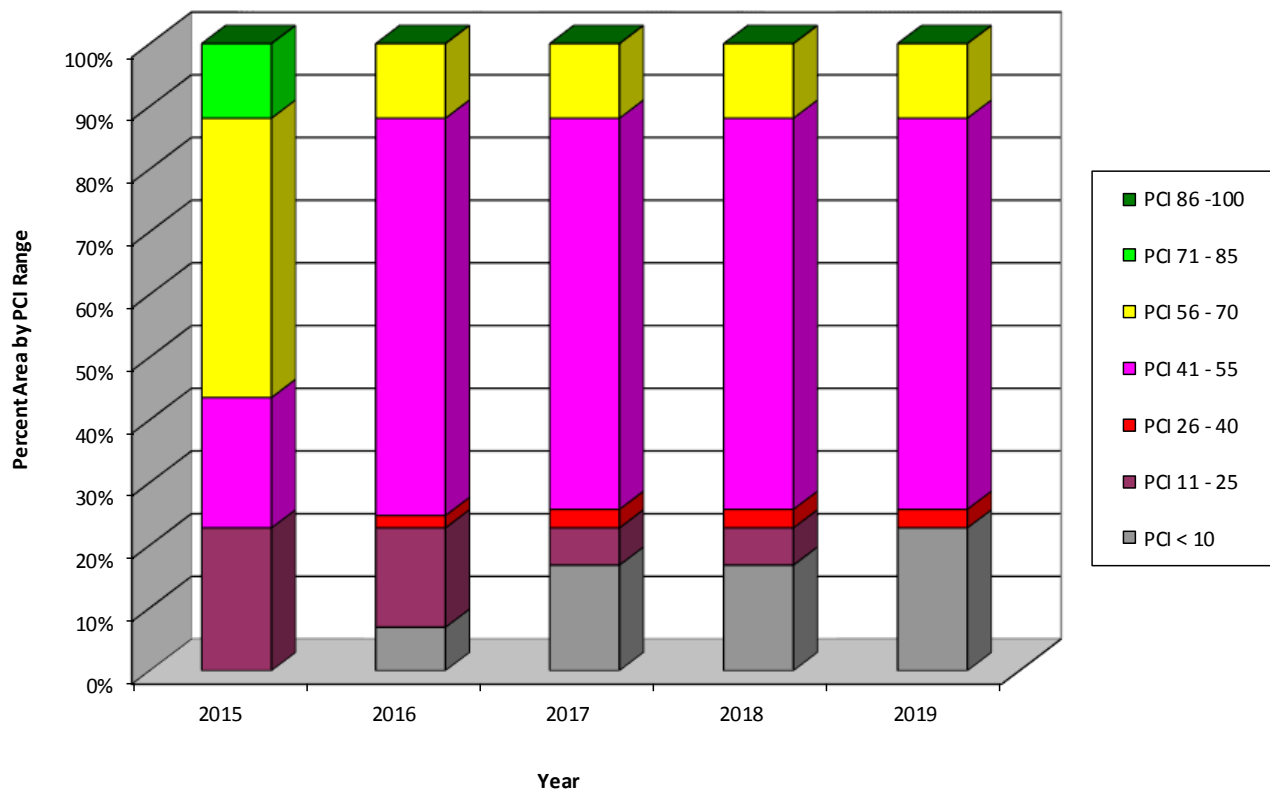
Figure 7. Projected PCI by percent area.

Figure 7 shows the projected PCI at DYT by percent area for the next 5 years assuming no major repairs (overlays, reconstruction, etc.) are performed during that period. It shows how quickly a pavement network can deteriorate when no capital improvements are made.
