Final Report

Pavement Condition Report

Fairmont Municipal Airport (FRM)

December 2014

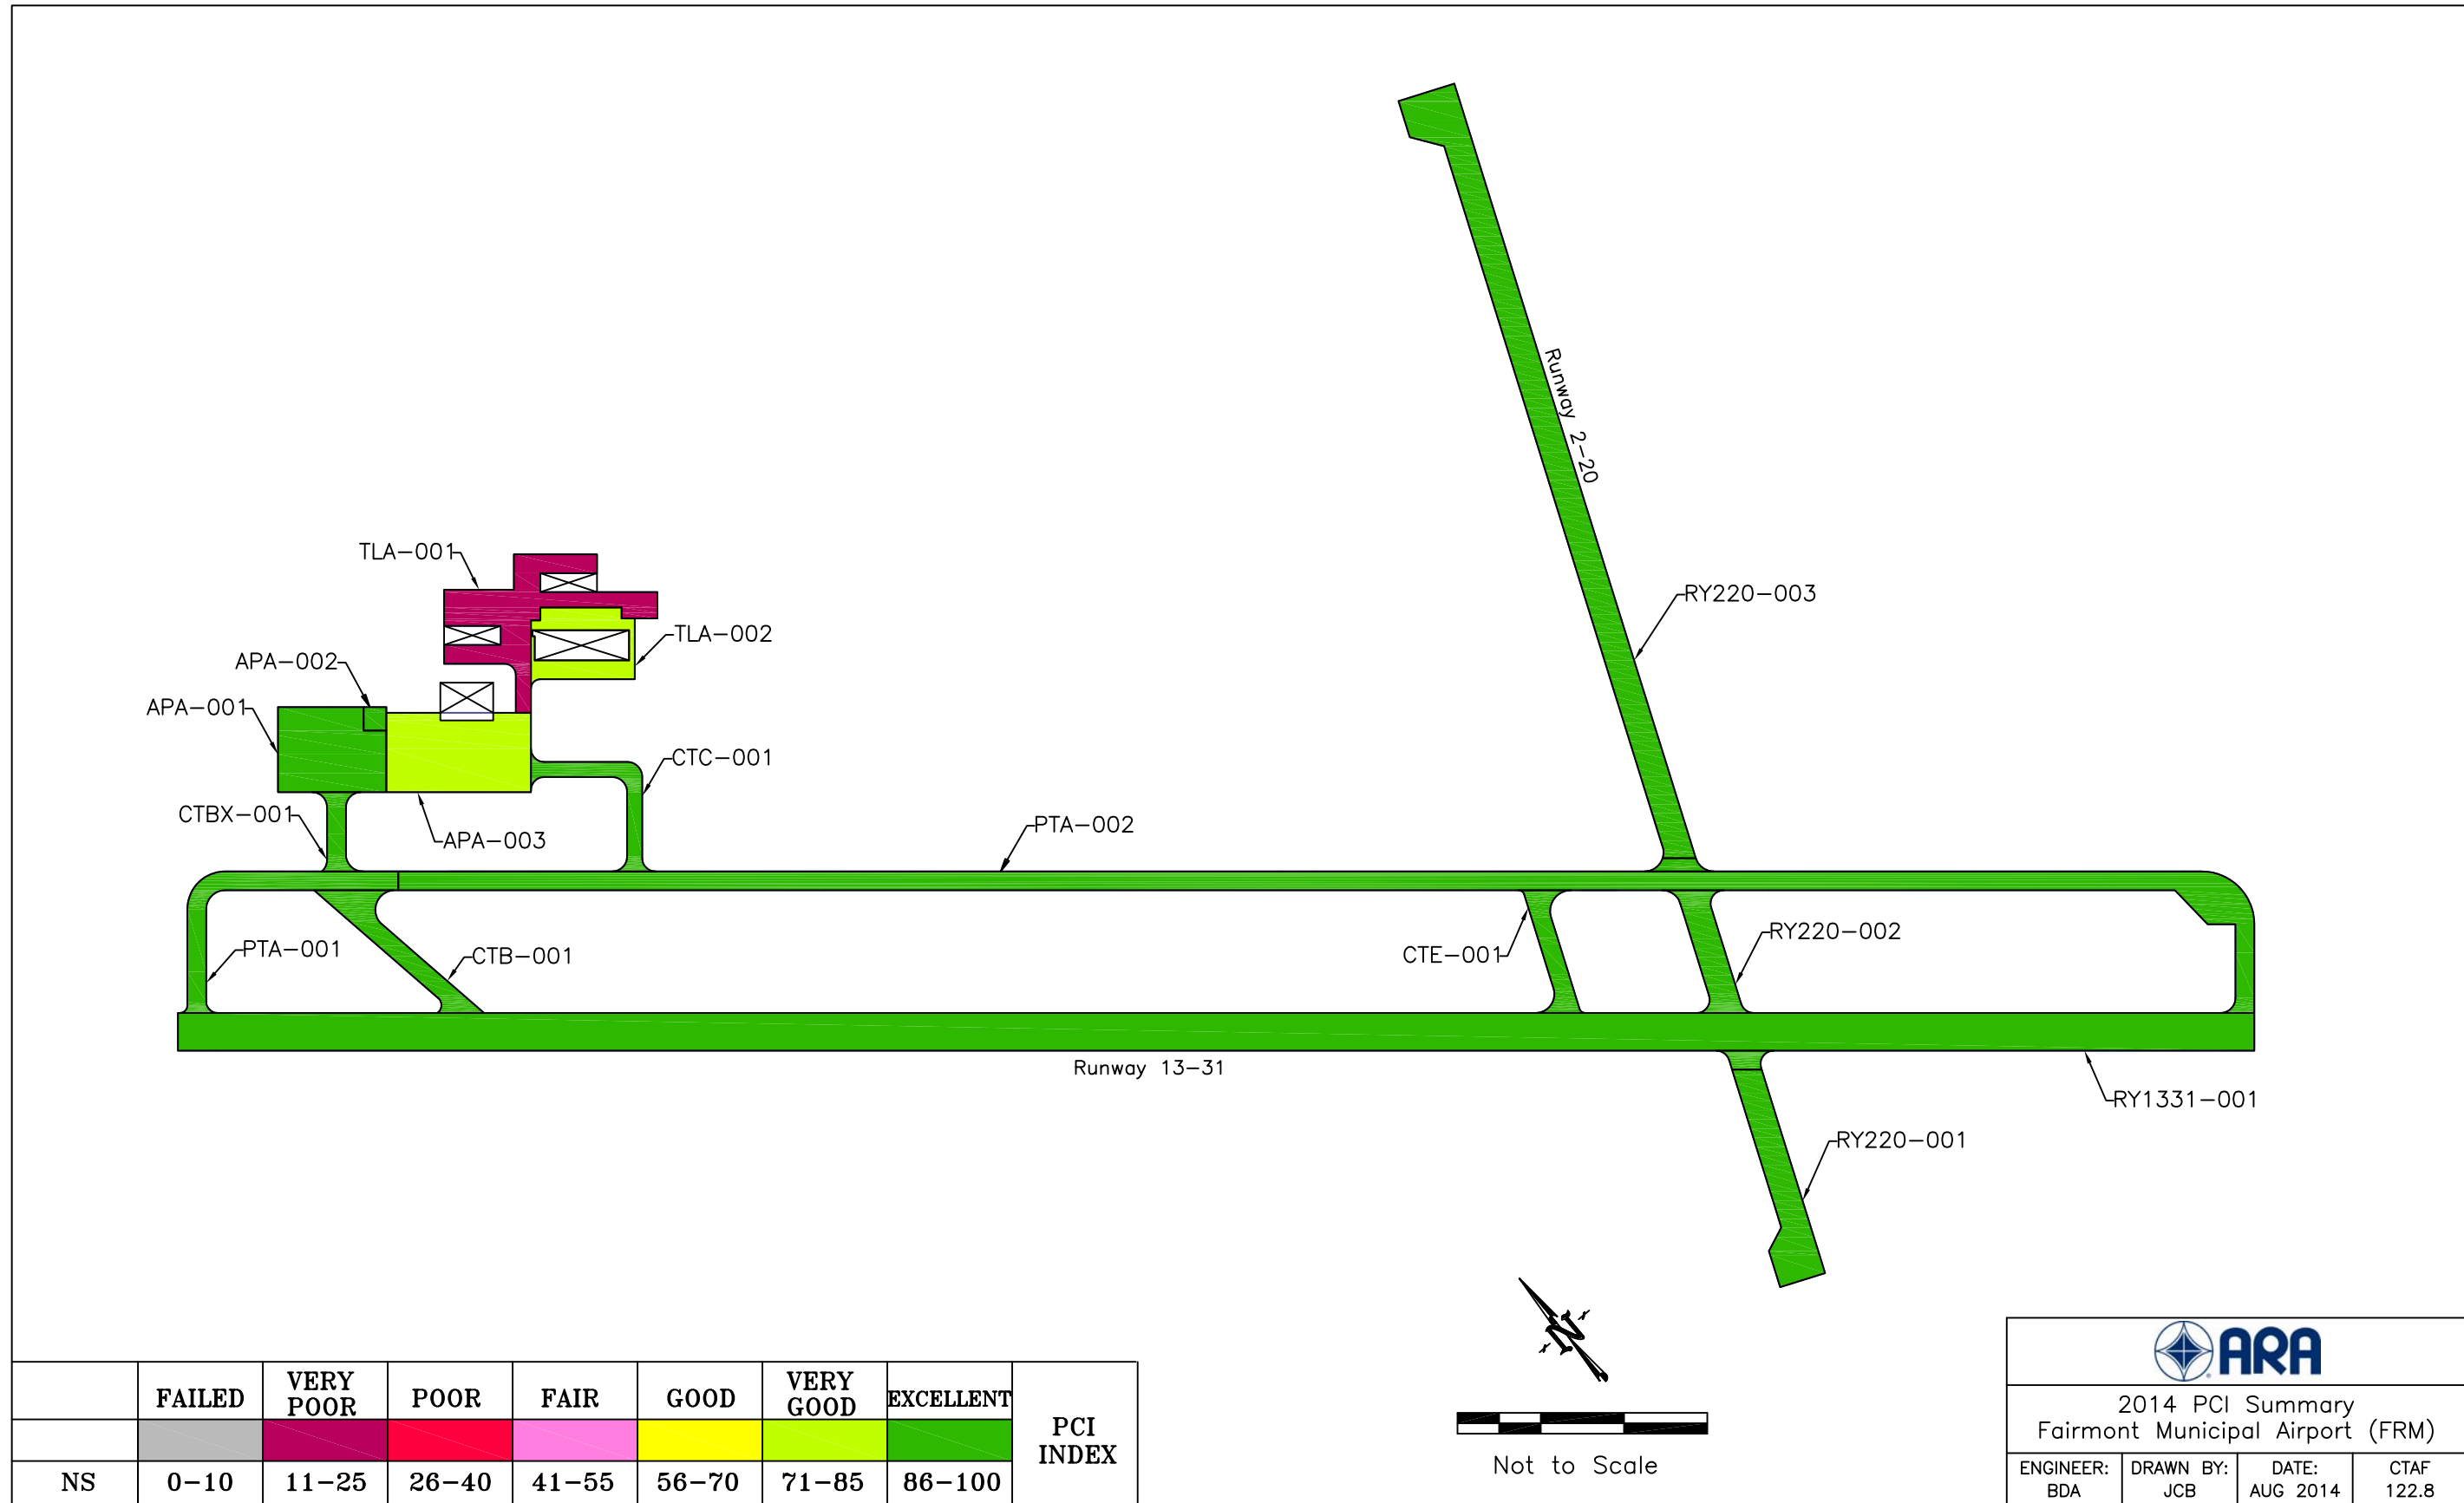
Figure 4. 2014 Pavement Condition Index Rating at Fairmont Municipal Airport (FRM).

The results of the 2014 PCI inspection are presented in figure 4. The overall area-weighted PCI for FRM is 87. When summarizing PCI values, an area-weighted calculation is used instead of a straight mathematical average because the area-weighted calculations eliminate the skewing of the PCI due to the disparity of the section sizes.

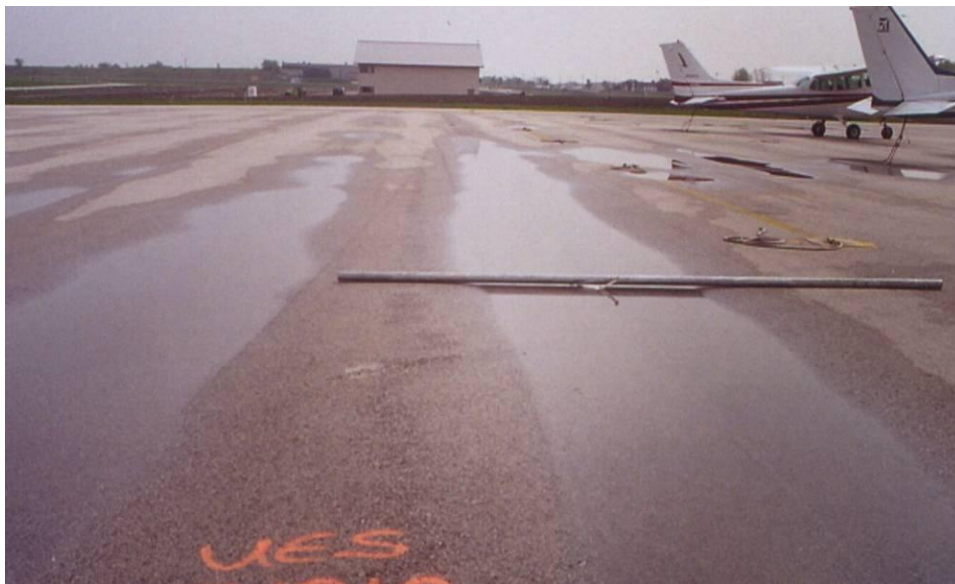
Example of Rutting

Ruts are localized, load related, areas of pavement having elevations lower than the surrounding sections. Rutting is due to base and subgrade consolidation, caused by excessive wheel loads or poor compaction. Ruts indicate structural failure, and can cause hydroplaning. At low severity, ruts have an

average depth of ¼ to ½ inches. At medium severity, ruts have an average depth of ½ to 1 inch. High severity, ruts have an average depth greater than 1 inch. Full-depth patching is the appropriate repair for ruts.

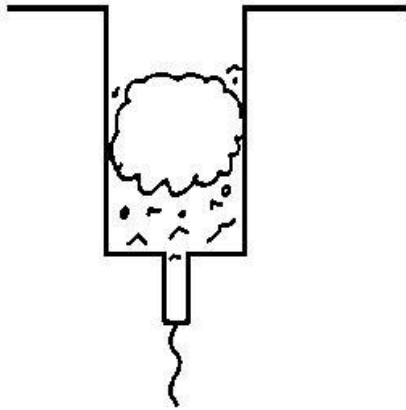
Typical joint with deficient sealant and a collection of debris & incompressibles.
