Final Report

Pavement Condition Report

Mora Municipal Airport (JMR)

December 2014

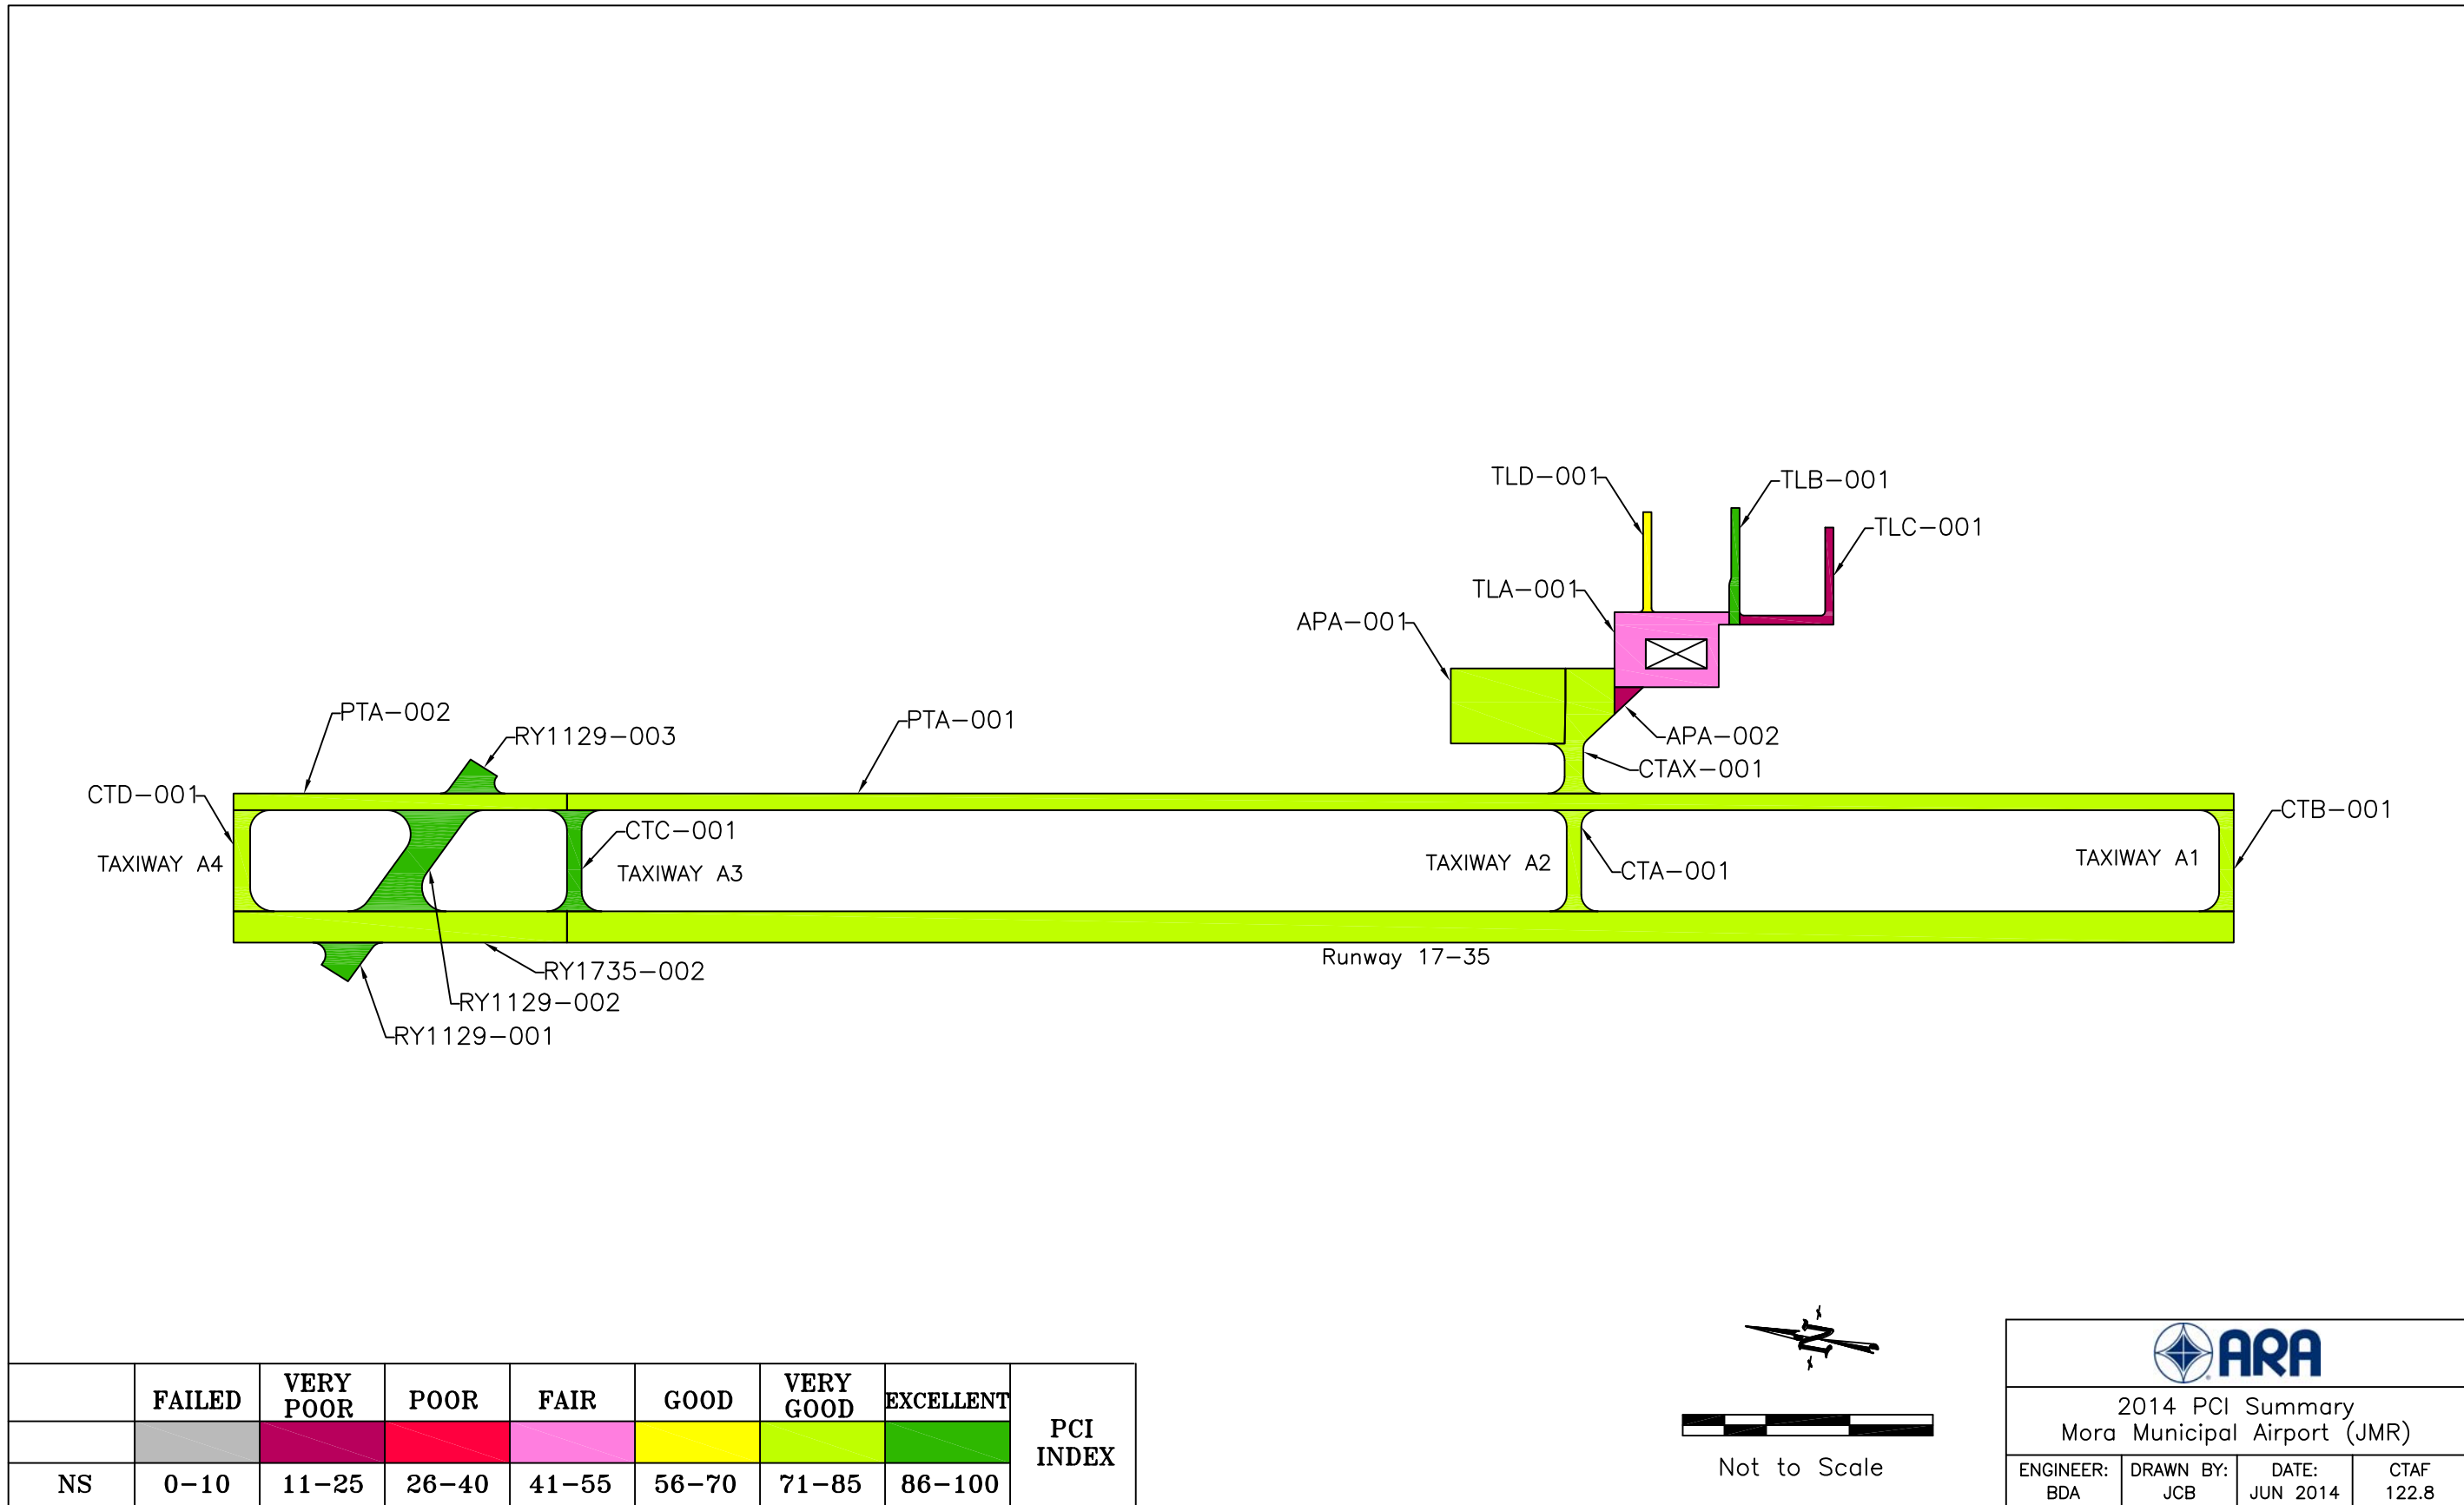
Figure 4. 2014 Pavement Condition Index Rating at Mora Municipal Airport (JMR).

The results of the 2014 PCI inspection are presented in figure 4. The overall area-weighted PCI for JMR is 78. When summarizing PCI values, an area-weighted calculation is used instead of a straight mathematical average because the area-weighted calculations eliminate the skewing of the PCI due to the disparity of the section sizes.
