Final Report

Pavement Condition Report

Roseau Municipal Airport (ROX)

December 2014

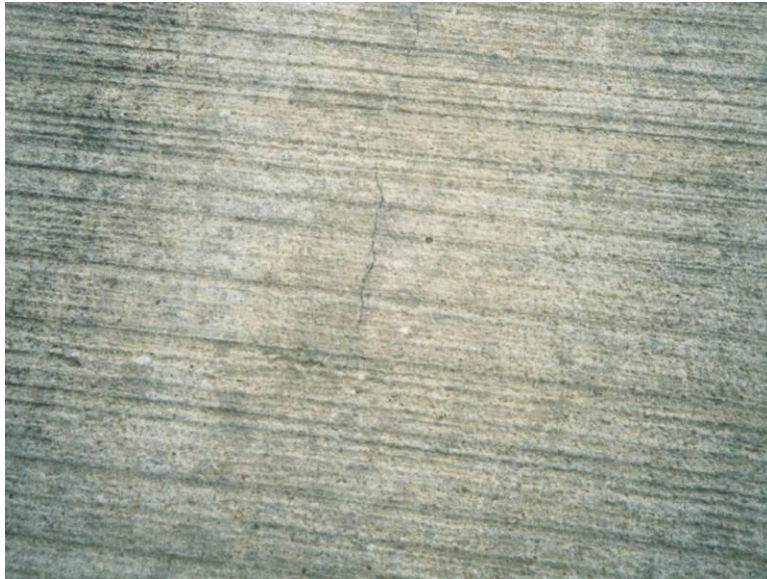
Example of Shrinkage Cracking

Shrinkage cracks are small, nonworking (no spalling along edge) cracks that are visible at the surface but do not penetrate through the full depth of concrete. Shrinkage cracks most commonly occur shortly after construction due to concrete shrinkage during the curing process. Shrinkage cracks are usually so small that they are not visible until staining or material loss at crack edges begins to take place. Shrinkage cracks do not represent a structural weakness, and no corrective action is prescribed.
