Final Report

Pavement Condition Report

Dodge Center Municipal Airport (TOB)

December 2014

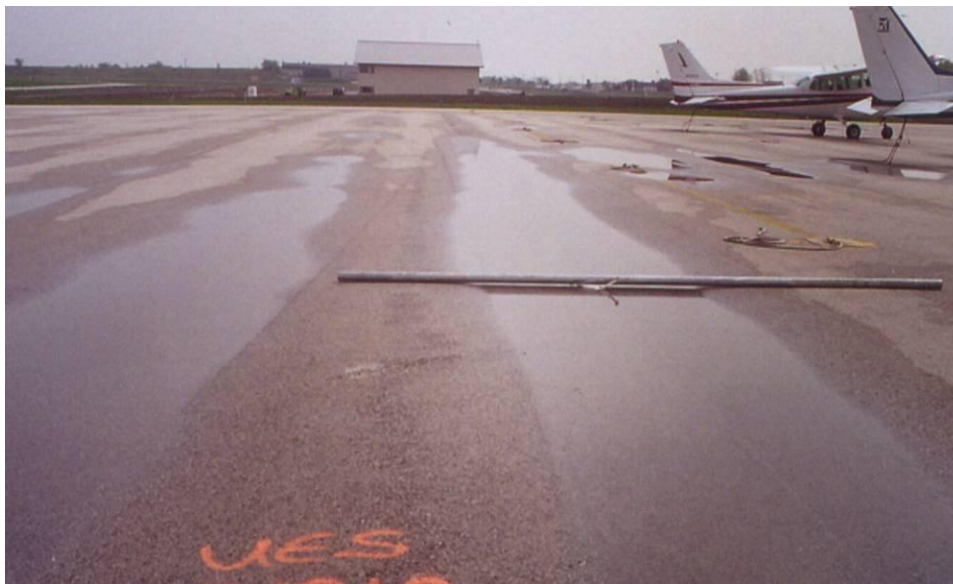
Example of Rutting

Ruts are localized, load related, areas of pavement having elevations lower than the surrounding sections. Rutting is due to base and subgrade consolidation, caused by excessive wheel loads or poor compaction. Ruts indicate structural failure, and can cause hydroplaning. At low severity, ruts have an

average depth of ¼ to ½ inches. At medium severity, ruts have an average depth of ½ to 1 inch. High severity, ruts have an average depth greater than 1 inch. Full-depth patching is the appropriate repair for ruts.
