Final Report

Pavement Condition Report

Elbow Lake Municipal Airport (Y63)

December 2014

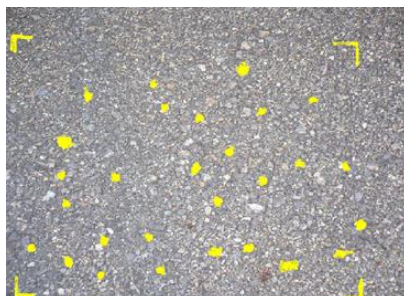
Raveling – At low severity, the number of missing coarse aggregates ($> 3/8$ inch) is between 5-20 missing/yd², medium severity (pictured below where the missing coarse aggregates have been dotted with yellow paint) is 21-40 missing/yd², and high severity is > 40 missing/yd².

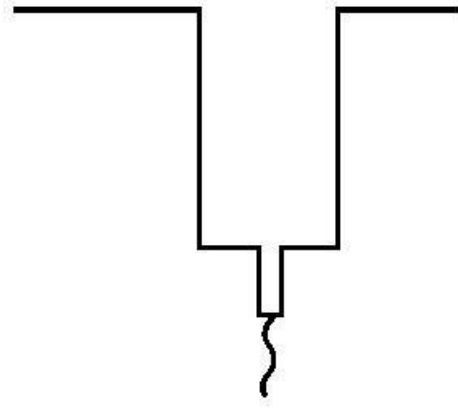
Typical joint with deficient sealant and a collection of debris & incompressibles.

Rout out old sealant, debris and incompressibles. Clean joint sides to expose fresh, clean concrete and stone. Retain existing reservoir shape.
