Pavement Condition Report

Hector Municipal Airport (1D6)

January 2016

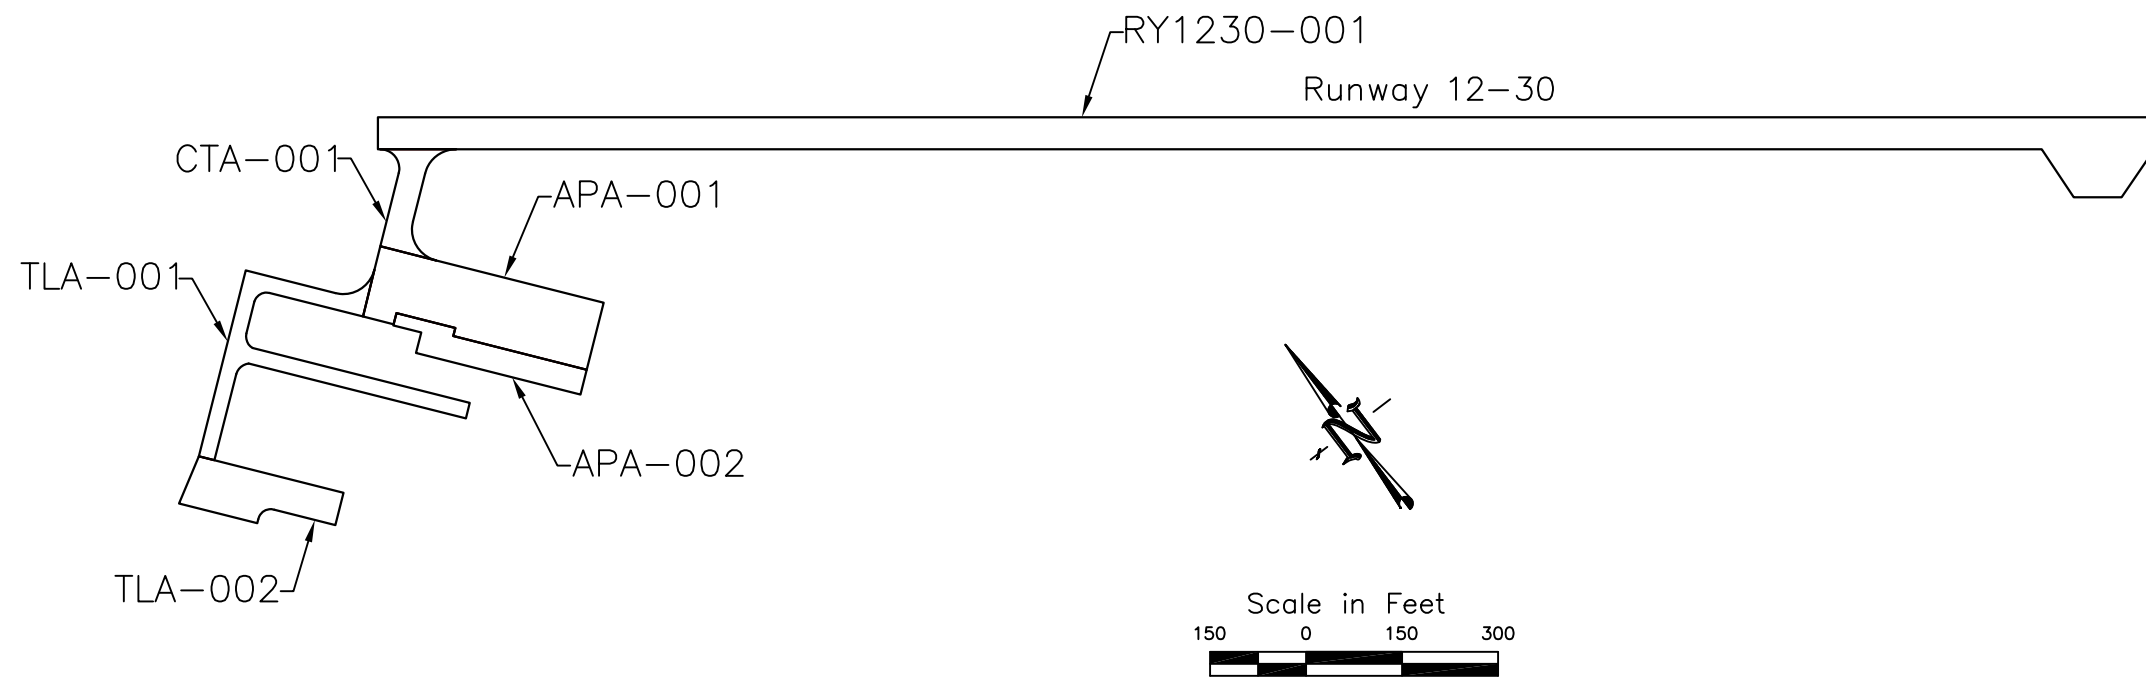
Figure 2. Network Definition at Hector Municipal Airport (1D6).

Figure 2 presents the network definition for 1D6 and represents the pavements included in the APMS. Some privately built/maintained pavements and “driveways” leading into hangars may not be included here because they are considered outside the scope of work.

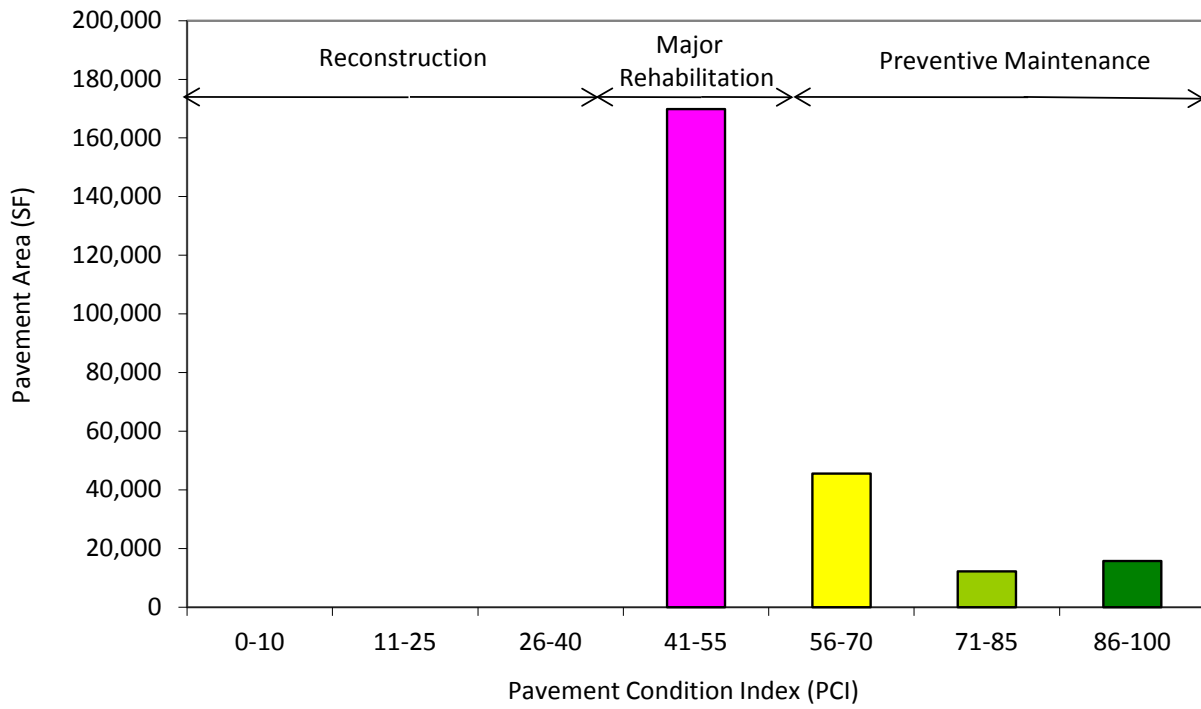
Figure 5. Condition distribution.

Figures 5 and 6 present the overall PCI for 1D6 by area distribution and pavement use, respectively. Table 3 presents the PCI summary for each section at 1D6, including the drop in PCI per year. Generally, pavement sections will deteriorate between 1 and 3 PCI points per year. Sections deteriorating at higher rates may need maintenance above the normal application rates and should be closely monitored in case major repairs become necessary earlier than expected.

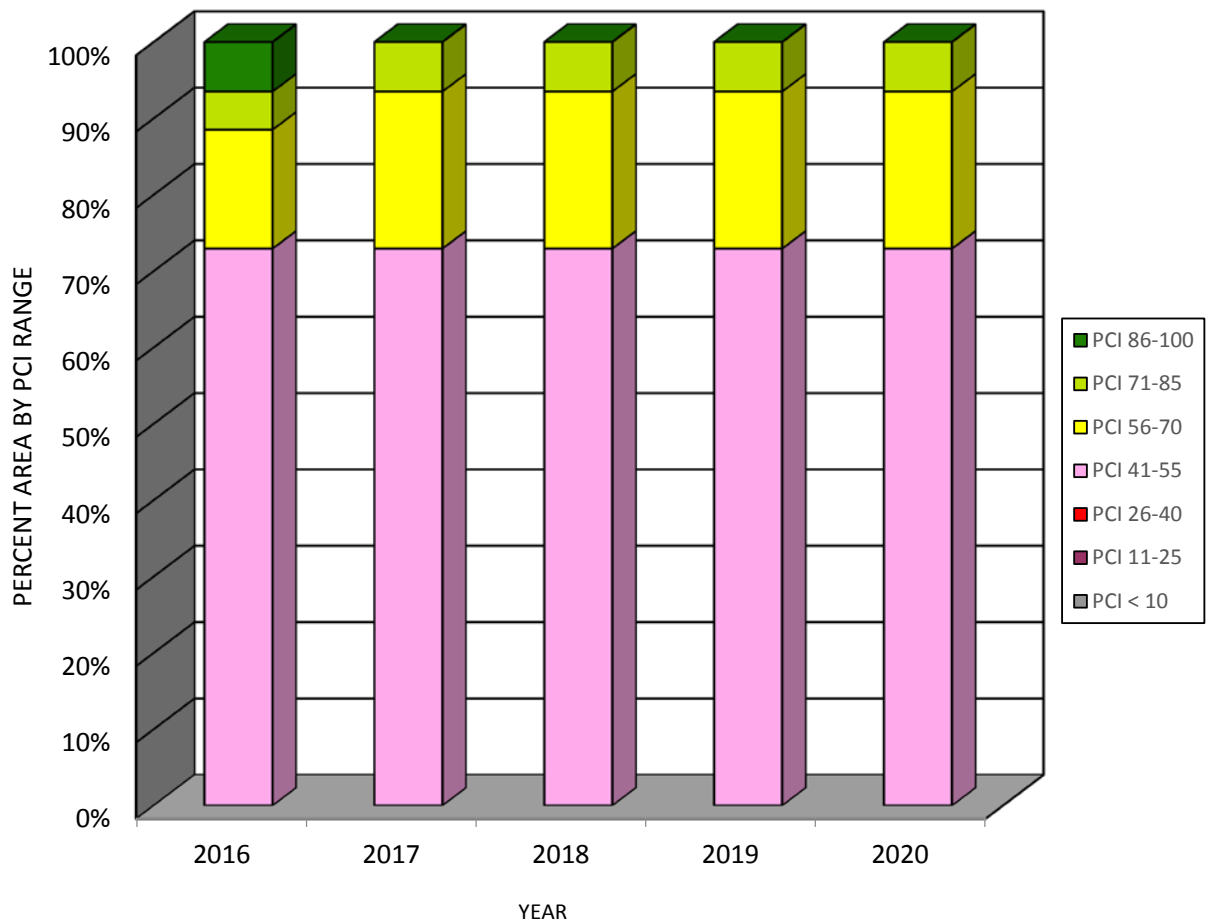
Figure 7. Projected PCI by percent area.

Figure 7 shows the projected PCI at 1D6 by percent area for the next 5 years assuming no major repairs (overlays, reconstruction, etc.) are performed during that period. It shows how quickly a pavement network can deteriorate when no capital improvements are made.
