# Pavement Condition Report

## Brooten Municipal Airport (6D1)

January 2016

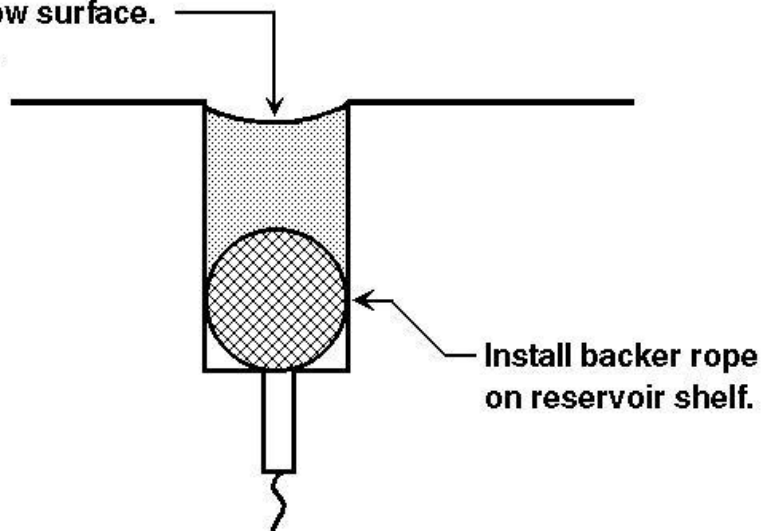
Figure 6. PCC joint/crack repair.

Typical joint with deficient sealant and a collection of debris & incompressibles.

Rout out old sealant, debris and incompressibles. Clean joint sides to expose fresh, clean concrete and stone. Retain existing reservoir shape.

Fill to 1/8" below surface.  
Do not overfill.
