# Pavement Condition Report

## Benson Municipal Airport (BBB)

Applied Research Associates, Inc.  
6314 Odana Rd  
Madison, WI 53719  
(608) 274-6409

January 2016

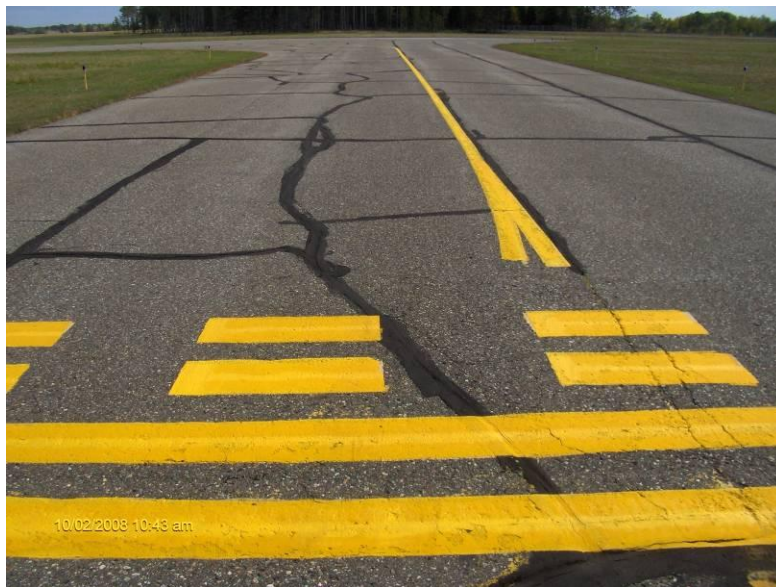
### ***Example of Longitudinal and Transverse Cracking (L&T cracking)***

Longitudinal and transverse cracks are caused by pavement aging, by construction, and by subsurface movement. Aging occurs as pavement loses some of its components to the atmosphere and becomes more brittle. Consistent application of pavement sealcoats can help to prevent the occurrence of age related cracks. Cracks will also develop along poorly constructed paving lane joints. Ensuring that joints are made when both sides are still hot, and near the same temperature, is one of the best ways to mitigate this potential problem. Seasonal movement caused by changes in moisture content or temperature differences can also cause pavement cracks. Asphalt pavement placed over a PCC pavement or cement stabilized base course may evidence reflective cracking from the underlying material. Longitudinal and transverse cracks are not caused by wheel loads, although traffic may worsen their condition.

Low severity longitudinal and transverse cracks are less than ¼ inch wide, or if sealed with suitable filler material in satisfactory condition can be any width, less than 3 inches, if they are not spalled. Maintenance usually is not indicated for low-severity cracking. Moderately spalled cracks and cracks wider than ¼ inch which are not satisfactorily sealed are at medium severity. Medium-severity cracks should be sealed with a high-quality crack filling material. Severely spalled cracks and cracks wider than 3 inches are at high severity. High-severity L&T cracks normally require patching.
