Pavement Condition Report

Silver Bay Municipal Airport (BFW)

January 2016

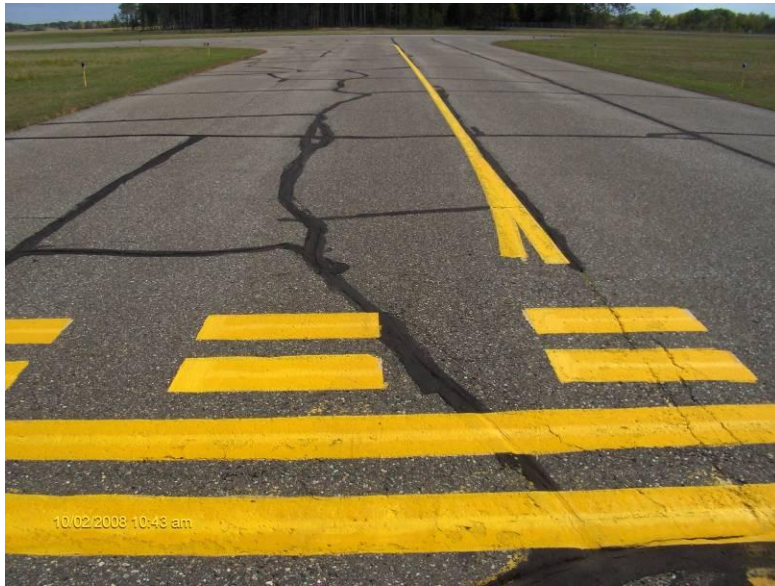
Example of Longitudinal and Transverse Cracking (L&T cracking)

Longitudinal and transverse cracks are caused by pavement aging, by construction, and by subsurface movement. Aging occurs as pavement loses some of its components to the atmosphere and becomes more brittle. Consistent application of pavement sealcoats can help to prevent the occurrence of age related cracks. Cracks will also develop along poorly constructed paving lane joints. Ensuring that joints are made when both sides are still hot, and near the same temperature, is one of the best ways to mitigate this potential problem. Seasonal movement caused by changes in moisture content or temperature differences can also cause pavement cracks. Asphalt pavement placed over a PCC pavement or cement stabilized base course may evidence reflective cracking from the underlying material. Longitudinal and transverse cracks are not caused by wheel loads, although traffic may worsen their condition.

Low severity longitudinal and transverse cracks are less than $\frac{1}{4}$ inch wide, or if sealed with suitable filler material in satisfactory condition can be any width, less than 3 inches, if they are not spalled. Maintenance usually is not indicated for low-severity cracking. Moderately spalled cracks and cracks wider than $\frac{1}{4}$ inch which are not satisfactorily sealed are at medium severity. Medium-severity cracks should be sealed with a high-quality crack filling material. Severely spalled cracks and cracks wider than 3 inches are at high severity. High-severity L&T cracks normally require patching.

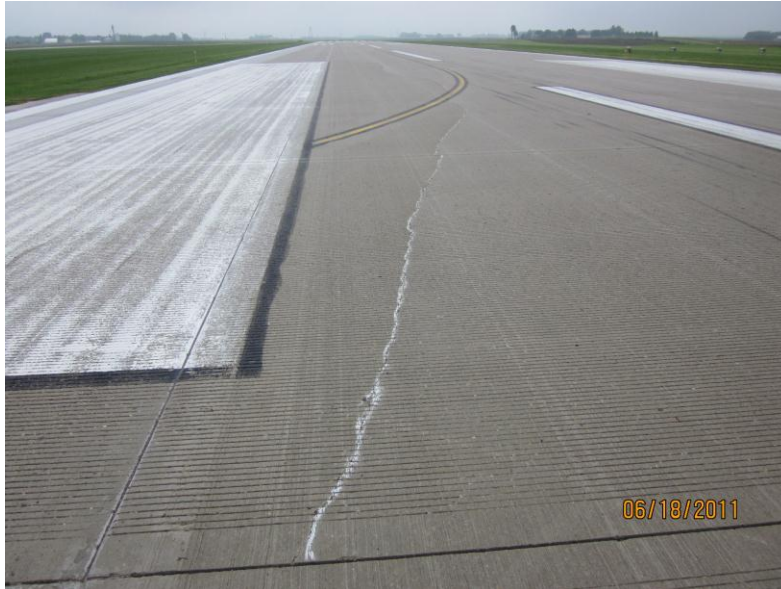
Example of Longitudinal, Transverse, and Diagonal Cracking

LTD cracking is most often a result of externally applied loads and/or constrained temperature deformations. External loads cause LTD cracking through flexure. Temperature changes on restrained slabs will result in stresses due to friction or curling. When any of these stresses exceed the strength of the slab, cracking will occur. LTD cracking is recorded at low, medium, or high severity, depending on the width of crack opening and degree of deterioration. At low severity, the crack is less than 1/8th inch wide with little spalling and no corrective action is indicated. At medium severity, LTD cracks can be up to 1 inch wide with moderate spalling, and should be repaired and sealed using procedures similar to joint sealing. At high severity, cracks exceed 1 inch in width and may be severely spalled. High-severity LTD cracking is evidence of serious load failure of the slab, and correction may require patching or slab replacement. If the distress occurs in several adjacent slabs at medium or high severity, major rehabilitation of that pavement area is indicated.

When a slab is divided by LTD cracks into four or more pieces, the slab is said to be "divided" or "shattered." Shattered slab is a separate distress category and is indicative of significant structural failure as the slab loses its ability to distribute loads to subgrade and further slab deterioration can be expected. Shattered slabs are rated in three severities, with slab replacement recommended for medium and high severities.

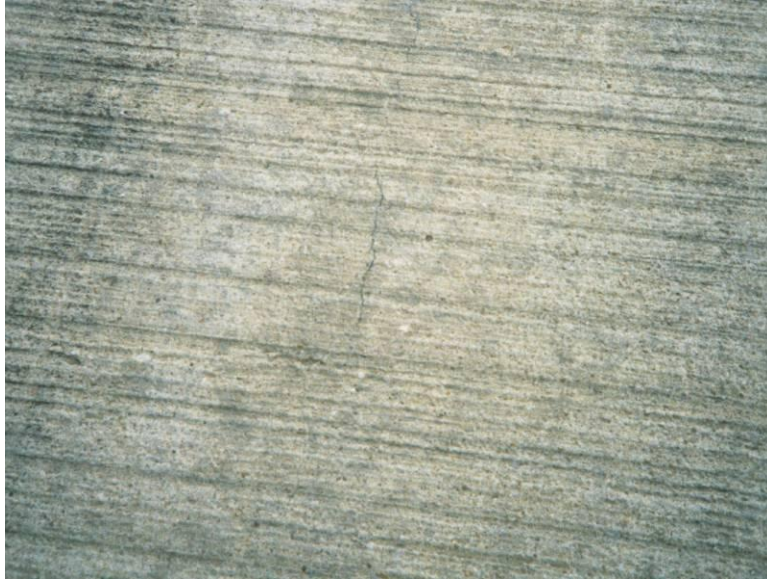
Example of Shrinkage Cracking

Shrinkage cracks are small, nonworking (no spalling along edge) cracks that are visible at the surface but do not penetrate through the full depth of concrete. Shrinkage cracks most commonly occur shortly after construction due to concrete shrinkage during the curing process. Shrinkage cracks are usually so small that they are not visible until staining or material loss at crack edges begins to take place. Shrinkage cracks do not represent a structural weakness, and no corrective action is prescribed.

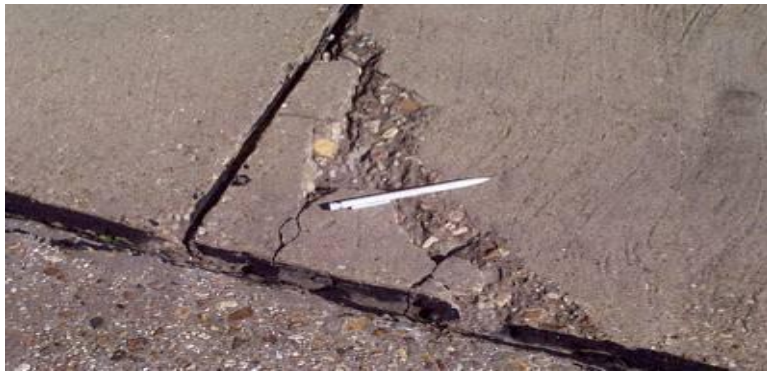
Example of Joint and Corner Spalling

Spalls at slab joints and corners are caused by excessive internal stress in the pavement. Spalls occur when these stresses exceed the shear strength of the concrete. Spalling usually results from thermal expansion during warm or hot weather. As slabs expand, they push against one another at joints. If the joints are filled with incompressibles, such as sand, or if adjacent slabs offset slightly, stresses can become severe, causing spalls. Spalling can be reduced significantly by conscientious maintenance of joint sealant.

Spall repair requires patching. The extent and severity of spalling on a pavement surface suggests appropriate action. For example, at low severity, spalled concrete remains securely in place in the slab. A low-severity spall should be monitored closely for further deterioration and should be patched when
