# Pavement Condition Report

## Ada/Twin Valley Airport (D00)

Office of Aeronautics  
Minnesota Department of Transportation  
222 East Plato Boulevard  
Saint Paul, MN 55107  
(800) 657-3922

January 2016

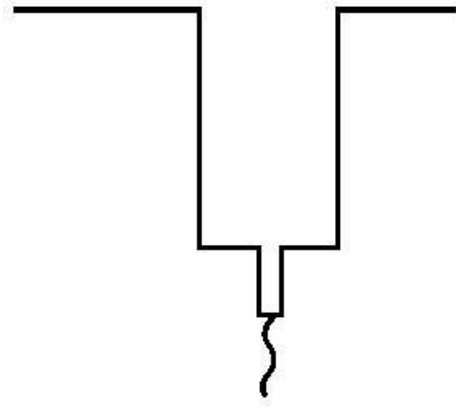
Typical joint with deficient sealant and a collection of debris & incompressibles.

Rout out old sealant, debris and incompressibles. Clean joint sides to expose fresh, clean concrete and stone. Retain existing reservoir shape.
