# Pavement Condition Report

## Warren Municipal Airport (D37)

January 2016

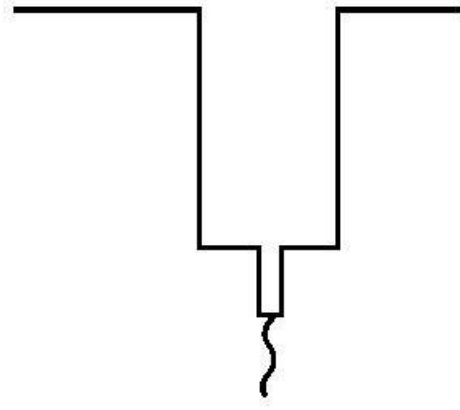
Typical joint with deficient sealant and a collection of debris & incompressibles.

Rout out old sealant, debris and incompressibles. Clean joint sides to expose fresh, clean concrete and stone. Retain existing reservoir shape.
