Pavement Condition Report

Luverne - Quentin Aanenson Field Airport (LYV)

January 2016

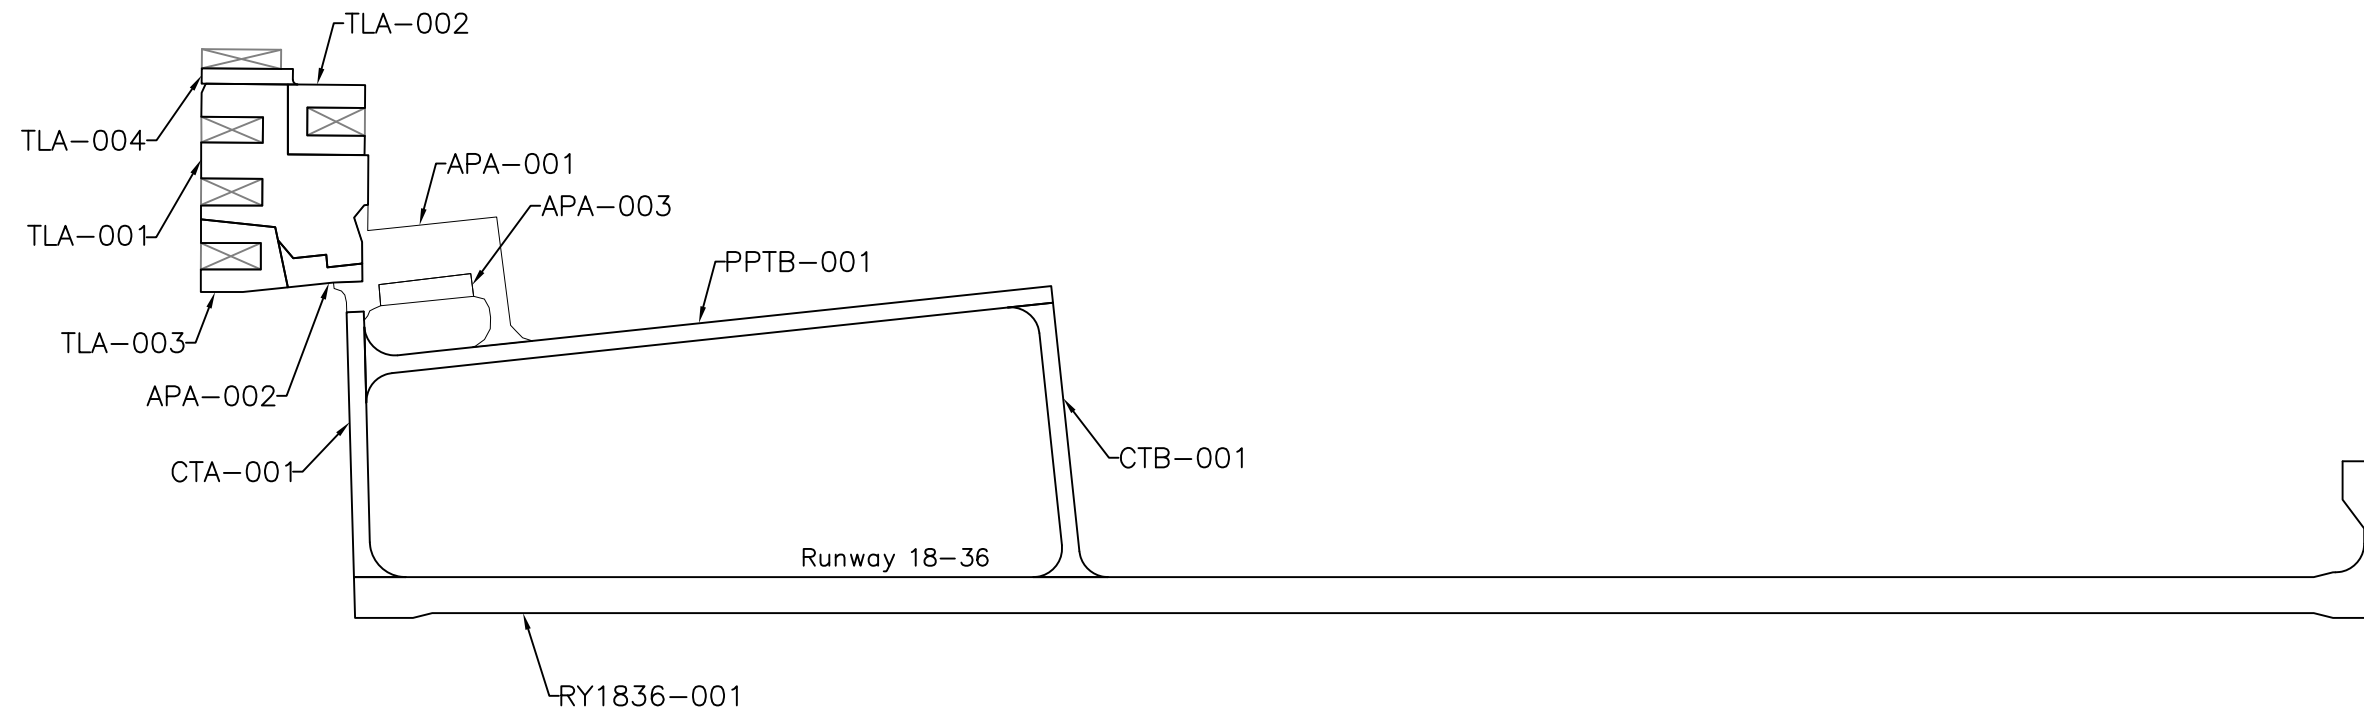
Figure 2. Network Definition at Laverne-Quentin Anenson Field Airport (LYV).

Figure 2 presents the network definition for LYV and represents the pavements included in the APMS. Some privately built/maintained pavements and “driveways” leading into hangars may not be included here because they are considered outside the scope of work.

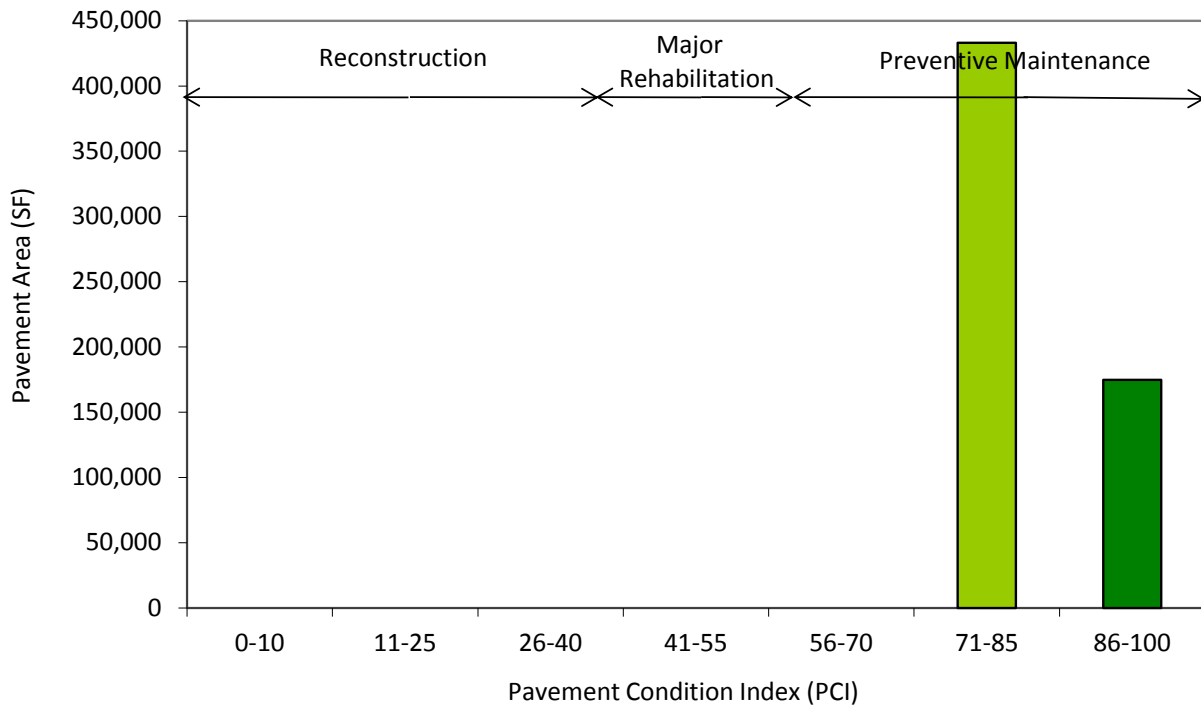
Figure 5. Condition distribution.

Figures 5 and 6 present the overall PCI for LYV by area distribution and pavement use, respectively. Table 3 presents the PCI summary for each section at LYV, including the drop in PCI per year. Generally, pavement sections will deteriorate between 1 and 3 PCI points per year. Sections deteriorating at higher rates may need maintenance above the normal application rates and should be closely monitored in case major repairs become necessary earlier than expected.

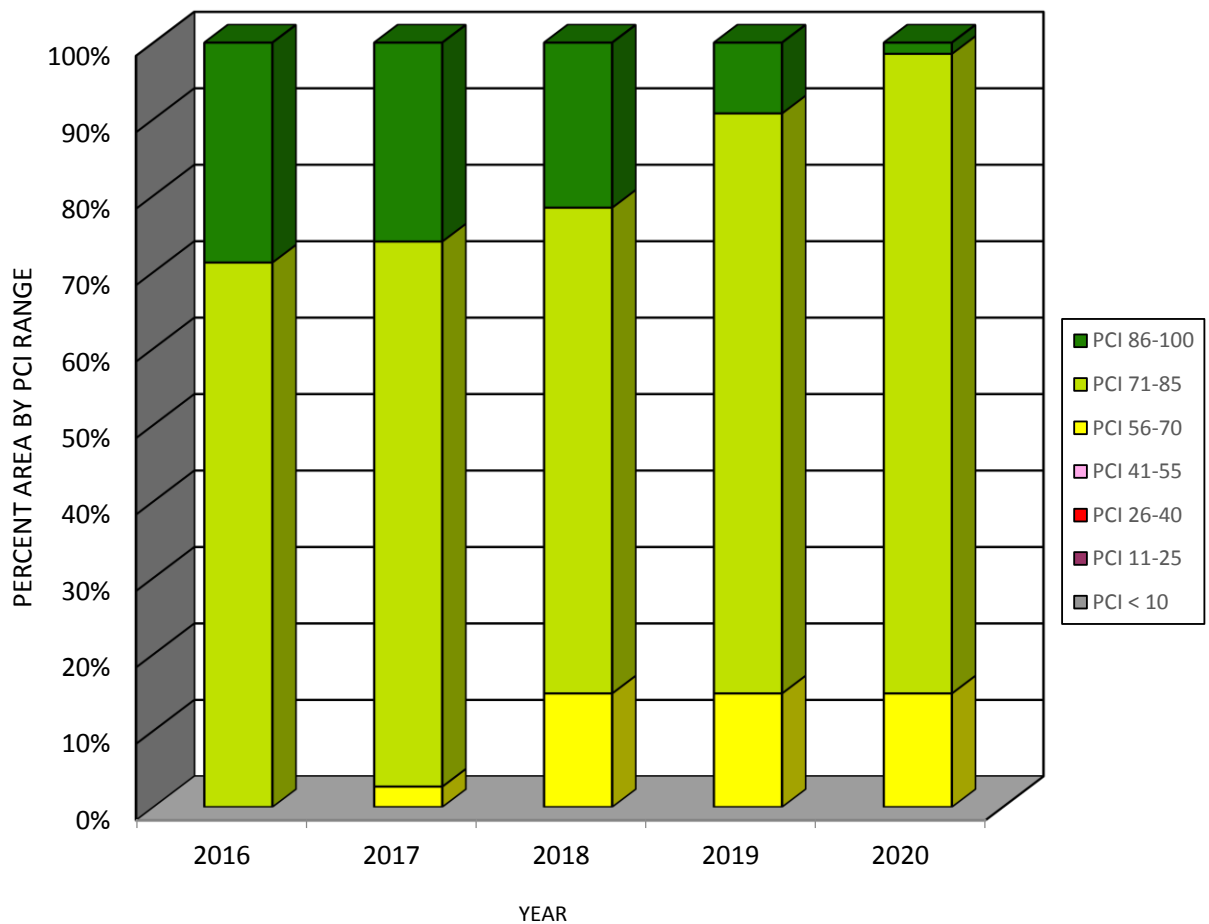
Figure 7. Projected PCI by percent area.

Figure 7 shows the projected PCI at LYV by percent area for the next 5 years assuming no major repairs (overlays, reconstruction, etc.) are performed during that period. It shows how quickly a pavement network can deteriorate when no capital improvements are made.

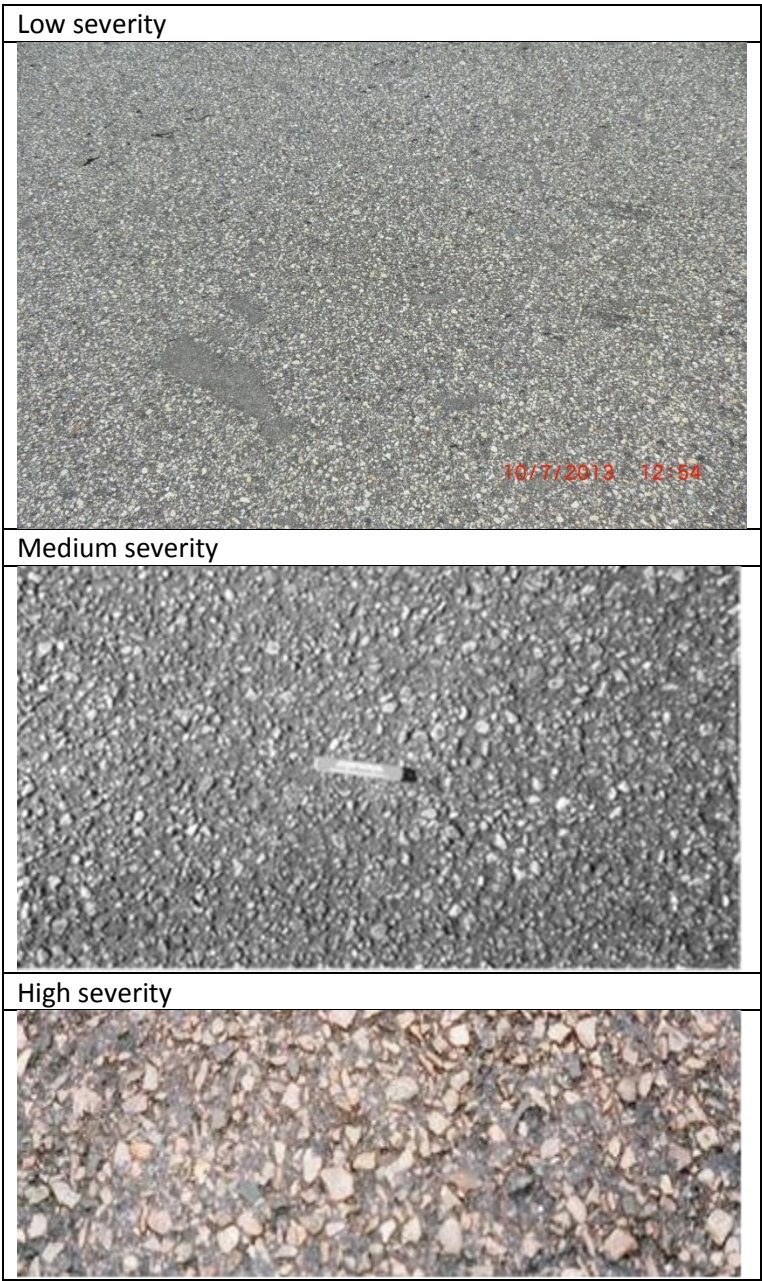
Weathering – At low severity, the coarse aggregate is slightly exposed due to the wearing away of the fine aggregate. At medium severity, the coarse aggregate is exposed up to ¼ the width of the longest side. At high severity, the coarse is exposed greater than ¼ the width of the longest side.
