Pavement Condition Report

Moose Lake - Carlton County Airport (MZH)

January 2016

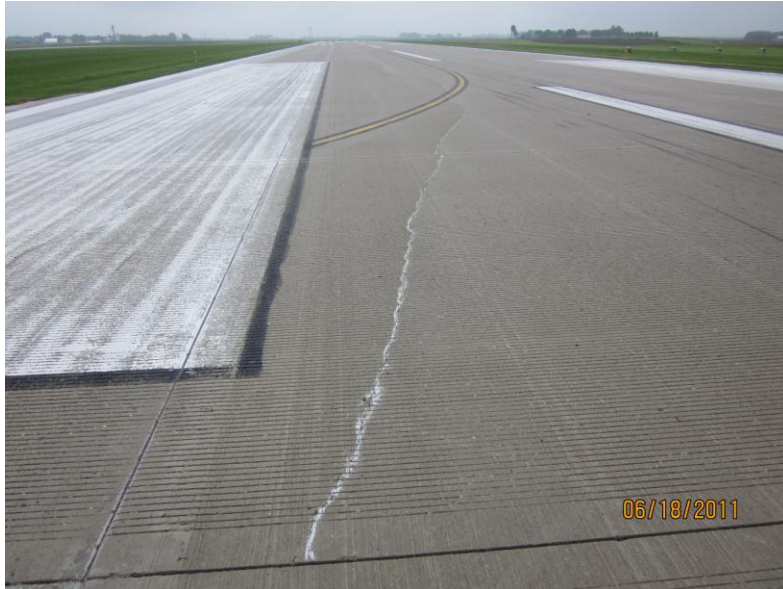
Example of Longitudinal, Transverse, and Diagonal Cracking

LTD cracking is most often a result of externally applied loads and/or constrained temperature deformations. External loads cause LTD cracking through flexure. Temperature changes on restrained slabs will result in stresses due to friction or curling. When any of these stresses exceed the strength of the slab, cracking will occur. LTD cracking is recorded at low, medium, or high severity, depending on the width of crack opening and degree of deterioration. At low severity, the crack is less than 1/8th inch wide with little spalling and no corrective action is indicated. At medium severity, LTD cracks can be up to 1 inch wide with moderate spalling, and should be repaired and sealed using procedures similar to joint sealing. At high severity, cracks exceed 1 inch in width and may be severely spalled. High-severity LTD cracking is evidence of serious load failure of the slab, and correction may require patching or slab replacement. If the distress occurs in several adjacent slabs at medium or high severity, major rehabilitation of that pavement area is indicated.

When a slab is divided by LTD cracks into four or more pieces, the slab is said to be "divided" or "shattered." Shattered slab is a separate distress category and is indicative of significant structural failure as the slab loses its ability to distribute loads to subgrade and further slab deterioration can be expected. Shattered slabs are rated in three severities, with slab replacement recommended for medium and high severities.
