Pavement Condition Report

Winona Municipal Airport (ONA)

January 2016

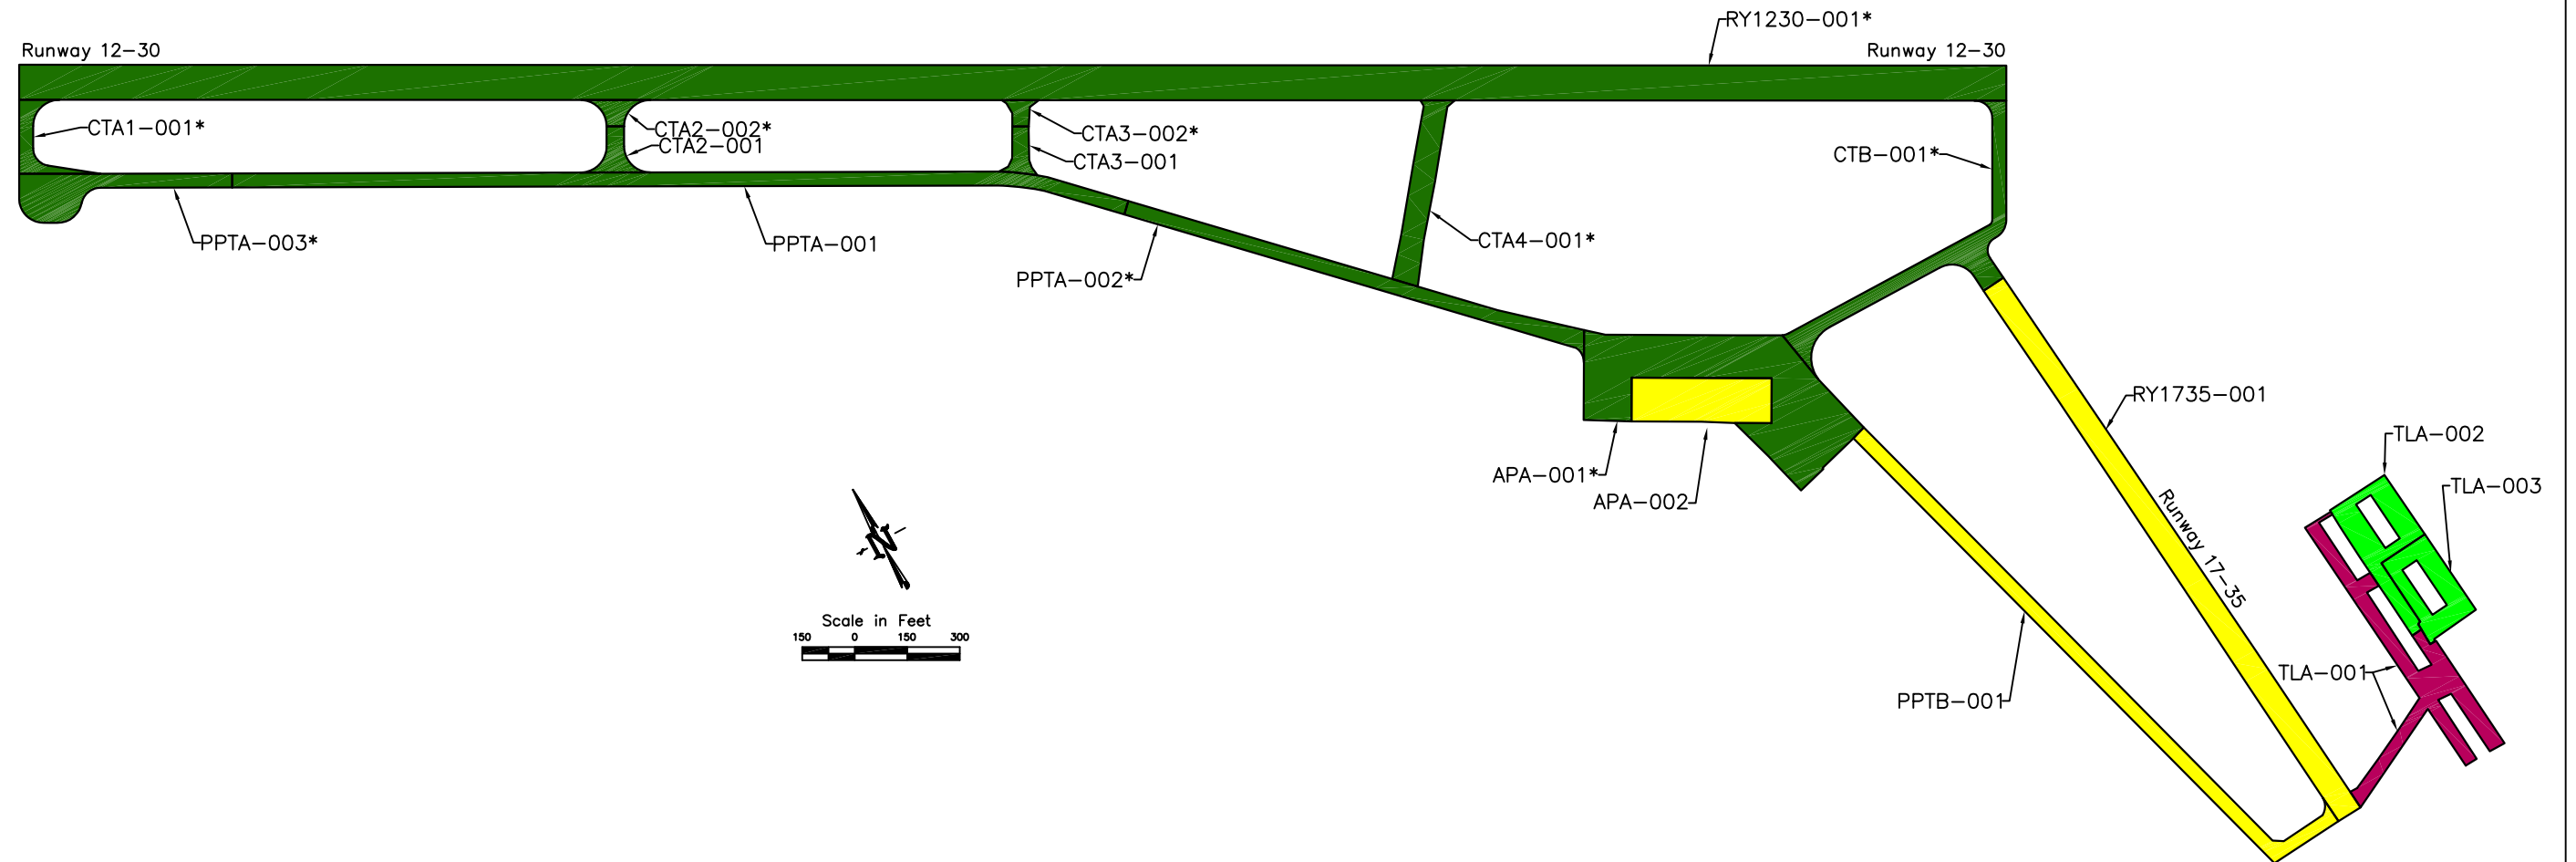
Figure 4. 2015 Pavement Condition Index Rating at Winona Municipal Airport (ONA).

The results of the 2015 PCI inspection are presented in figure 4. The overall area-weighted PCI for ONA is 88. When summarizing PCI values, an area-weighted calculation is used instead of a straight mathematical average because the area-weighted calculations eliminate the skewing of the PCI due to the disparity of the section sizes.
