Pavement Condition Report

Redwood Falls Municipal Airport (RWF)

January 2016

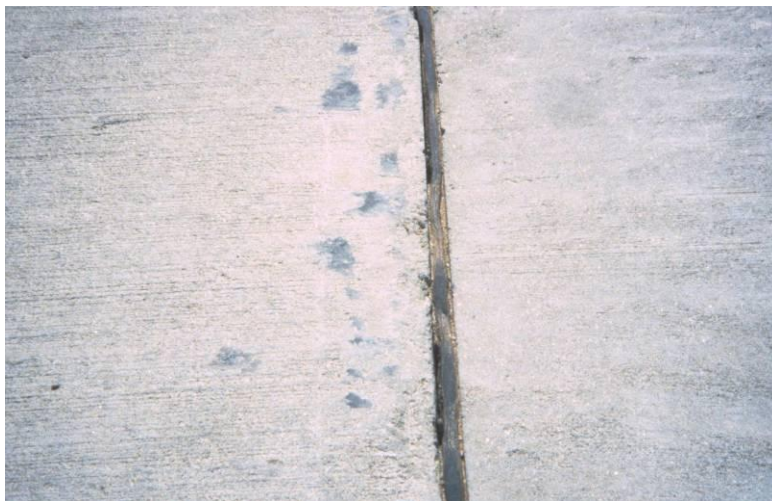
Example of Joint Seal Damage

Joint seal damage is recorded at three severities: low, medium, and high. When joint sealant is in perfect condition (no damage), it is not a distress. At low severity, at least 10 percent of the sealant is debonded but still in contact with the joint edges (i.e., joint sealant is in serviceable condition but should

be monitored for evidence of more serious failure). Medium-severity joint seal damage is recorded when at least 10 percent of the sealant has visible gaps smaller than 1/8th inch and is an indicator that replacement should be programmed as soon as is practicable. In the meantime, aggressive inspection and sustaining maintenance is recommended to minimize subsurface damage from moisture penetration. At high severity, visible gaps exceed 1/8th inch and the amount and degree of joint seal damage is such that repair is no longer feasible. The only appropriate corrective action is sealant replacement.
