Pavement Condition Report

Buffalo Municipal Airport (CFE)

December 2016

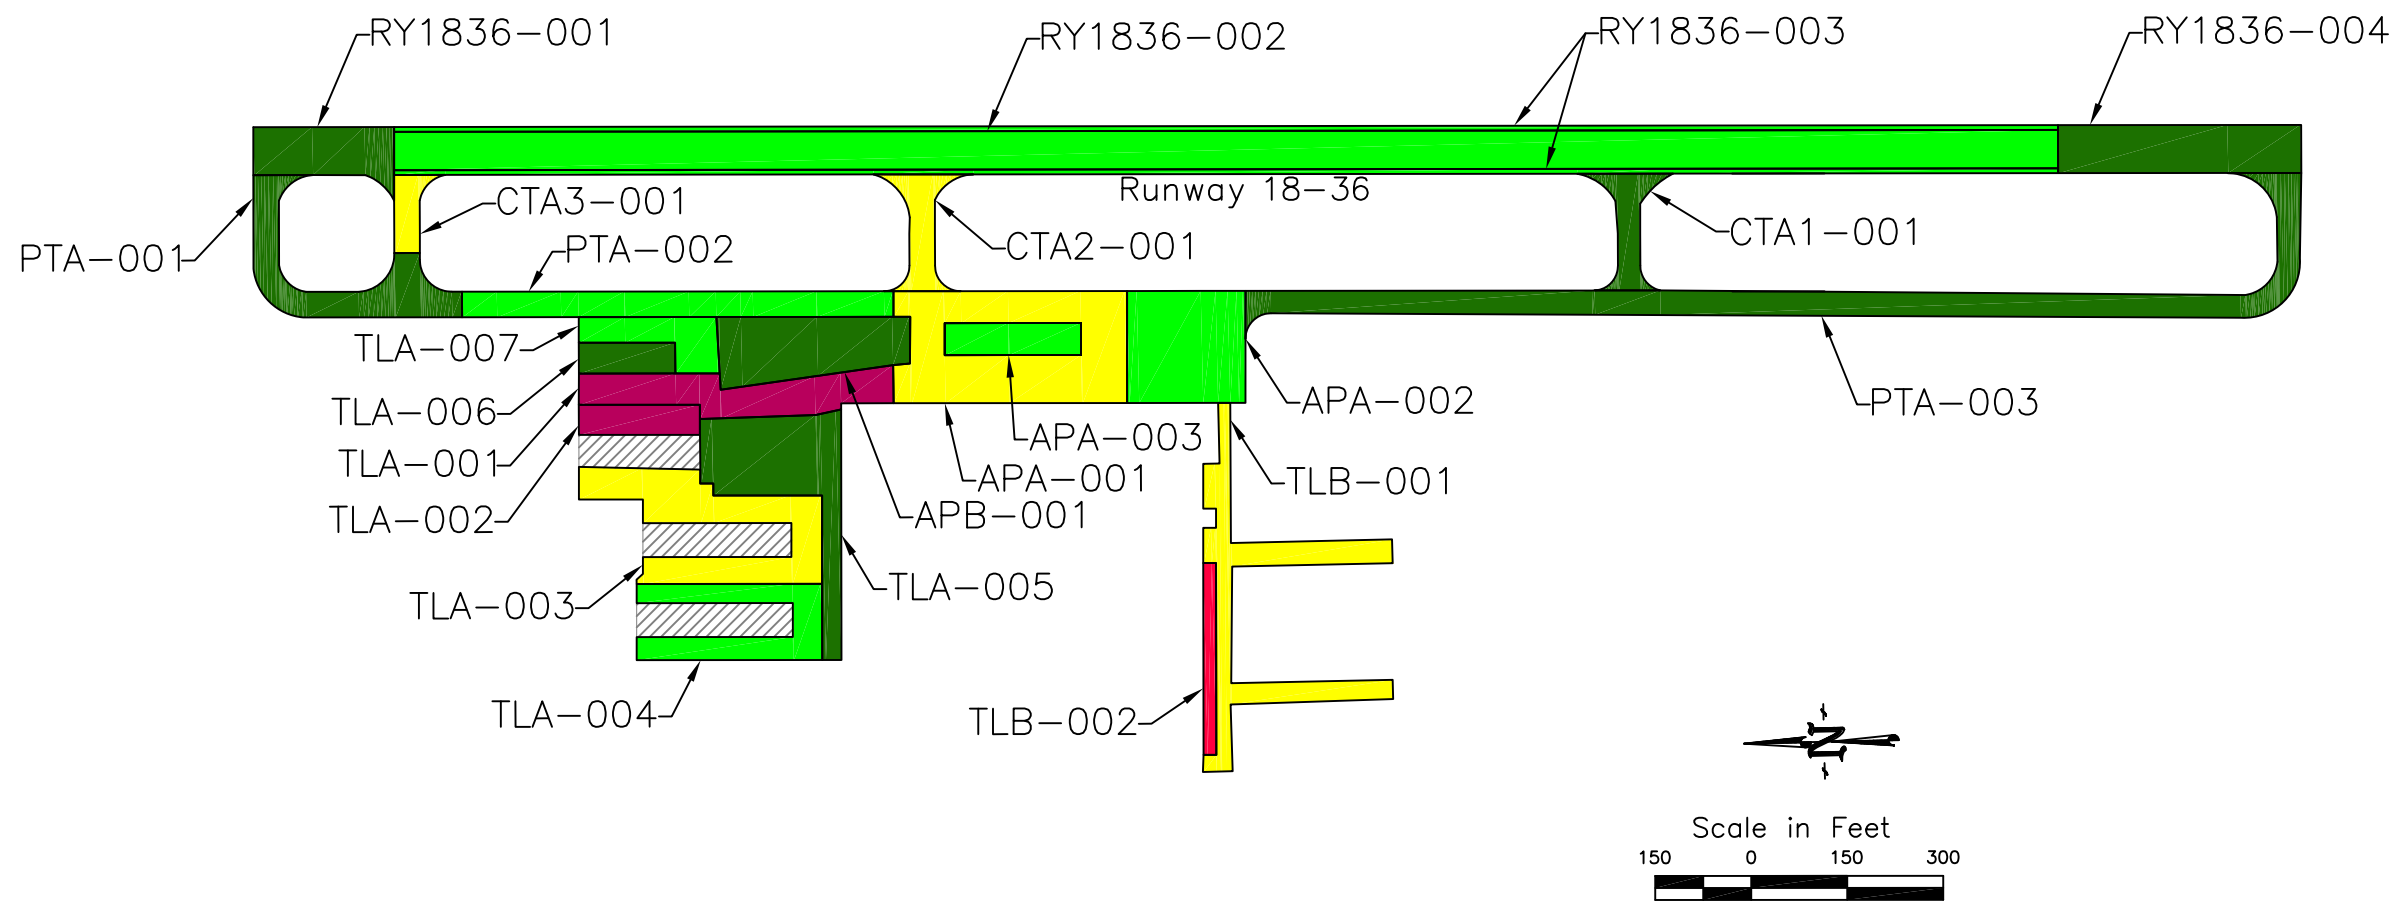
Figure 4. 2016 Pavement Condition Index Rating at Buffalo Municipal Airport (CFE).

The results of the 2016 PCI inspection are presented in figure 4. The overall area-weighted, inspected PCI for CFE is 77. When summarizing PCI values, an area-weighted calculation is used instead of a straight mathematical average because the area-weighted calculations eliminate the skewing of the PCI due to the disparity of the section sizes.

Note: Significant load related distress in taxilane sections with high deterioration rates.
