# Culvert Inspection and Repair

Bonnie Peterson, HydInfra Coordinator  
Minnesota Department of Transportation  
APWX Mpls 2016

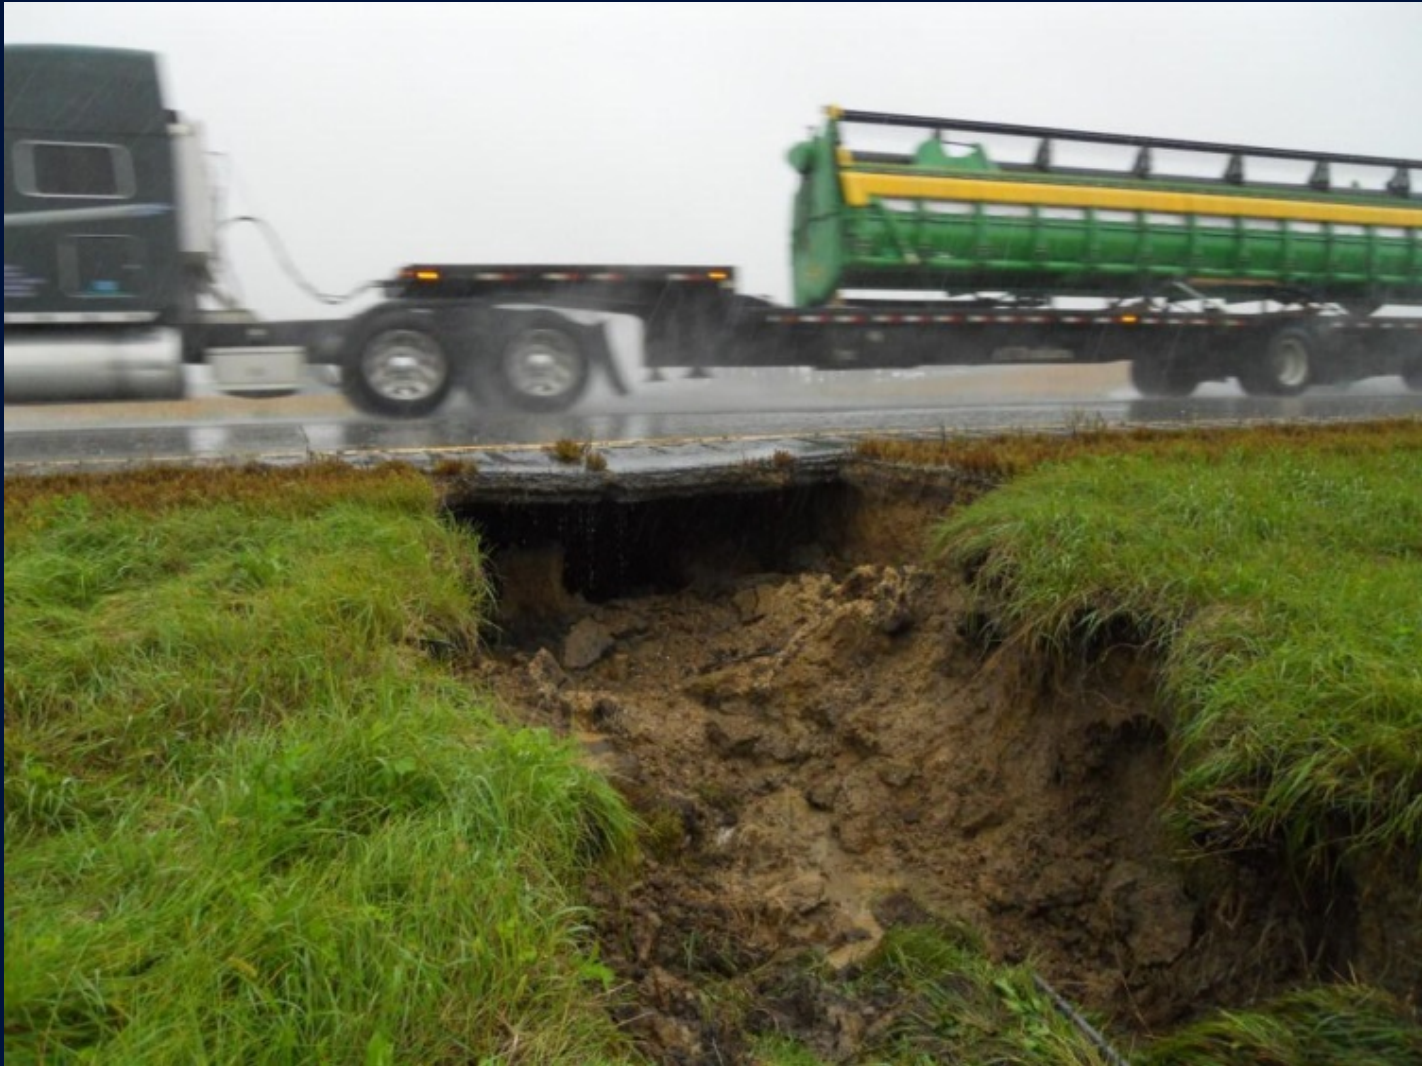
# Big storm + bad pipe = wrecked road

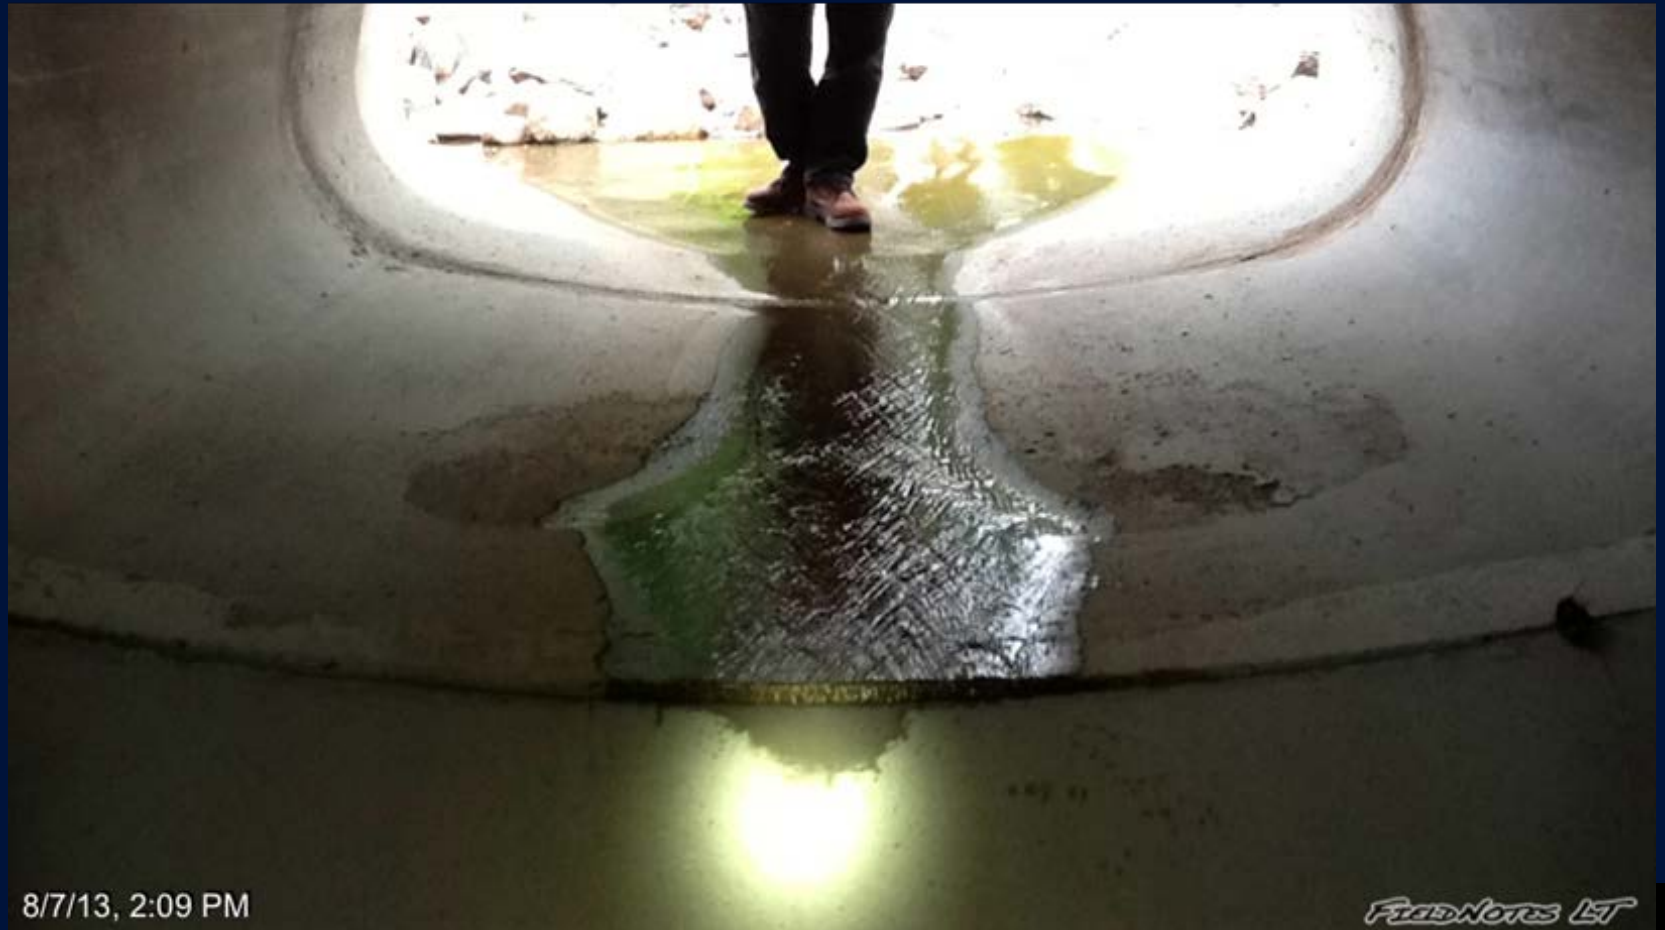
This is what **pipng** looks like –  
water leaves the pipe at holes or joint separations  
and **flows along the outside**

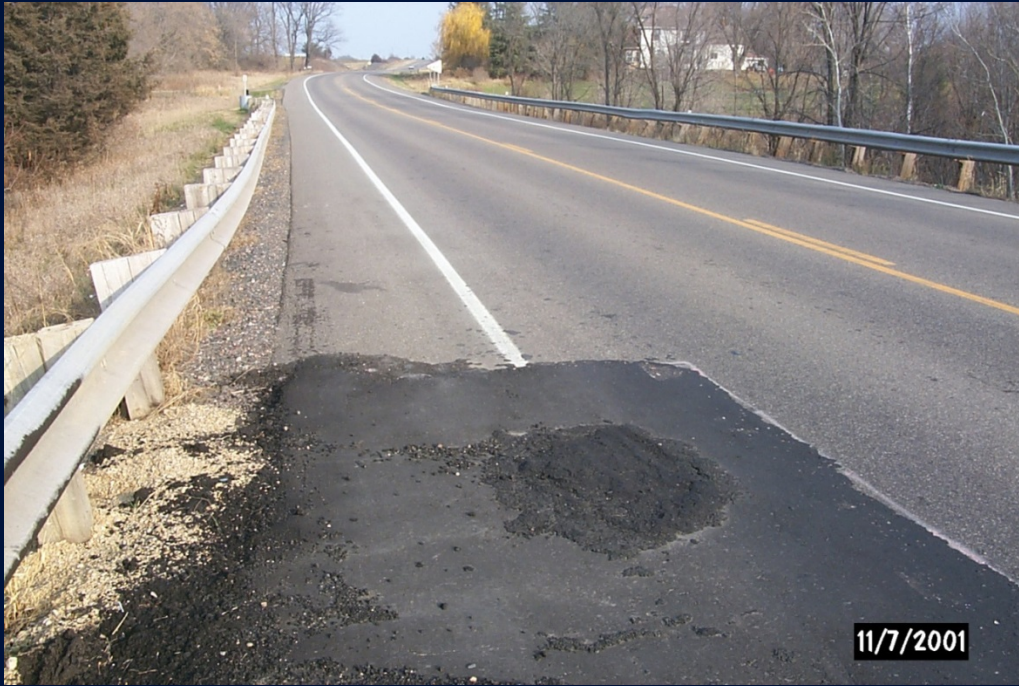
MN 95 near MP 89, near Marine on the St. Croix

Water flows along the outside  
of pipe carrying road fill away.

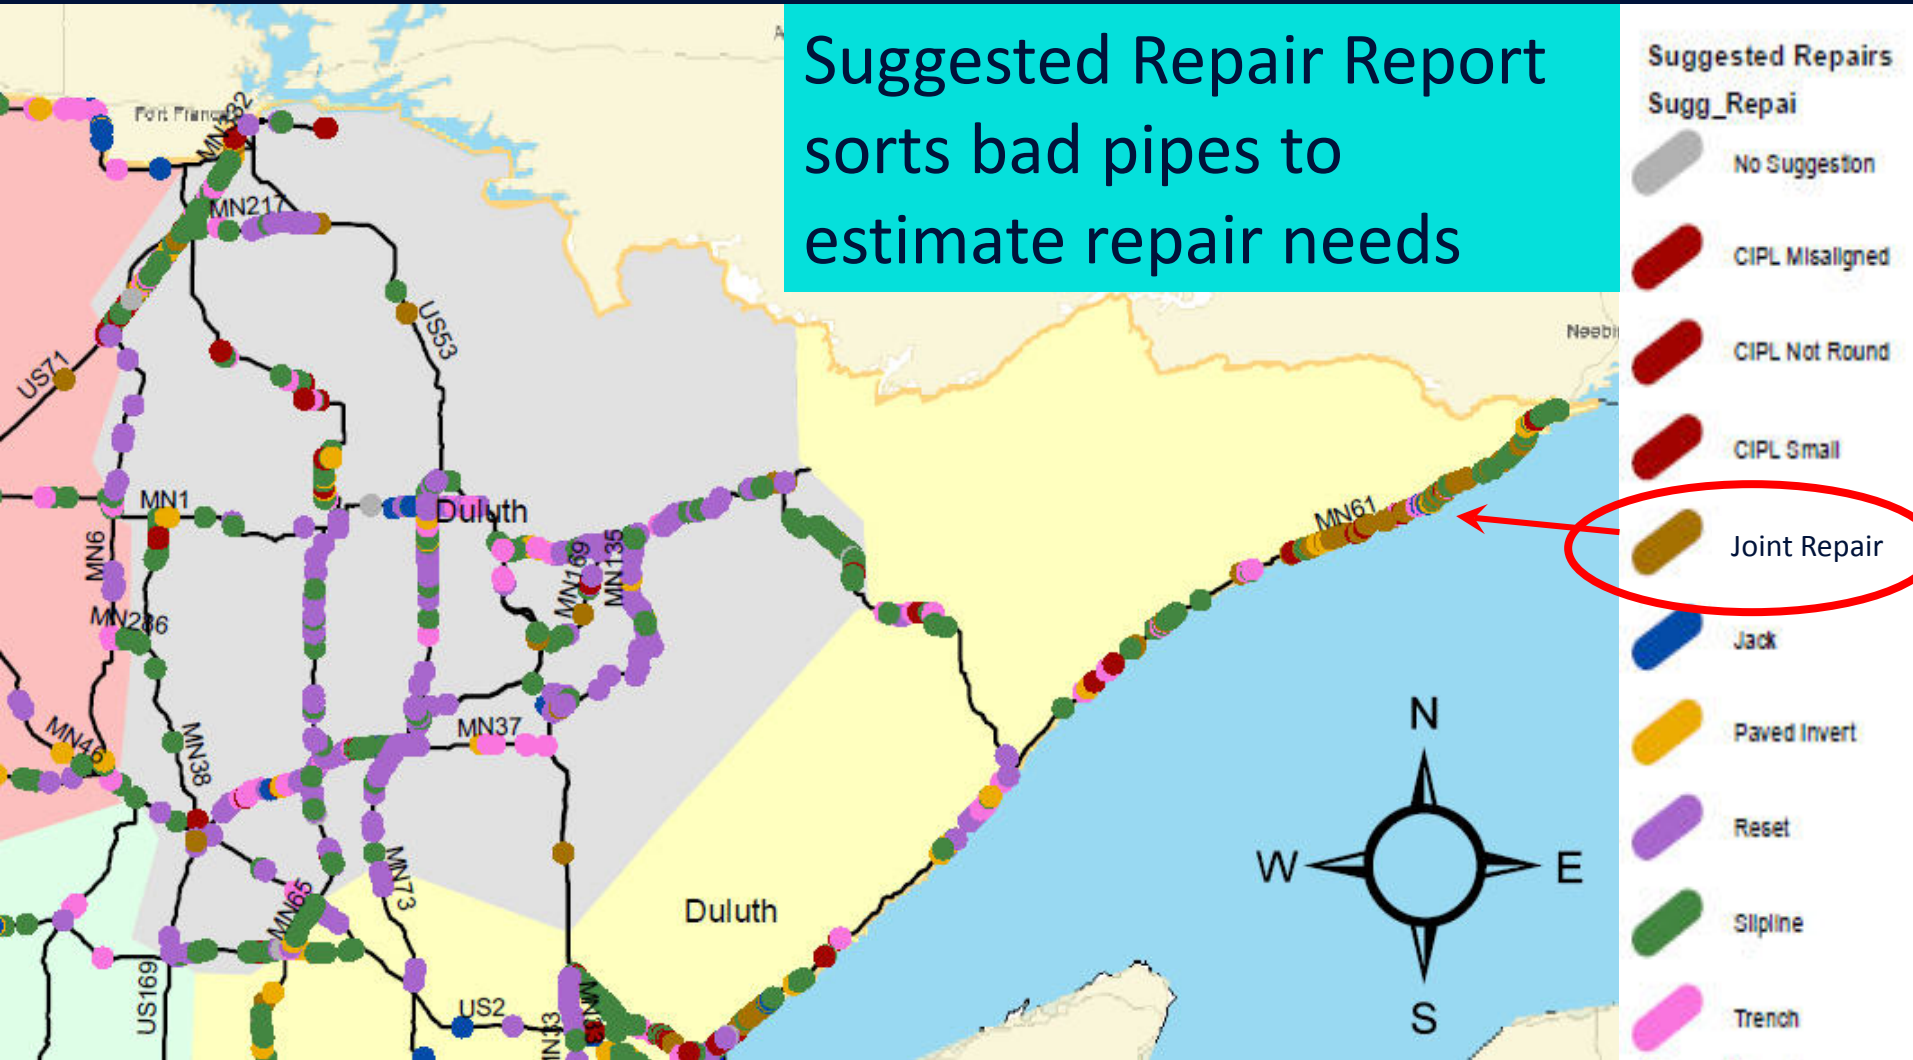
Cluster of suggested Joint Repairs indicates joint separations along Highway 61

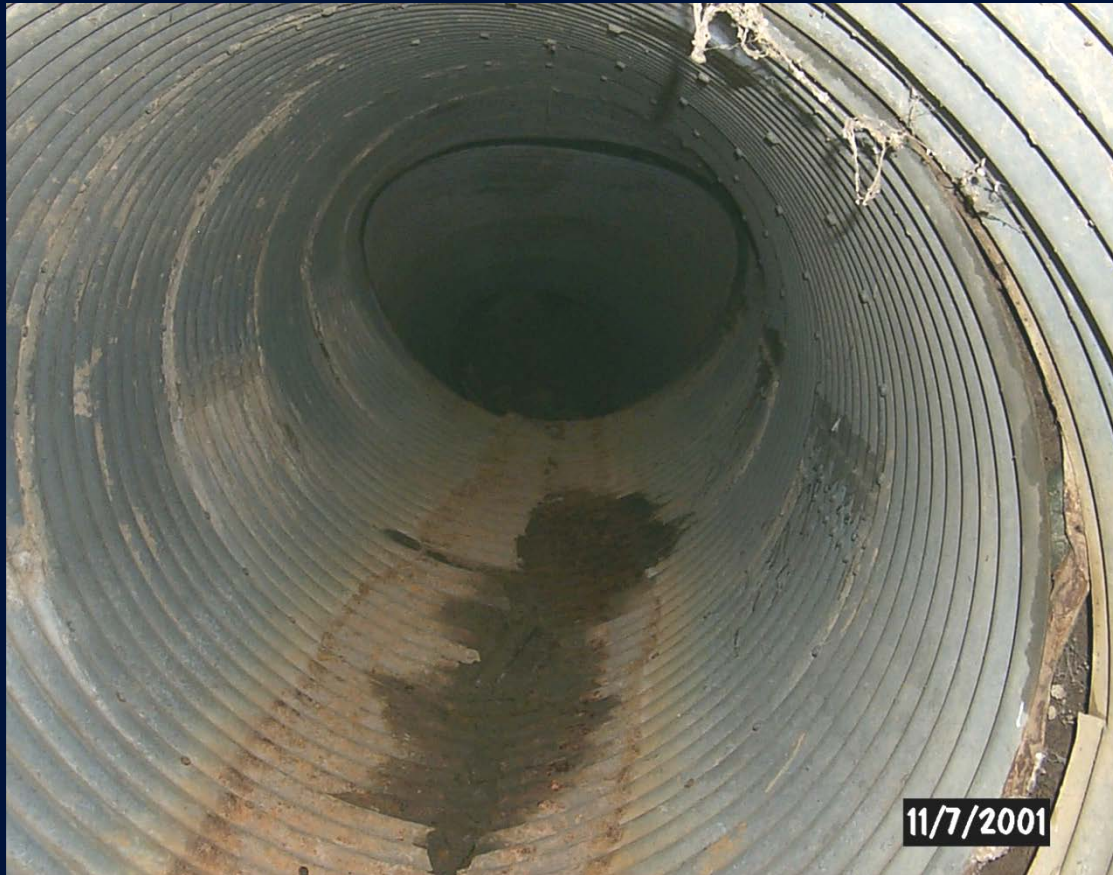
Most Steel pipe **gradually** deteriorates through a **series of defects** shown by inspection flags:

1. Pitting/Rusting
2. Spalling/Flaking
3. Holes
4. Piping
5. Road Void
6. Deformation

HydInfra data shows that about 10% of MnDOT's steel pipe has holes

Pave the invert, install a liner or  
replace the culvert  
before piping and road voids occur

when inspection shows Flaking Rust or  
a **Hole less than 1 inch**

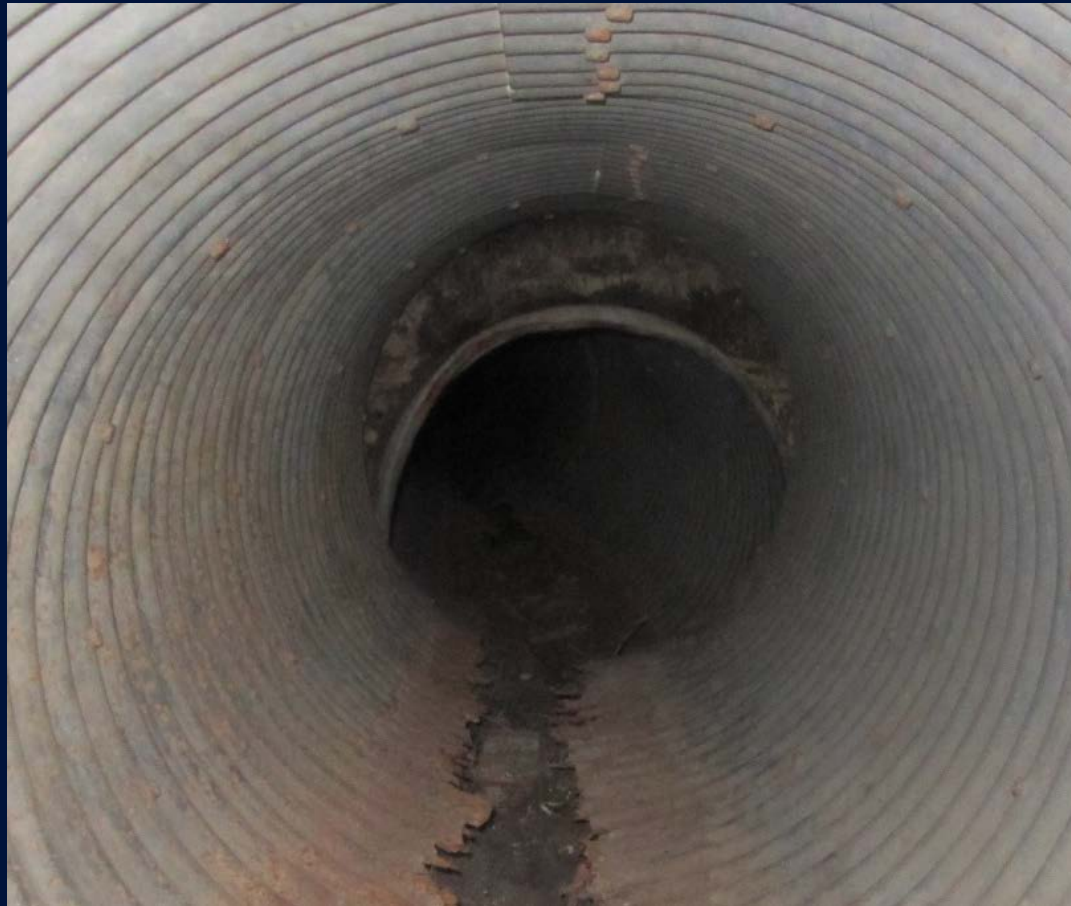
Joint Separation and Misalignment  
is rare in **Steel** pipe  
and may indicate a slope failure

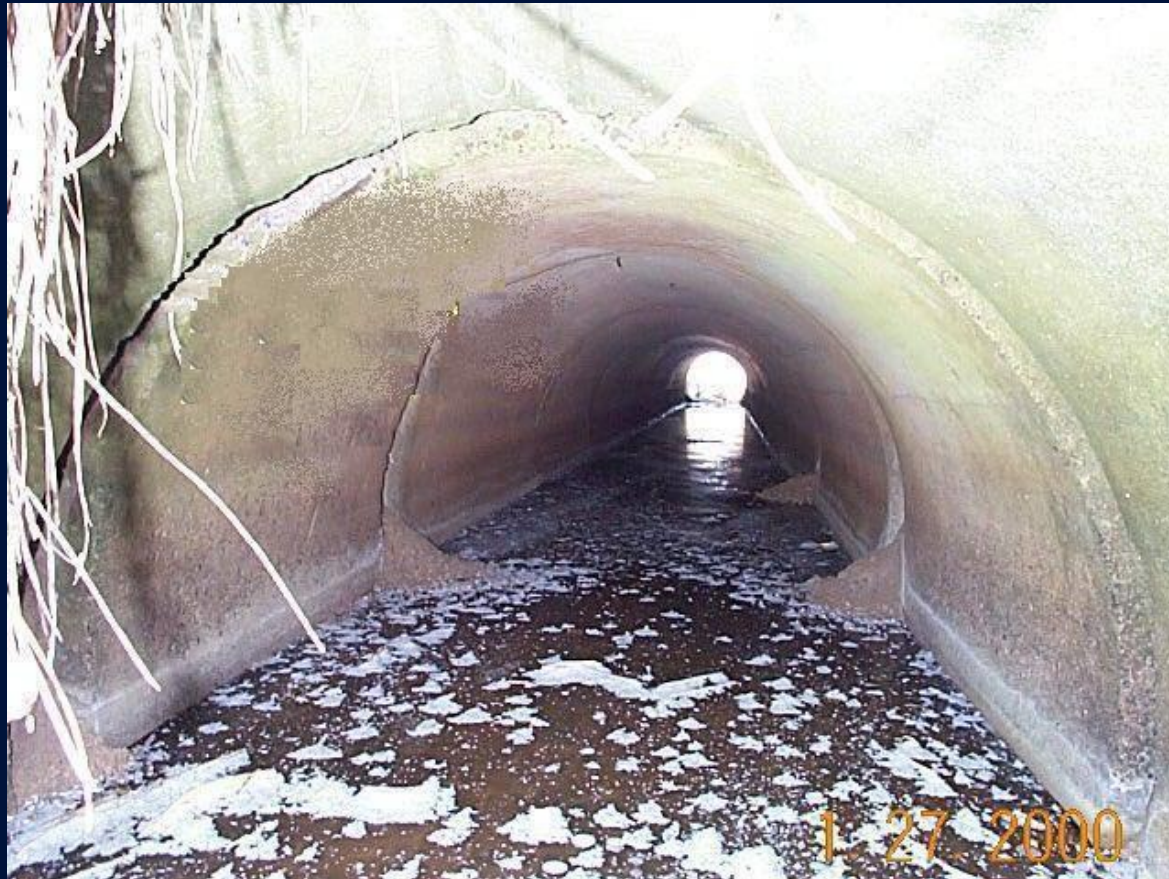
# Concrete pipe fails most often when **Joint Separation** and **Piping** causes **Road Void**

HydInfra data shows about 7% of MnDOT's  
concrete pipes have separated joints

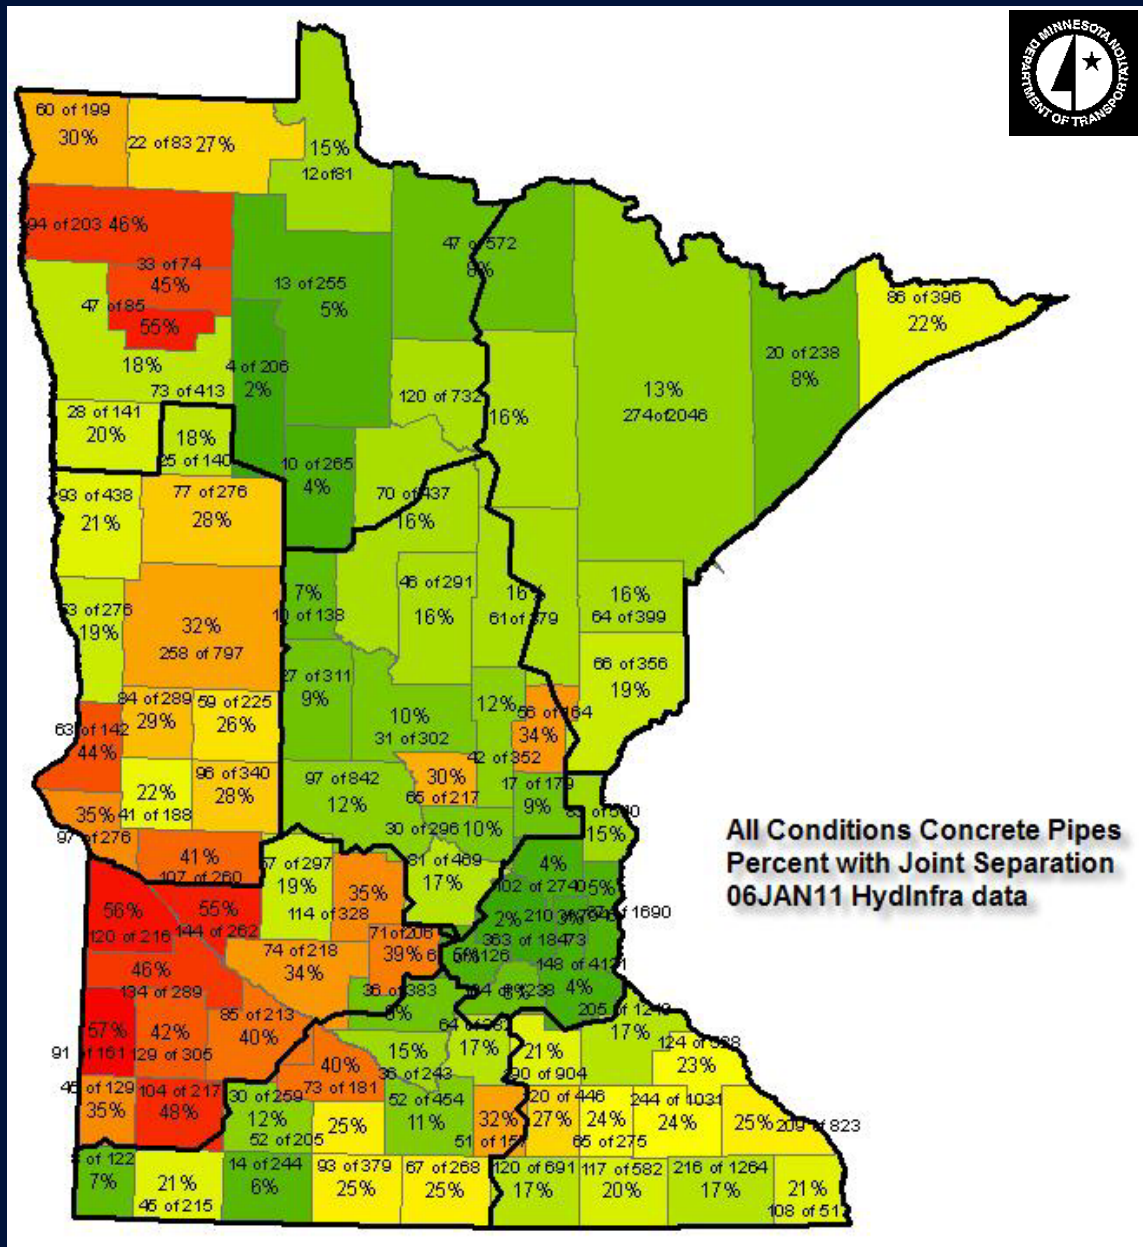
Concrete  
**Joint Separation**  
may be worse in  
western  
Minnesota

Inspection flags  
show **hotspots** for  
Joint Separation

This 2011 map was created after Highway Culvert inventory was completed but before most Districts were focused on repairing pipes.
