# Culvert Inspection and Repair

Bonnie Peterson, HydInfra Coordinator  
Minnesota Department of Transportation  
APWX Mpls 2016

2 Decades of  
Culvert Inspection

Culvert and Storm Drainage System  
Inventory and Inspection Program

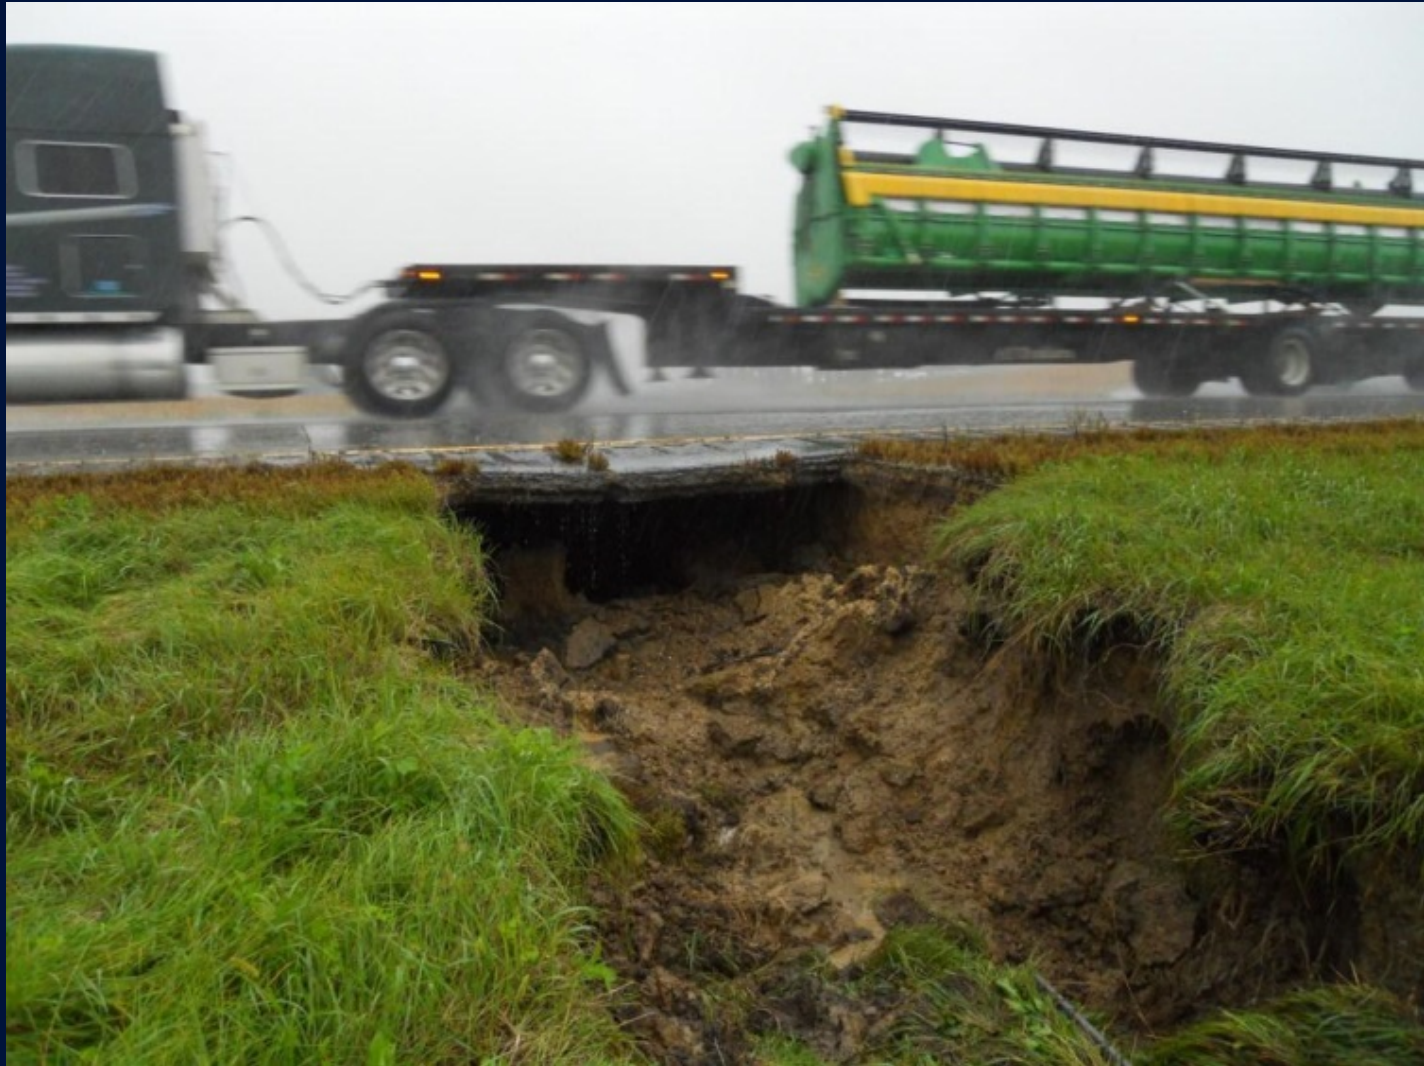
# Big storm + bad pipe = wrecked road

*We could have fixed it cheaper, sooner.*

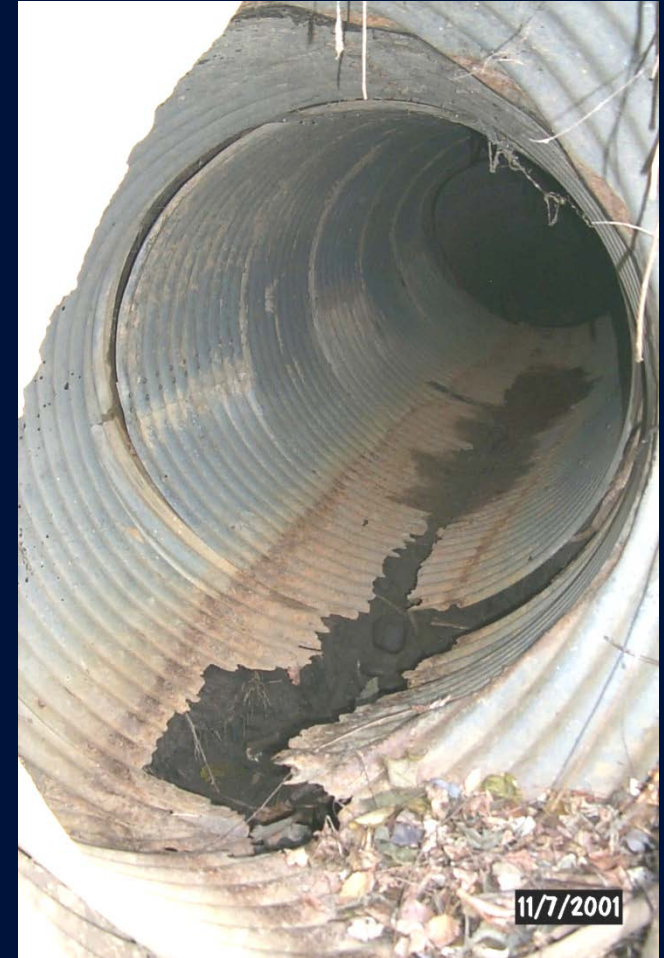
MN 95 near MP 89, near Marine on the St. Croix

**Pipe Repair is too late**  
when the road surface  
reflects condition of pipe

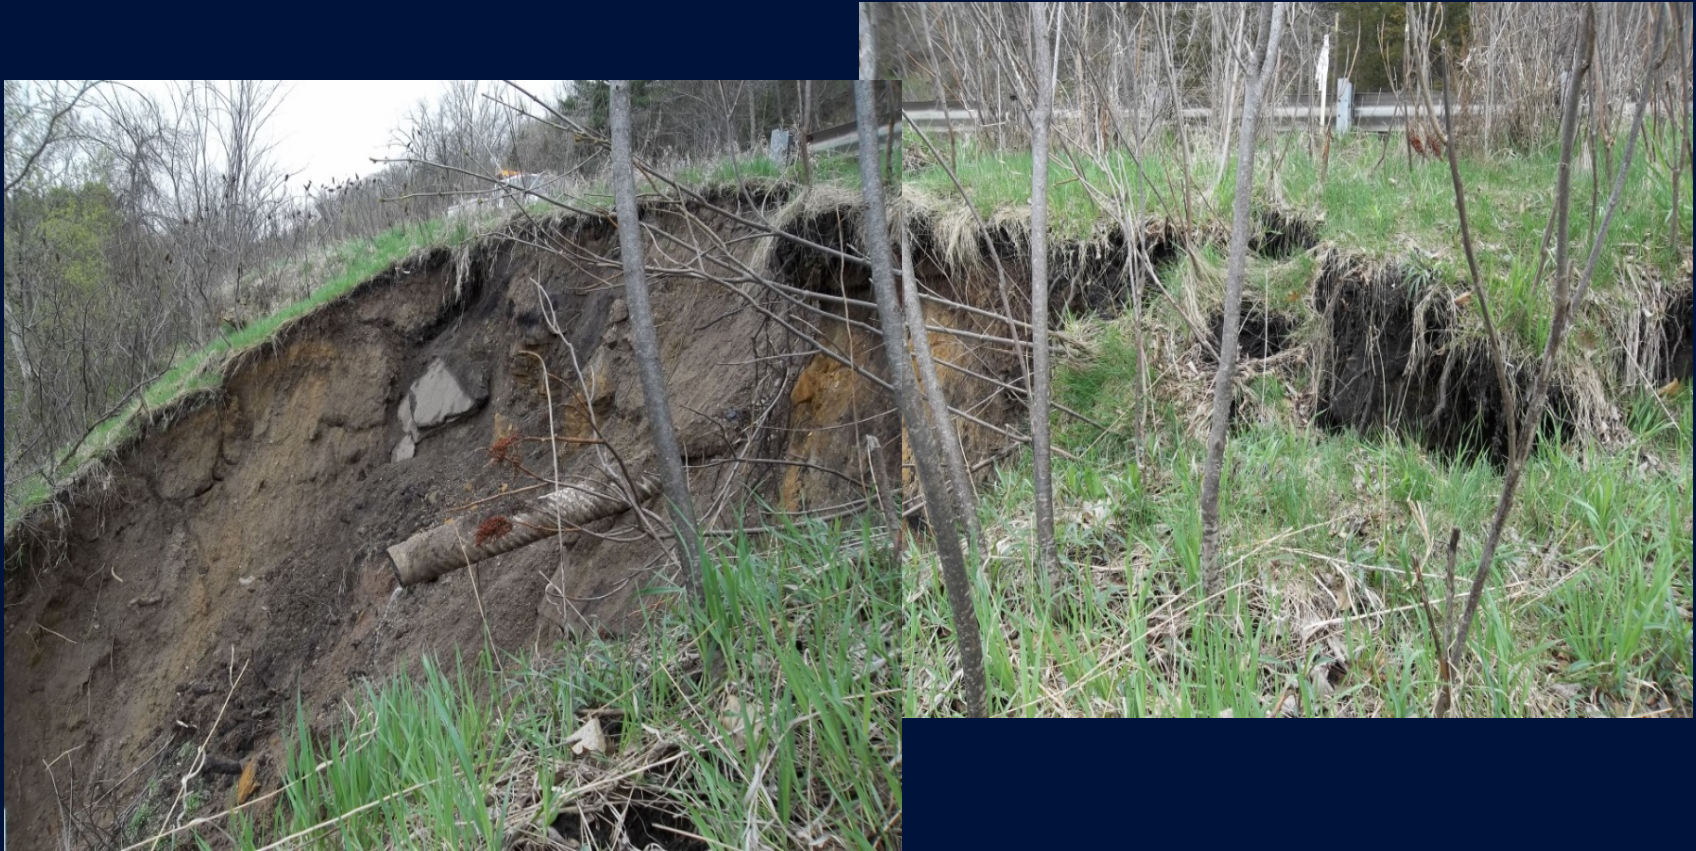
While some steep slopes are prone to failure **leaking pipes lubricate the slide**

Pavement may span the void for awhile

until it doesn't.

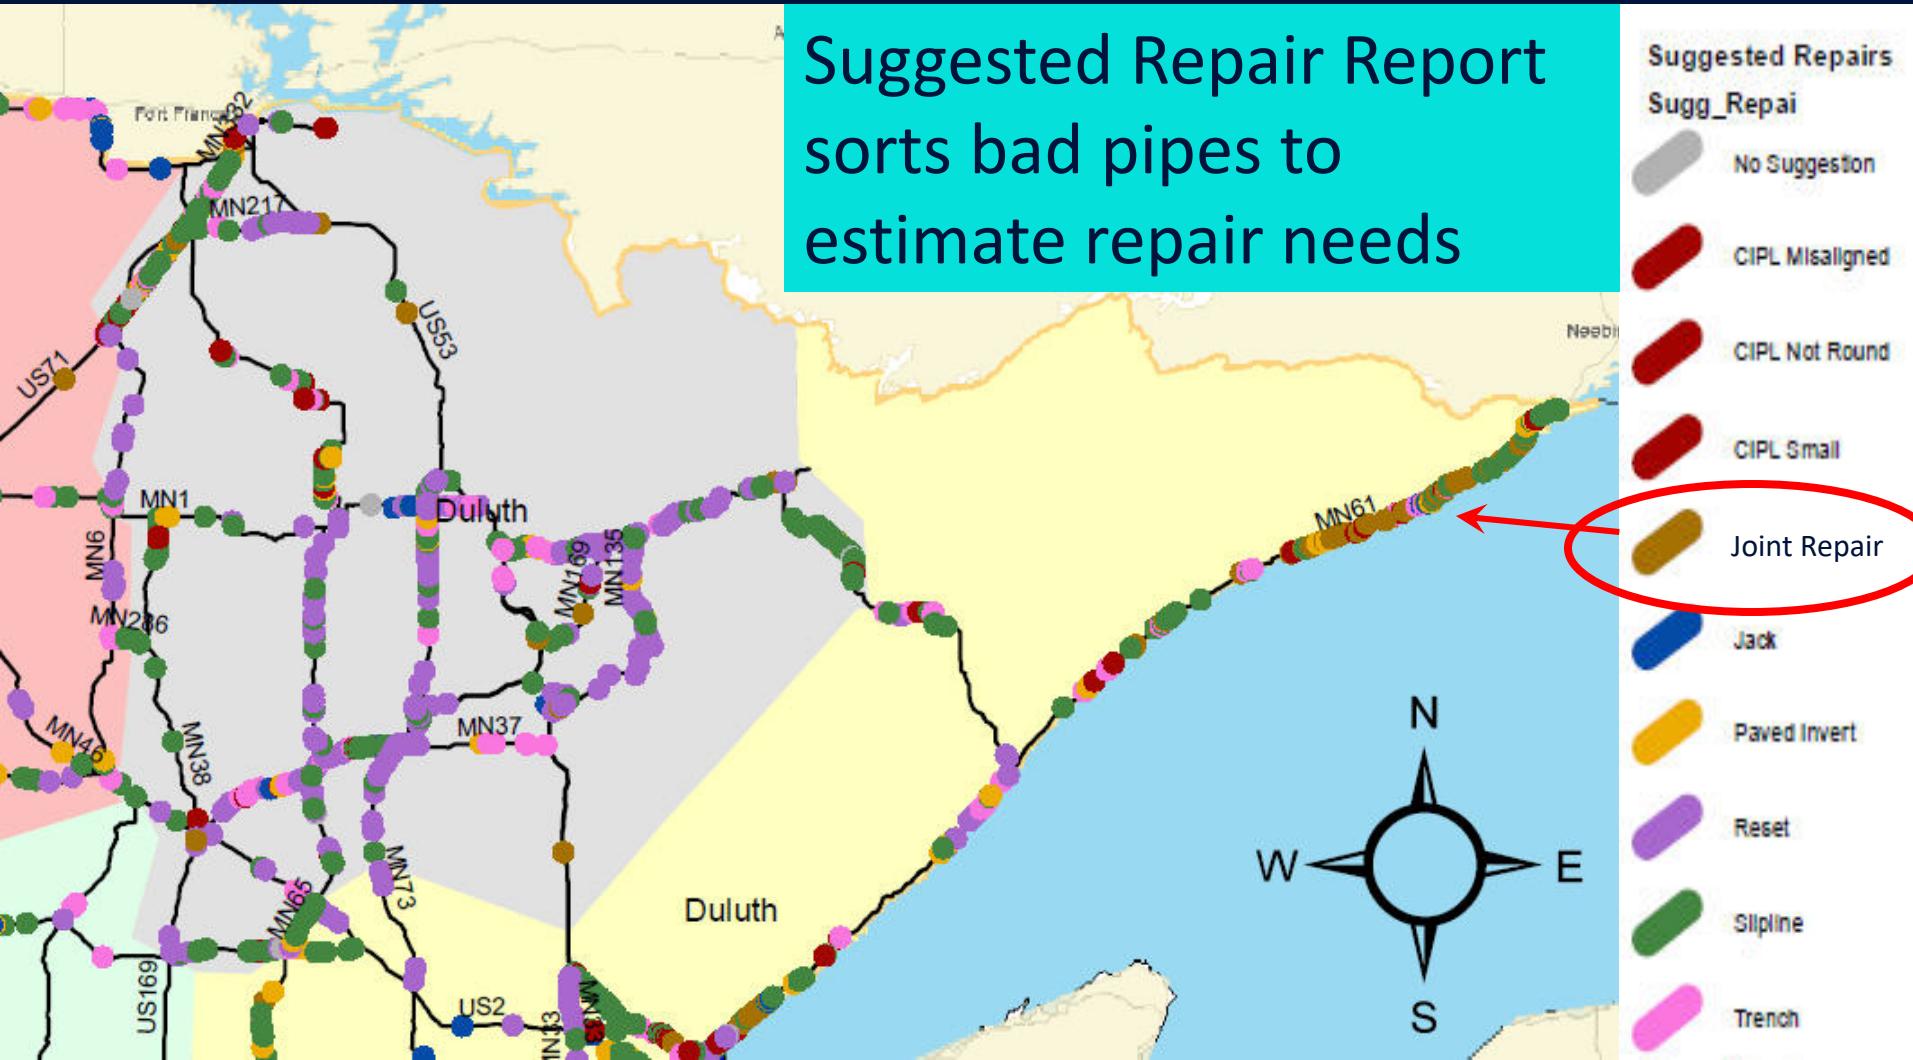
Cluster of suggested Joint Repairs indicates joint separations along Highway 61

Suggested Repair Report sorts bad pipes to estimate repair needs

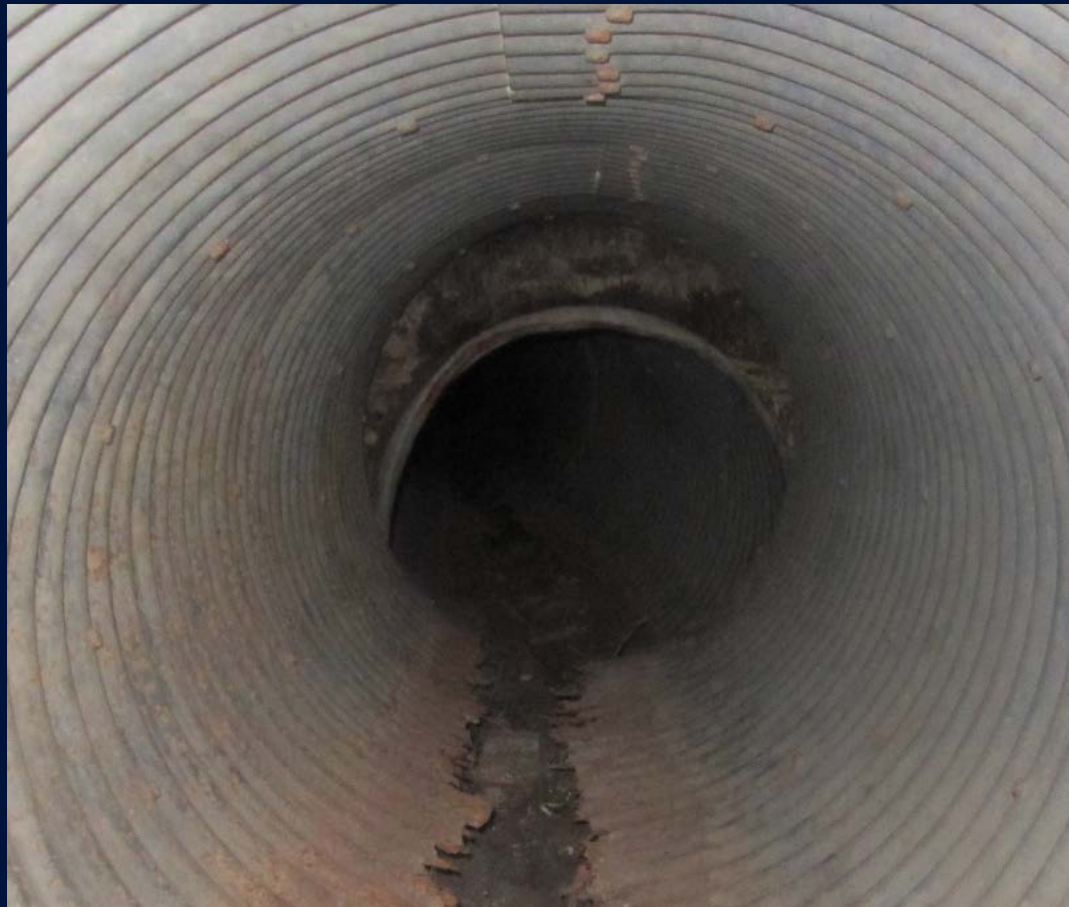
Joint Separation and Misalignment  
is rare in **Steel** pipe  
and may indicate a slope failure

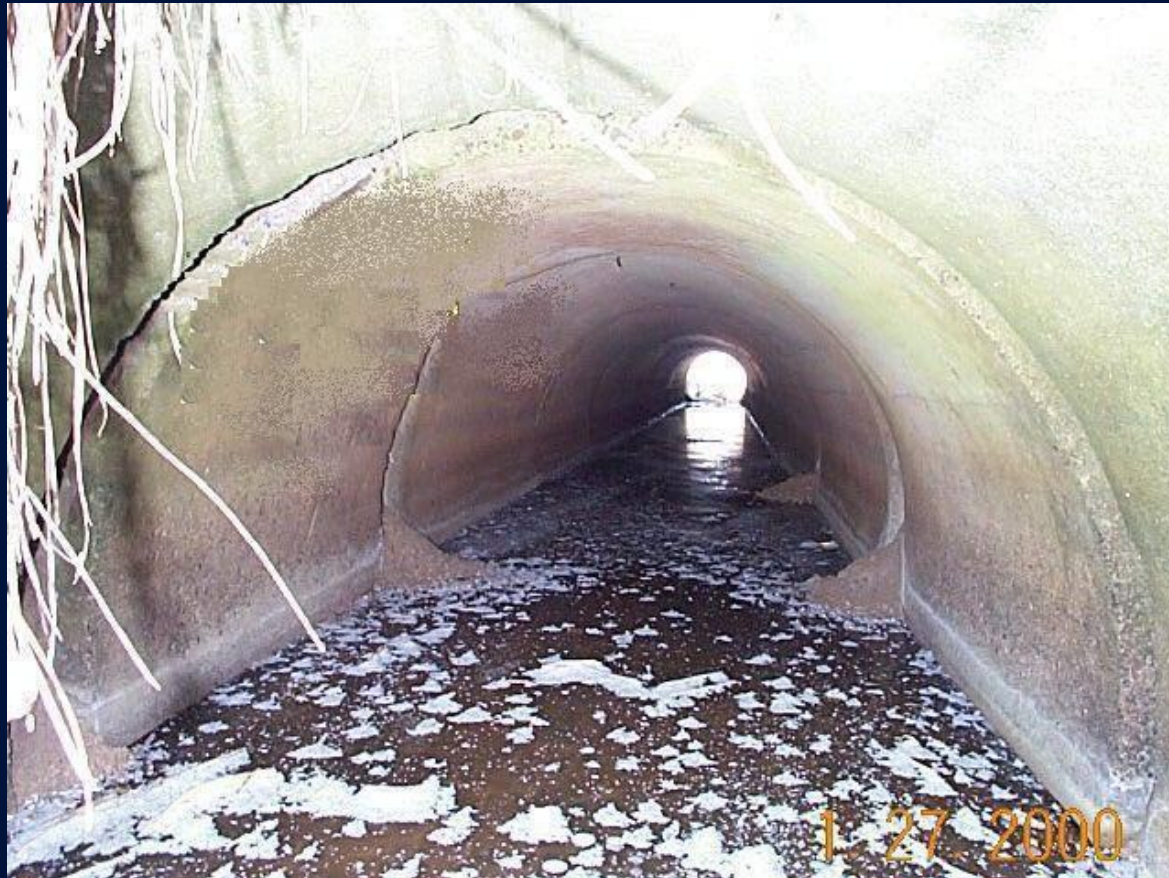
# Concrete pipe fails most often when **Joint Separation** and **Piping** causes **Road Void**

HydInfra data shows about 7% of MnDOT's  
concrete pipes have separated joints

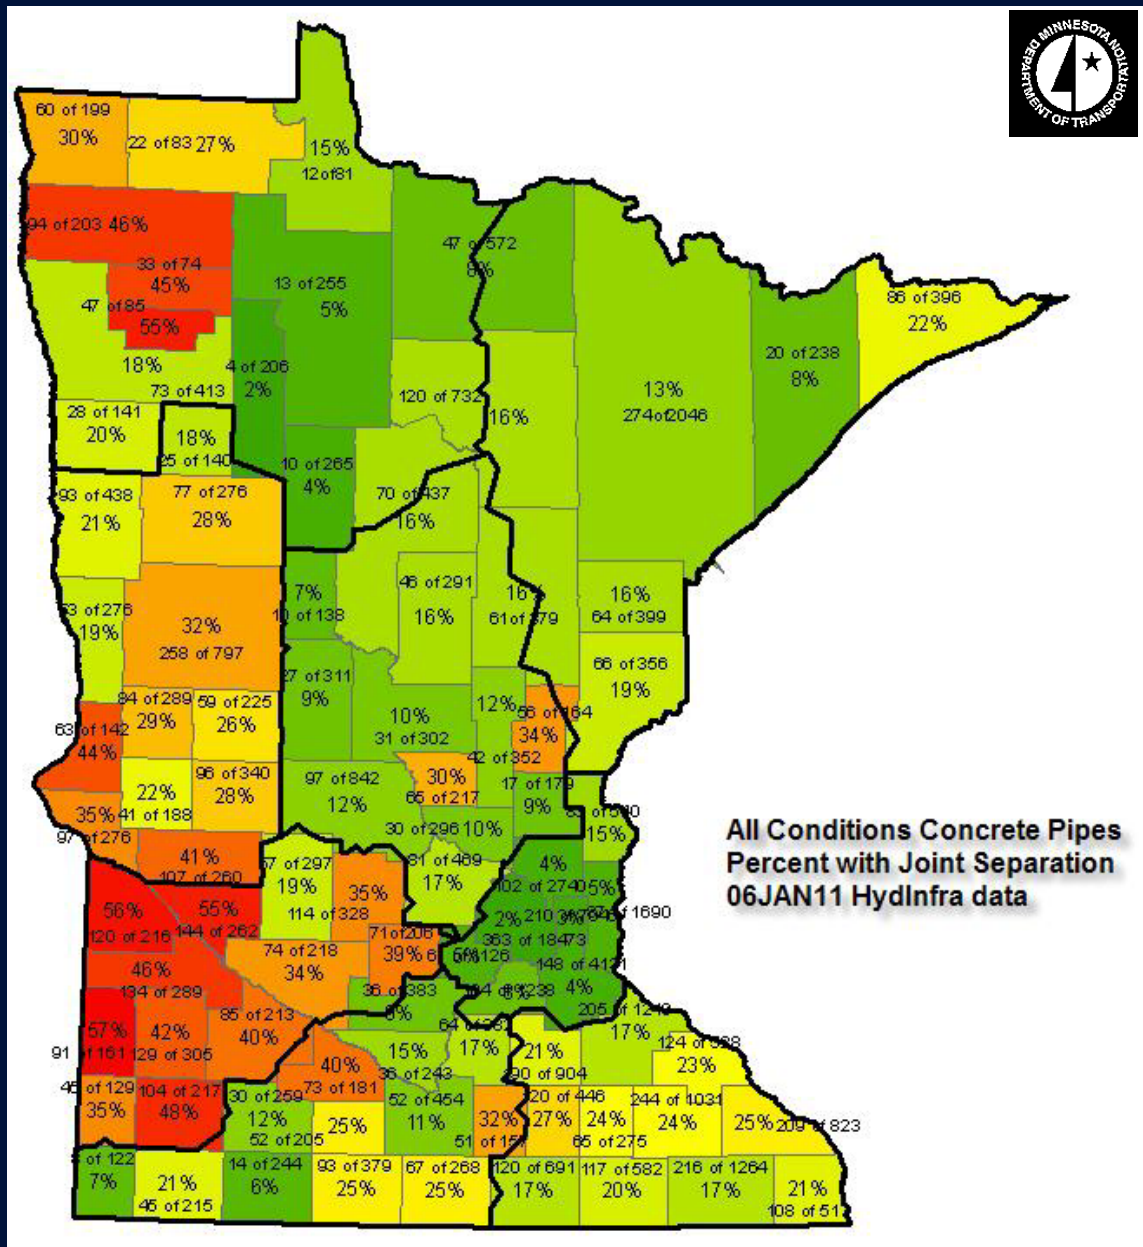
Concrete  
**Joint Separation**  
 may be worse in  
 western  
 Minnesota

Inspection flags  
 show **hotspots** for  
 Joint Separation

This 2011 map was created after Highway Culvert inventory was completed but before most Districts were focused on repairing pipes.
