## **BRIDGE MAINTENANCE, REHABILITATION, AND REPLACEMENT: CASE HISTORIES**

## CASE HISTORY 15.1- IN-PLACE PRESERVATIVE TREATMENT OF DETERIORATING TIMBER BRIDGES

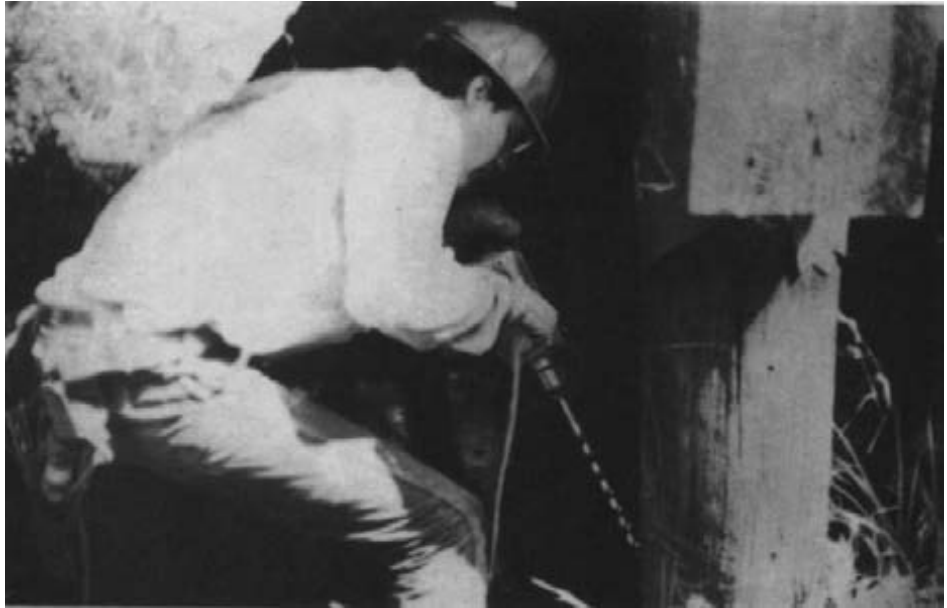
*Figure 15-5. - Drilling holes for solid preservative cartridges.*

- a. In addition to the inspection borings, extra holes were drilled in the piling at the groundline. Tie-Gard preservative cartridges were inserted into the holes, which were then plugged with treated wood dowels (Figures 15-5 and 15-6). The cartridges dissolve over a period of time and the preservative diffuses into the pile by capillary action.

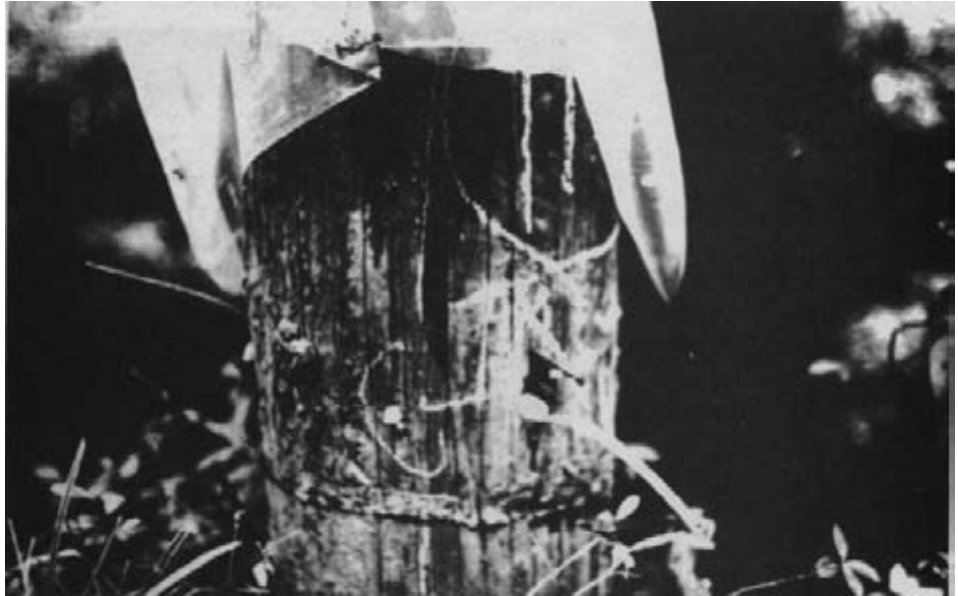
*Figure 15-7. - Fumigant vial in wood-plugged hole, with location tab visible.*

- b. Vials of Timber-Fume fumigant were inserted into holes drilled in the midsection of all piles (Figure 15-7). This chemical becomes a gas and diffuses into the pile. Timber-Fume is not effective when water is present. It is a highly toxic substance so extra care was used in preparing and placing the vials (Figure 15-8).

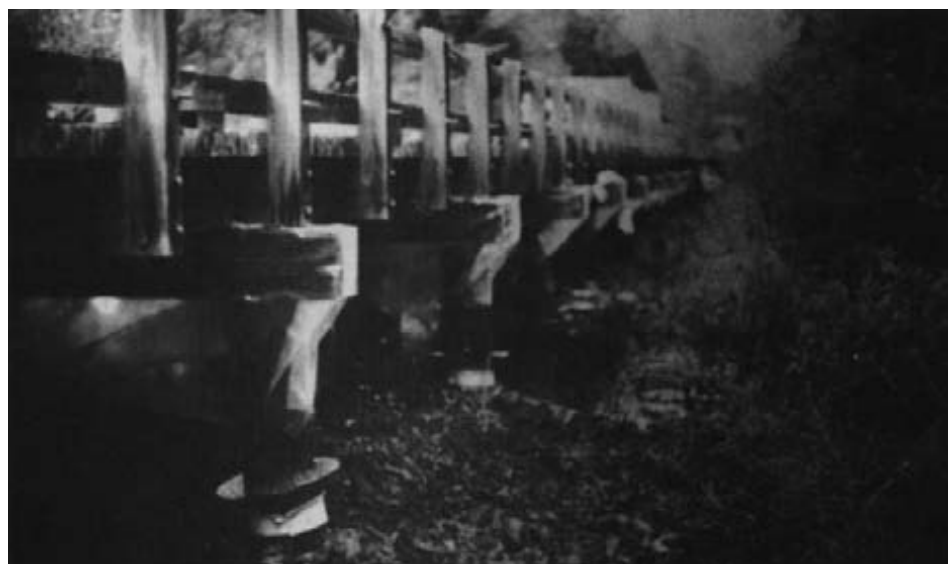
*Figure 15-11. - Bridge draping for spillage protection, in place and ready for preservative injection.*

**7. Treat caps.** Osmose 24-12 preservative was injected under pressure into all inspection holes in the pile caps. A treated wood plug was driven into each hole to seal the chemical in the wood after injection. Plastic draping was used to catch any chemical that seeped out of cracks during injection (Figures 15-10 and 15-11).

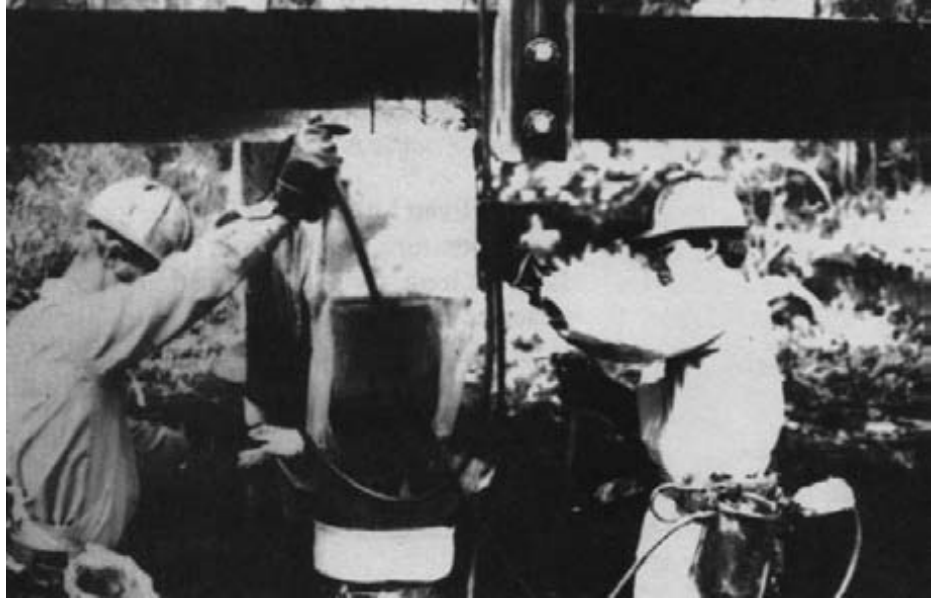
*Figure 15-12. - Two-person crew injects liquid wood preservative solution into piles and caps. Note the safety backflow valve on the worker's belt.*

In the injection process, a relief valve and catch bucket were used to suppress back-pressure spills. The two-person crew worked well in preventing spills (Figure 15-12).

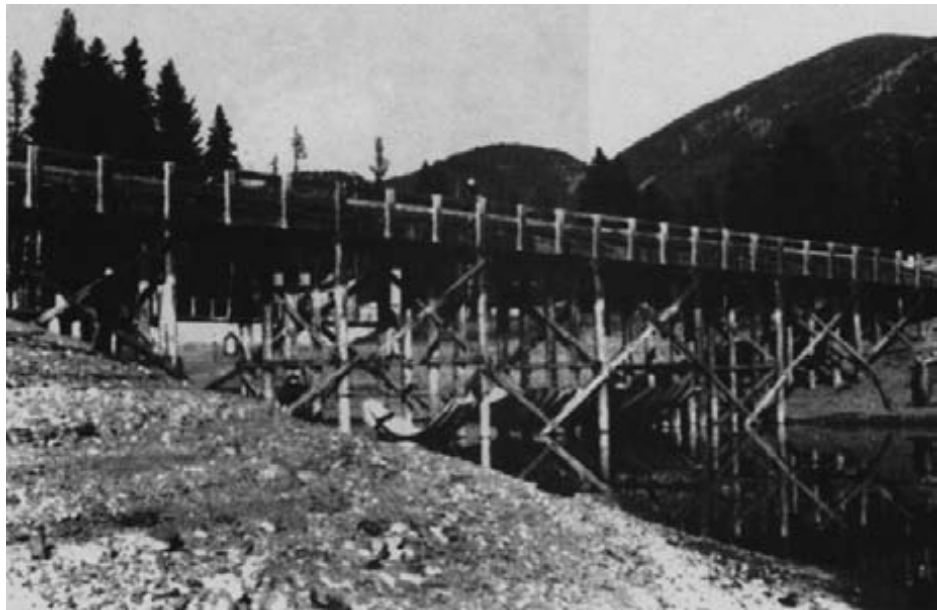
*Figure 15-13. - View of the Sullivan Lake Outlet Bridge as in-place treatment was commencing. Note the canvas slings placed under the bridge to prevent water contamination should accidental spillage of treatment chemicals occur.*

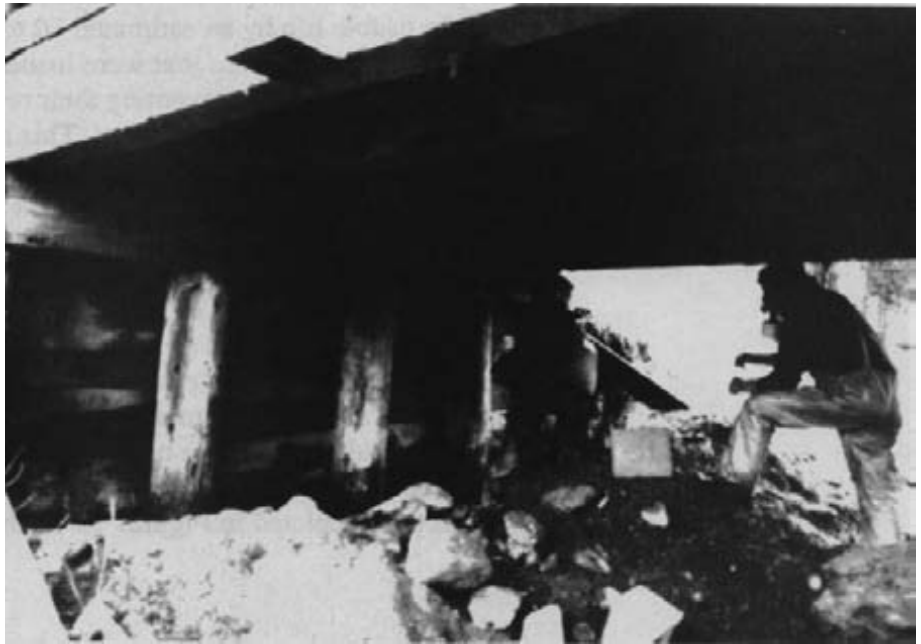
*Figure 15-14. - Liquid fumigants being applied to the timber abutment.*

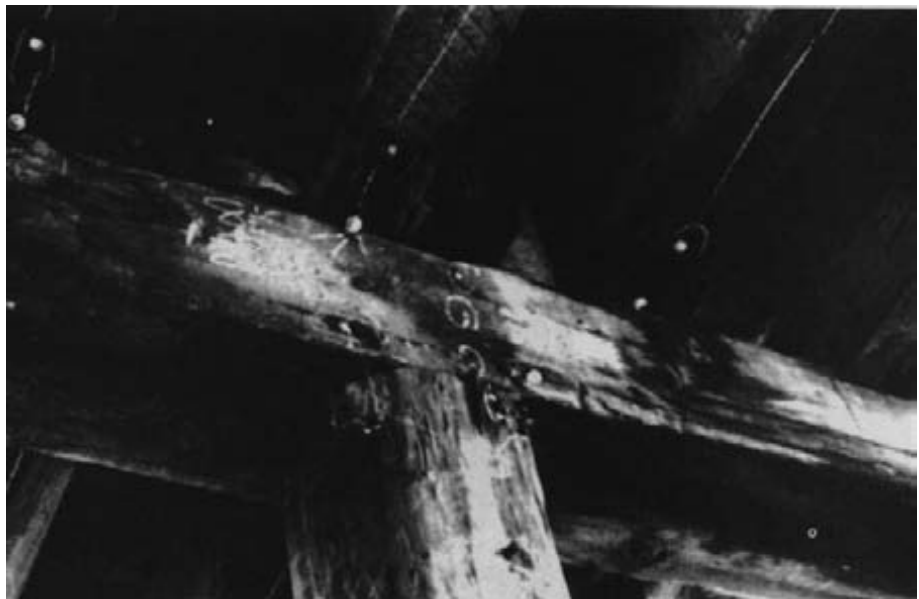
*Figure 15-15 - Underside view of an intermediate bent cap after treatment was completed. Holes drilled for treatment application have been plugged with treated-wood dowels.*

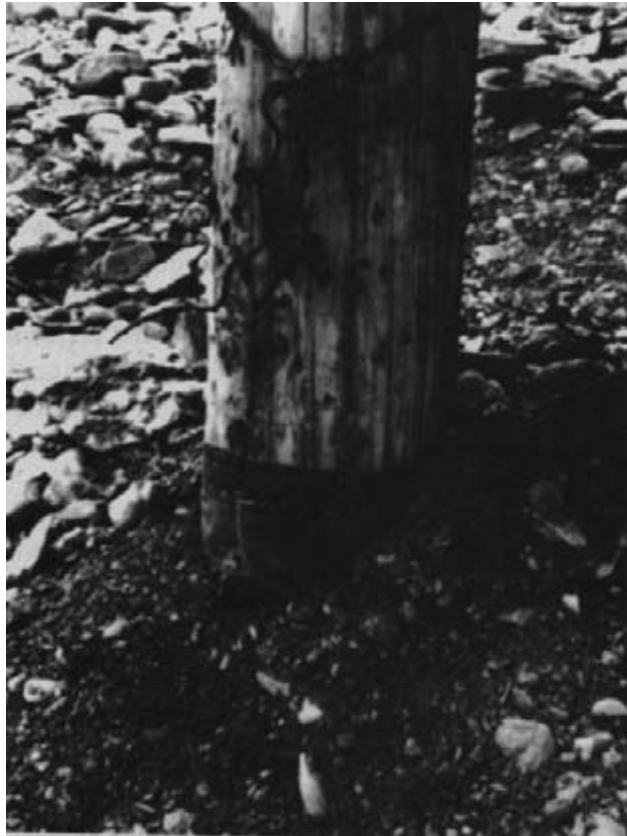
*Figure 15-16. - Timber pile after treatment of the soil contact area. The treated portion of the pile was wrapped in waterproof paper to prevent potential soil contamination.*

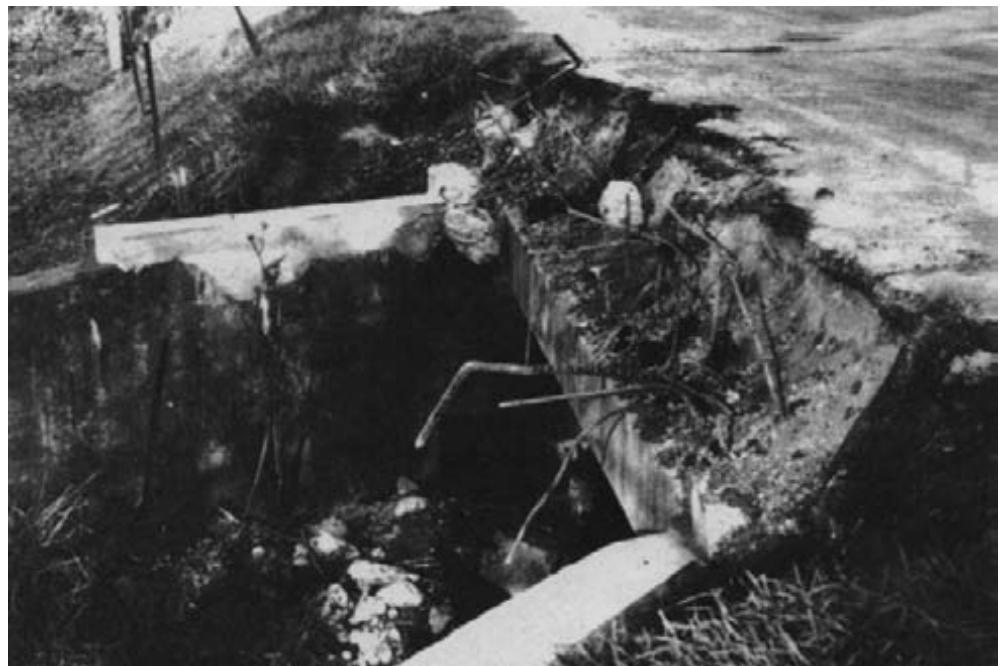
*Figure 15-19. - The first step in the rehabilitation was removal of the concrete curb and railing. Next, a concrete seat was poured on the wing walls to support the additional deck width. This bridge also had 2 feet of overburden removed as part of the contract.*

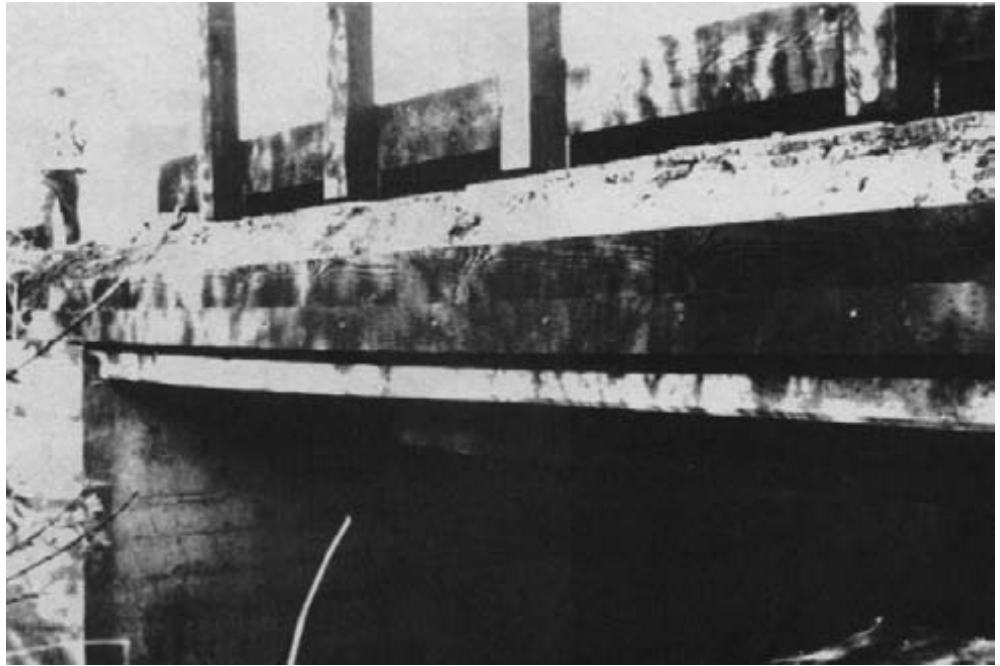
*Figure 15-20. - A 4-inch-thick by 14-inch-wide creosote-treated Douglas-fir plank was attached to the edge of the existing concrete deck with galvanized machine bolts and cinch type anchors. The ends of this plank rest on the concrete placed on the wing walls. A 4-inch-thick by 7-inch-wide splice plank was spiked to the bottom half of the plank to form a ship-lap-type joint with the timber deck panel.*

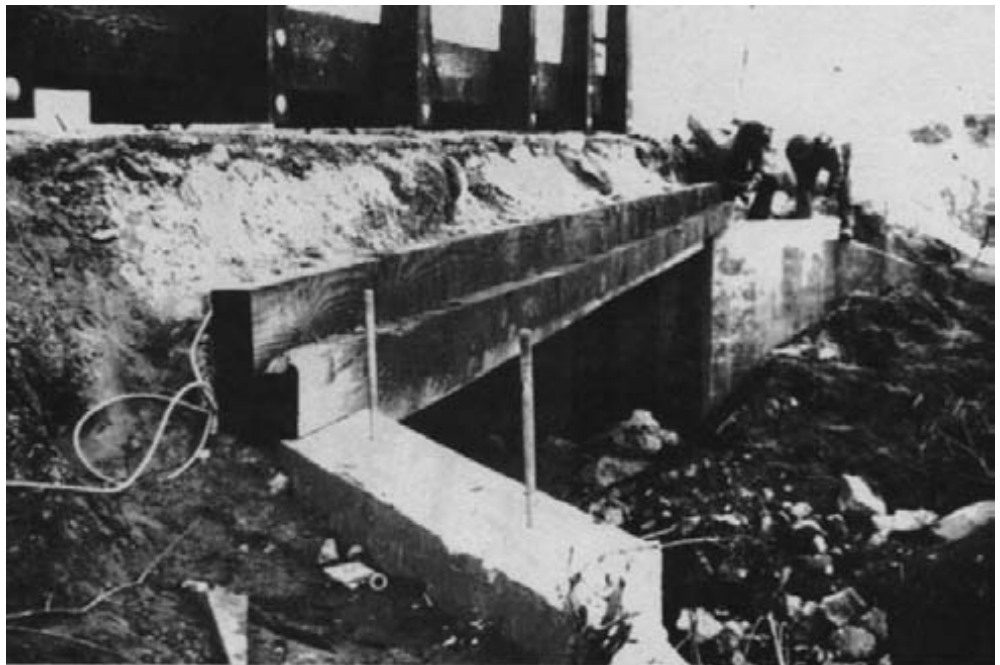
*Figure 15-21. - Anchor bolts are placed in the concrete wingwalls that match predrilled holes in the timber deck panels.*

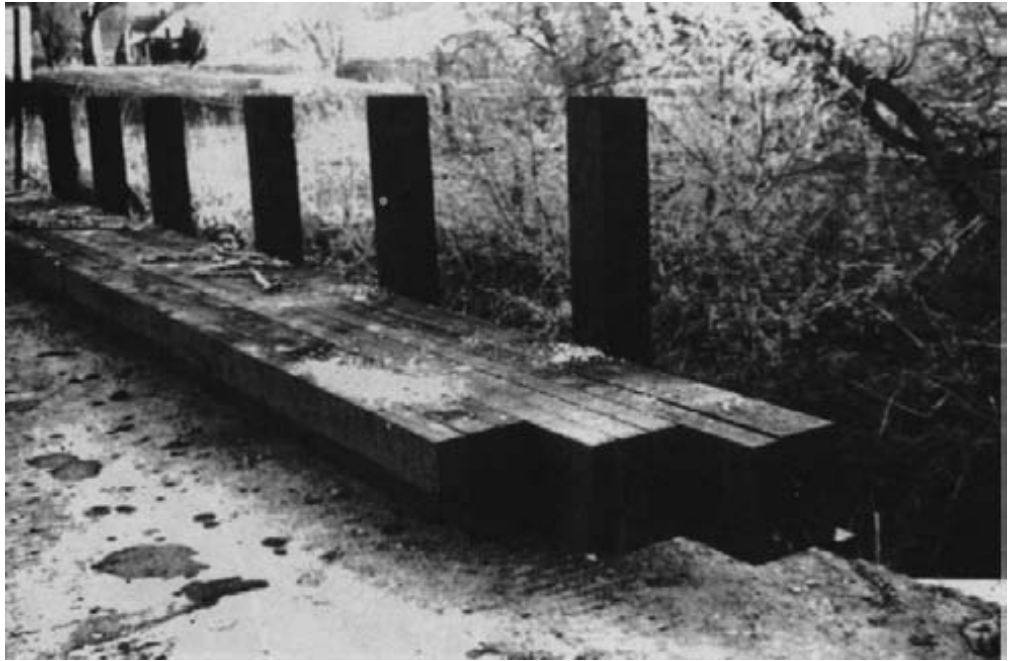
*Figure 15-22. - Rail posts are attached to the deck panels before the panels are placed on the abutments.*

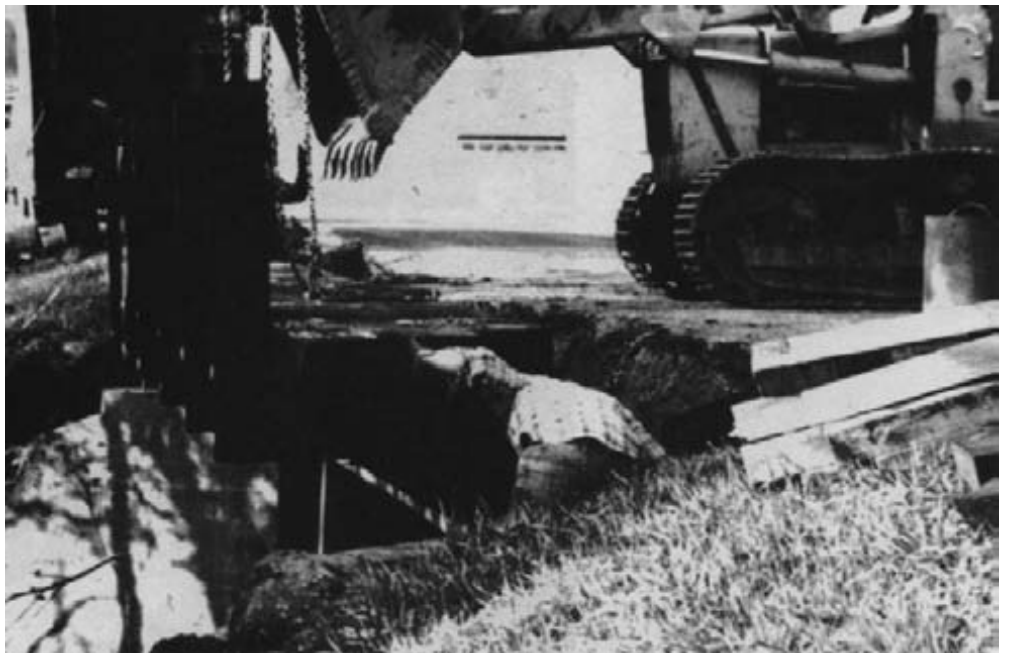
*Figure 15-23. - A prefabricated deck panel is lifted onto the abutments. Each panel was prefabricated to fit each bridge.*

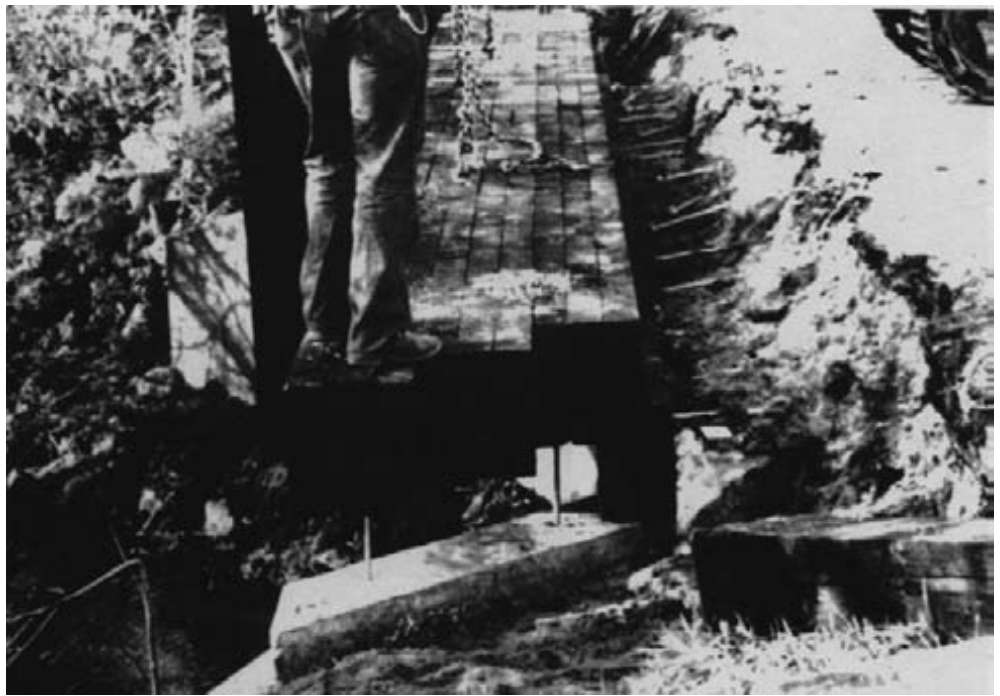
*Figure 15-24. - A panel is lowered over the anchor bolts.*

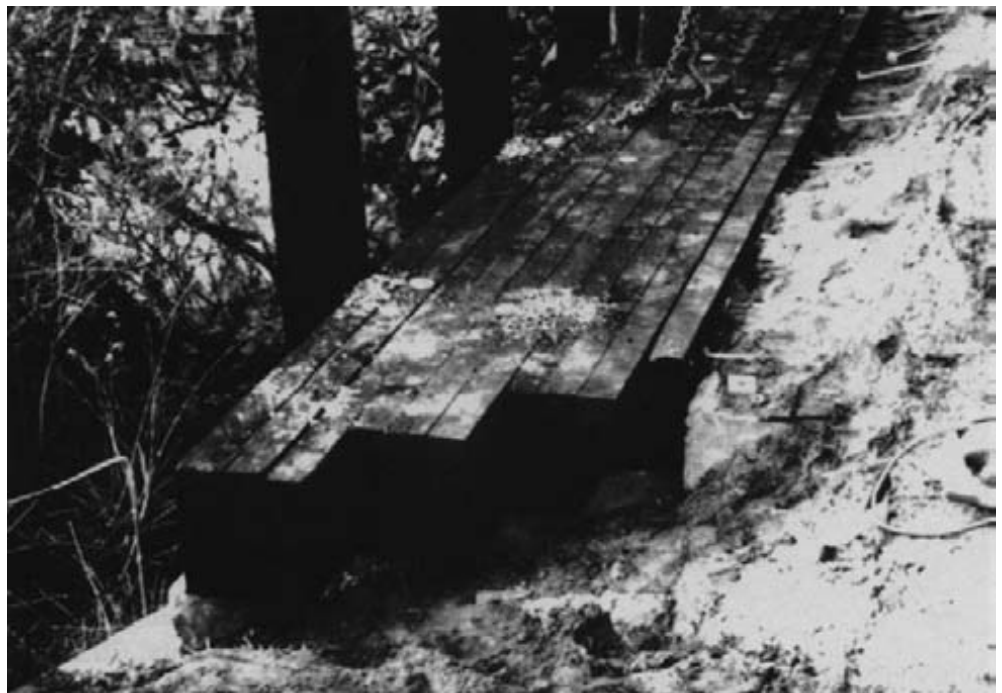
*Figure 15-25. - A panel in final position. The ship-lap joint between the deck panel and first plank are interconnected with 5/8-inch-diameter by 13-inch-long drive spikes placed vertically through the joint.*

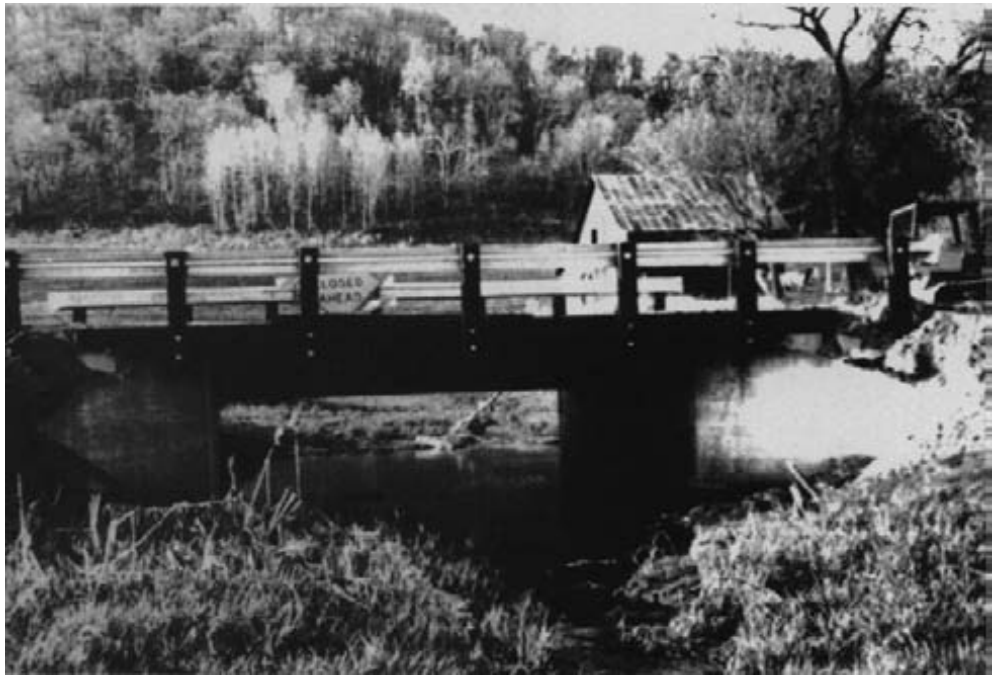
*Figure 15-26. - The completed project with widened roadway, ready for paving.*

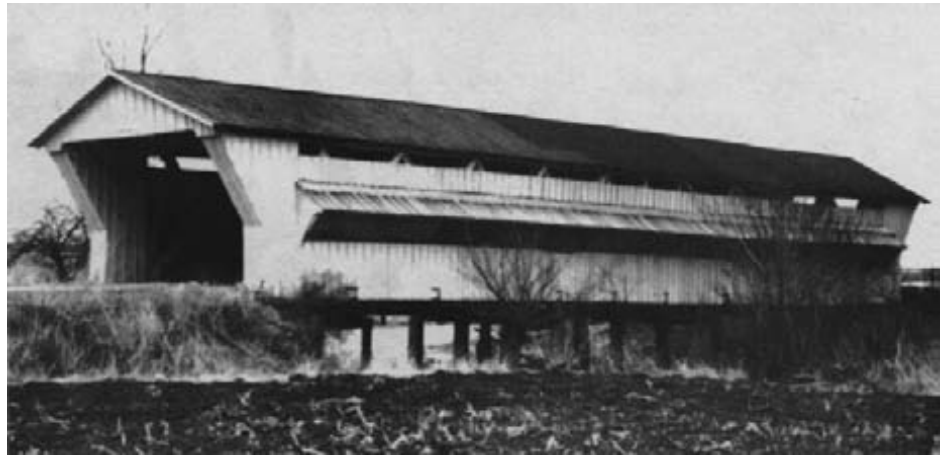
*Figure 15-28. - Another view of the bridge before rehabilitation. One objective of the project was to maintain the bridge's appearance.*

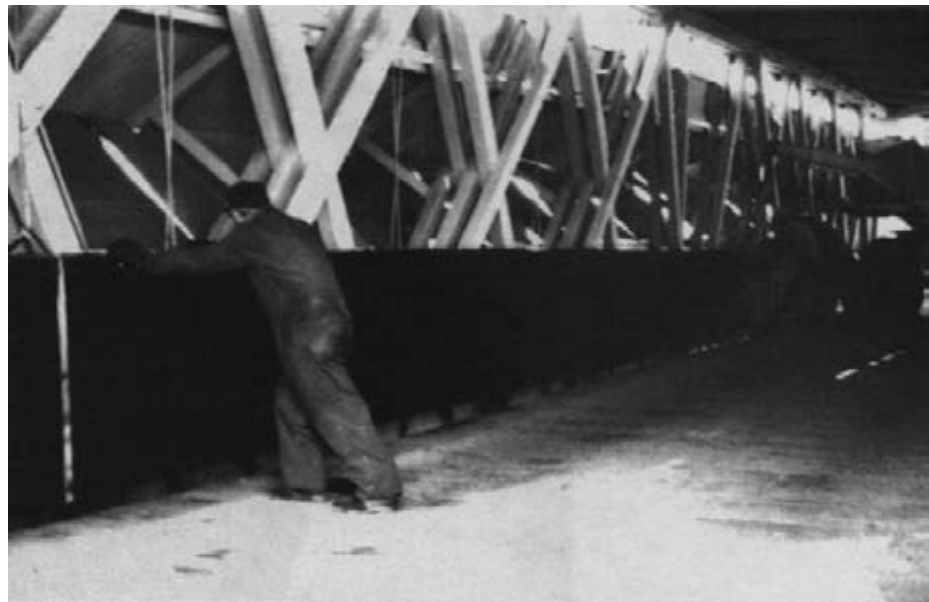
*Figure 15-29. - Support for the roadway was obtained by installing two pressure-treated glulam girders inside the existing bridge, one along each side of the roadway.*

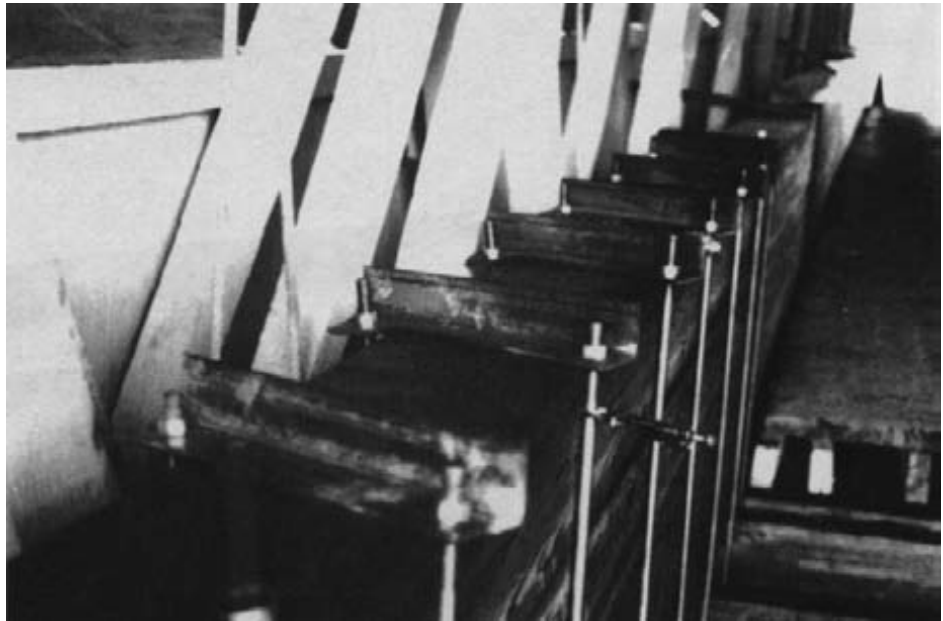
*Figure 15-30. - Transverse glulam floorbeams were suspended from the tops of the girders by steel-rod hangers.*

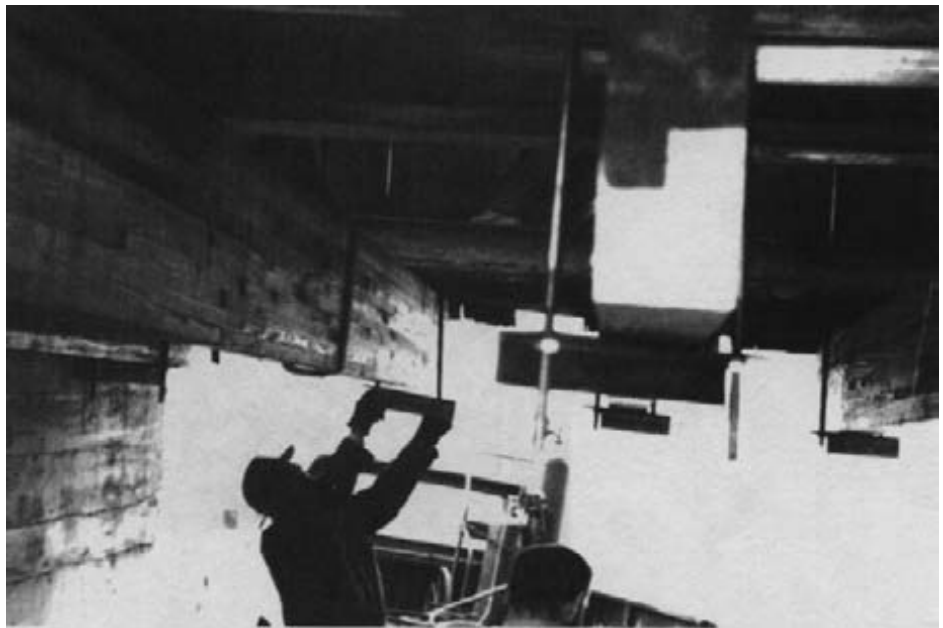
*Figure 15-31. - Floorbeams are installed on the hangers from the bridge underside.*

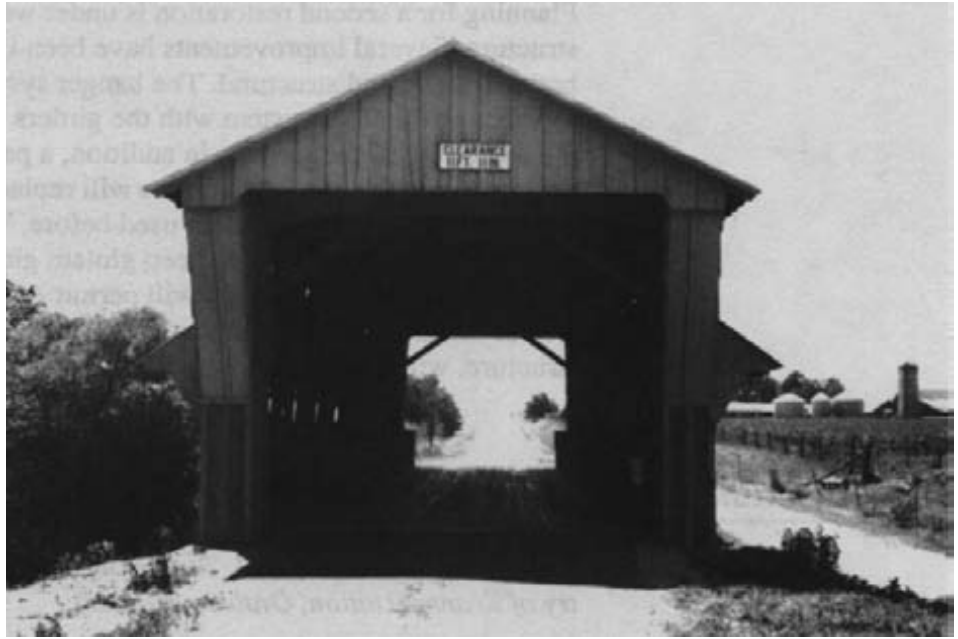
*Figure 15-36. - The final result of the bridge-within-a-bridge concept. Four kneebraces to the roof system, which had been removed over the years, were reinstalled for stability and appearance. Note the improved truss alignment.*

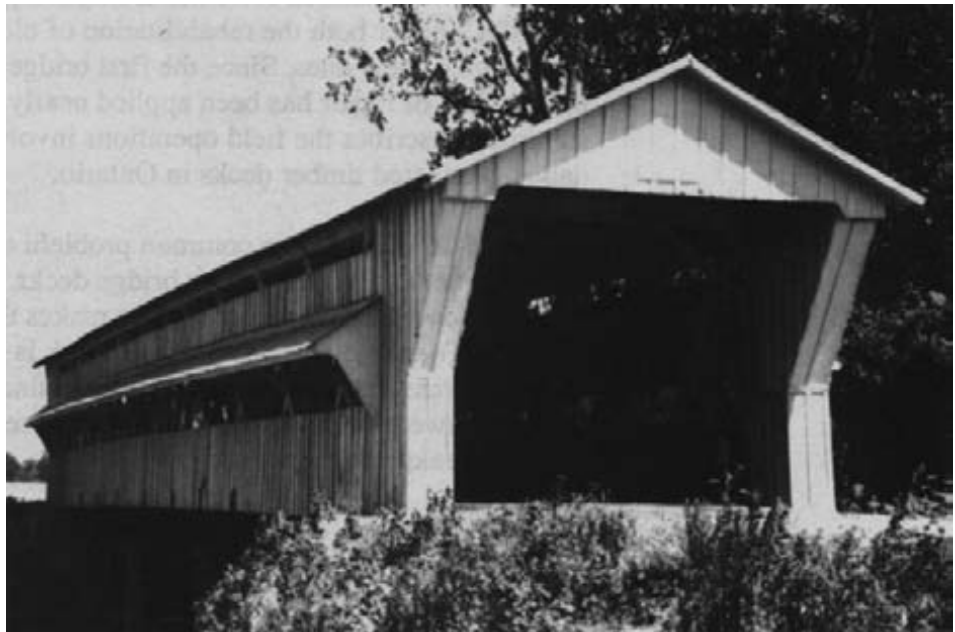
*Figure 15-37. - The completed rehabilitation results in a significantly increased load capacity (18 tons), while maintaining the historic bridge's aesthetic appeal.*

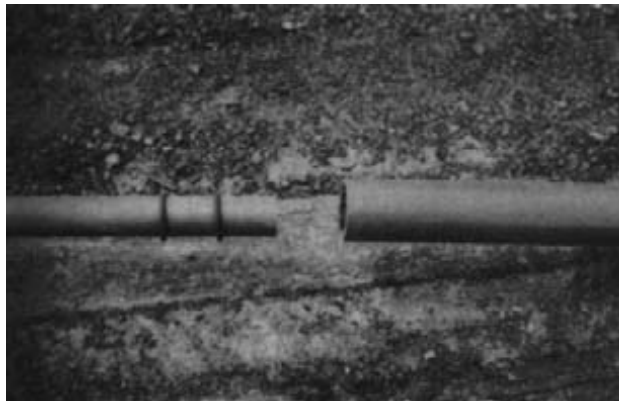
The joint between the PVC pipe and the steel sleeve that extends from the steel anchorage plate (Figure 15-40) is sealed with neoprene O-rings. The same O-ring joint is used at the collapsible connection shown in Figure 15-39. Figure 15-41 displays these O-rings, before assembly, as applied at the Pickerel River Bridge.

*Figure 15-41. - PVC sleeve connection with neoprene O-rings.*

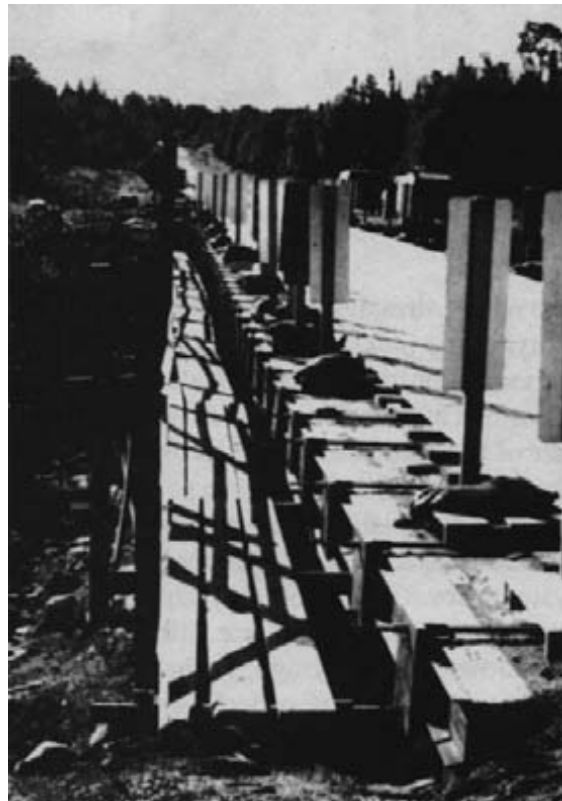
operation has been the installation of a temporary plank surface (Figure 15-43). The two-way plank system includes a bottom layer parallel to the bars spaced so that the bars can be installed beneath the running planks. Maintenance of the plank surface has not been a problem.

*Figure 15-43. - Temporary plank surface placed over prestressing bars during construction at the Pickerel River Bridge.*

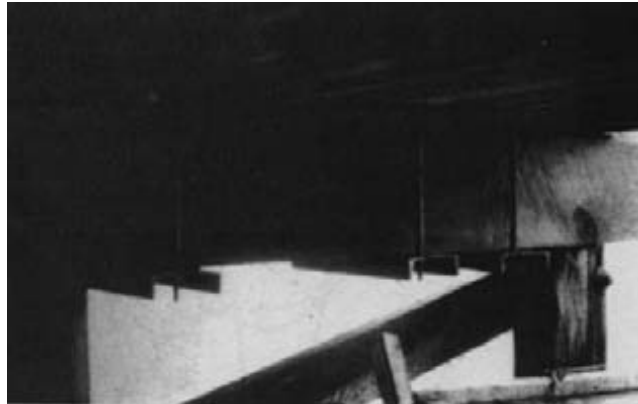
Stressing an existing deck has not resulted in any visible distress at the bearing support of the laminations. The original toenailing of the laminations may have deteriorated or may simply provide little resistance to the transverse movement of the laminates. In any case, no repairs have been necessary other than tying down the final deck to the supports. Simple

*Figure 15-45. - Tie-down of the deck to supports at the Kabaigon River Bridge.*

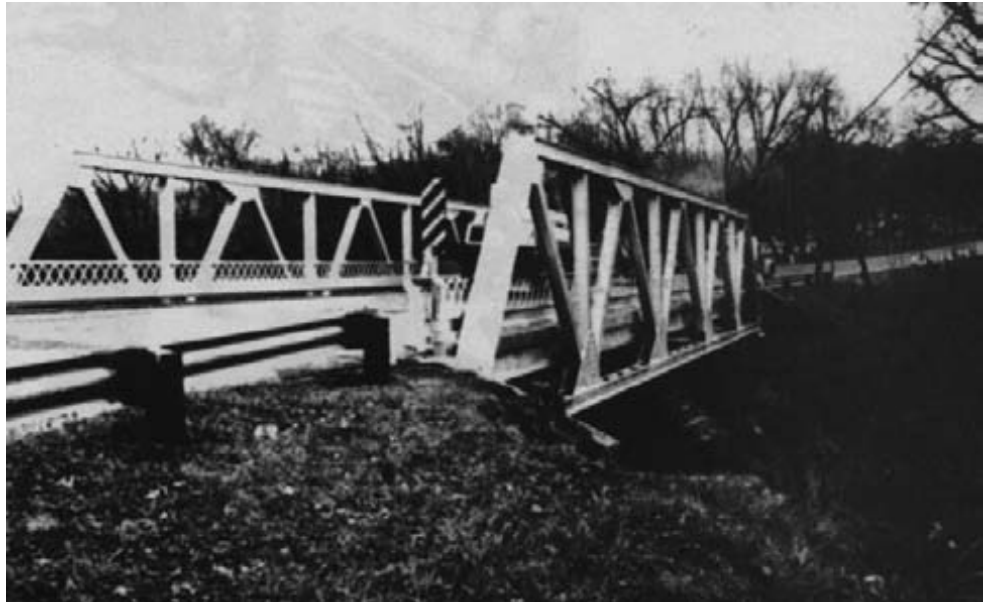
Figure 15-47. - The existing bridge was a steel truss, 96 feet long, with a 26-foot roadway width. The noncomposite concrete deck was supported by steel stringers (WF16 x 50) spaced 4 feet 6 inches on center. The stringers were supported by steel floor beams (WF30 x 116).

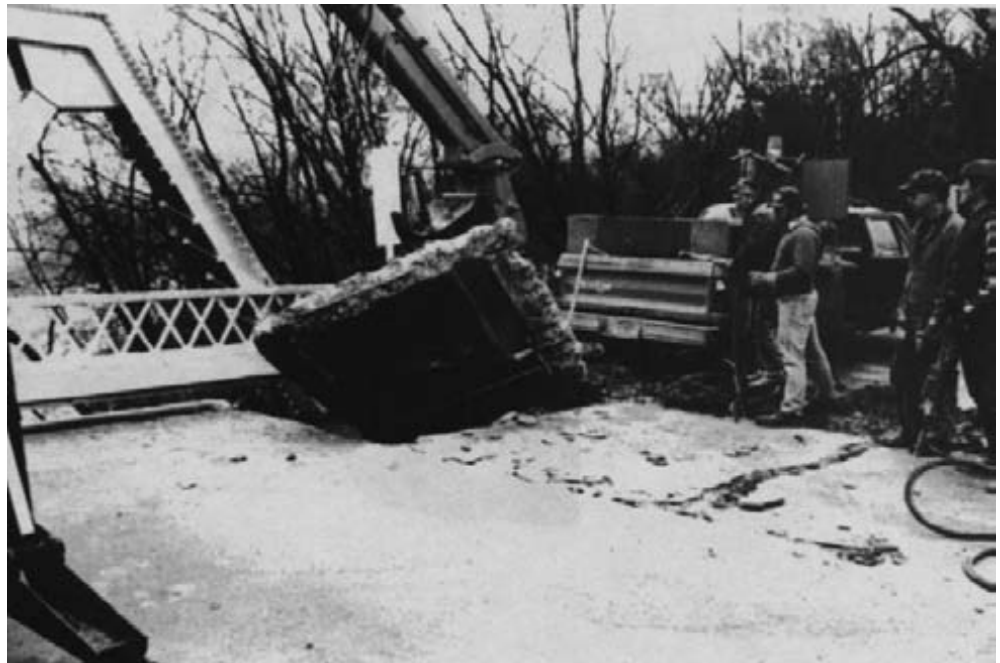
Figure 15-48. - The concrete deck was removed in approximately 5-foot-square sections by the Sauk County Highway maintenance crew. The concrete was broken using jackhammers, and reinforcing bars were flame cut. The sections were lifted and loaded on the trucks with a hydraulic excavator.

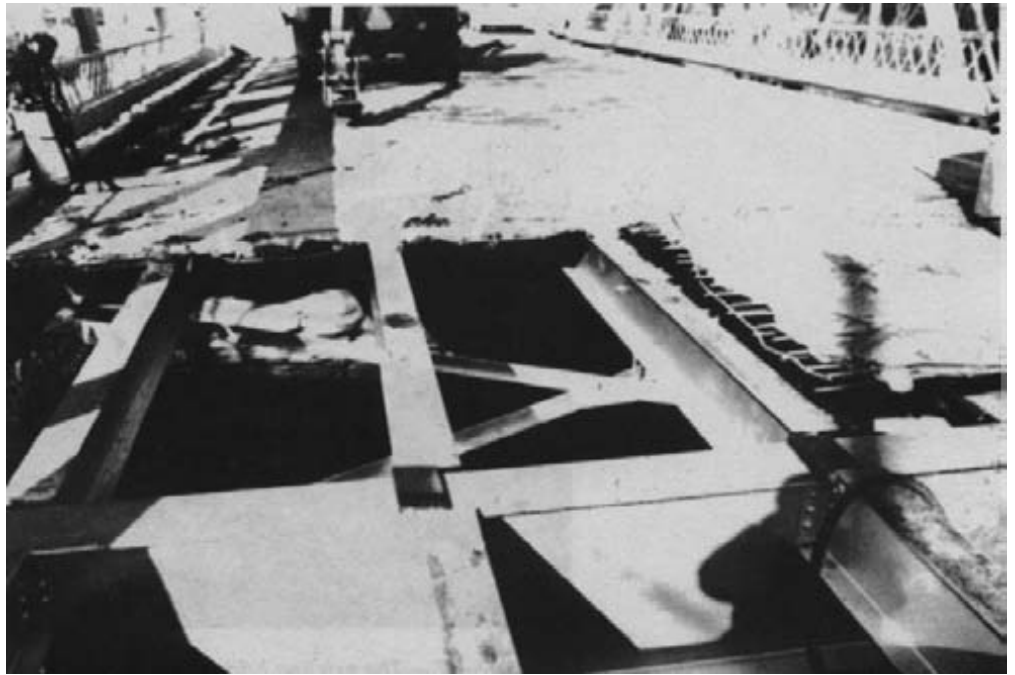
*Figure 15-49. - Exposed steel floorbeams and stringers as deck removal proceeds.*

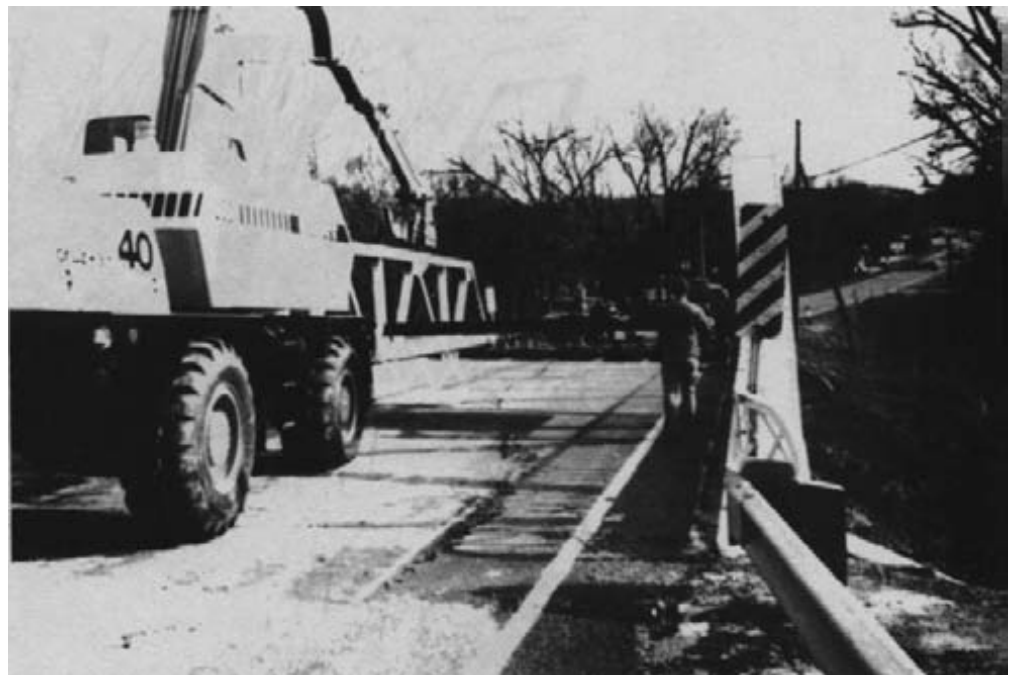
*Figure 15-50. - New, prefabricated treated-timber deck panels were placed with a hydraulic excavator. The panels were designed to fit transversely on the stringers and were placed without removing the existing railing.*

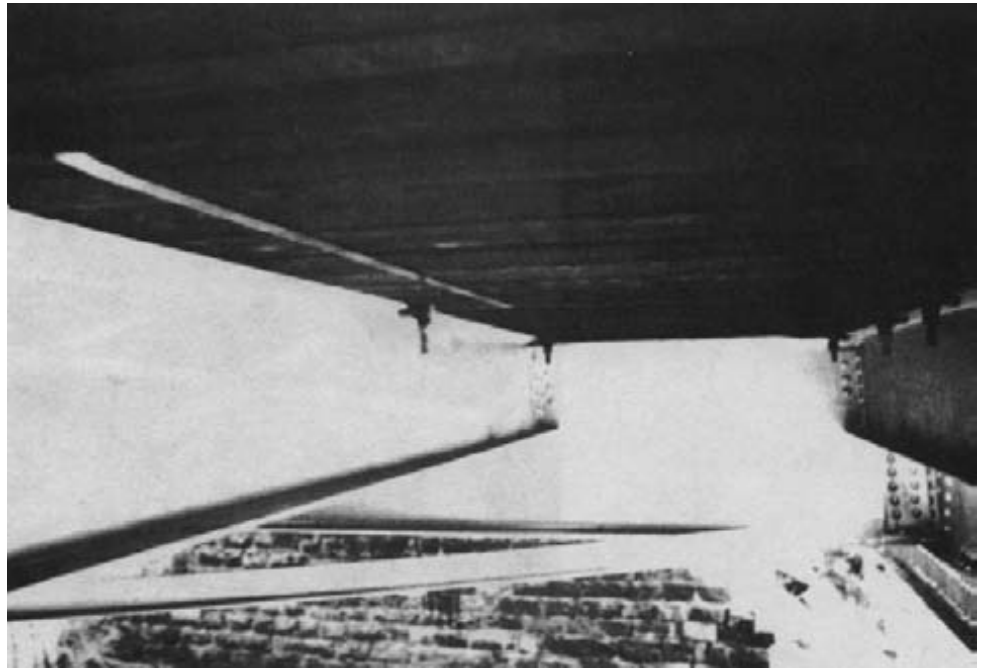
*Figure 15-53. - Panels were attached to the stringers with 3/4-inch-diameter by 9-inch-long machine bolts, using a 3/4-inch offset shoe and spring. The offset shoe grips the flange of the stringer, and the compression spring compensates for changes in deck thickness from moisture changes in the timber.*

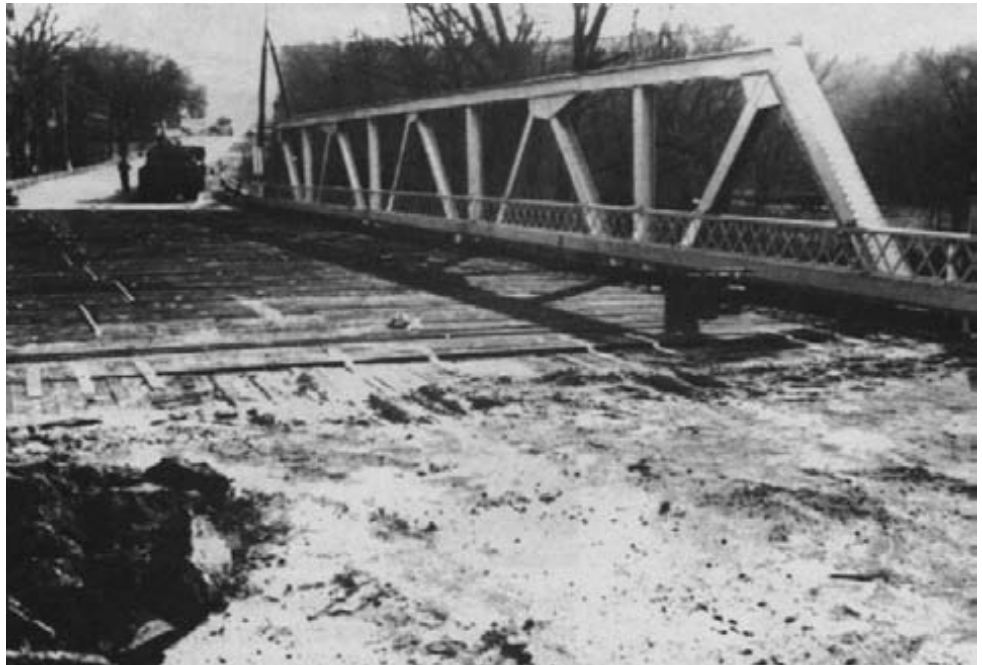
*Figure 15-54. - The completed treated-timber deck, before placement of an asphalt-pavement wearing surface.*

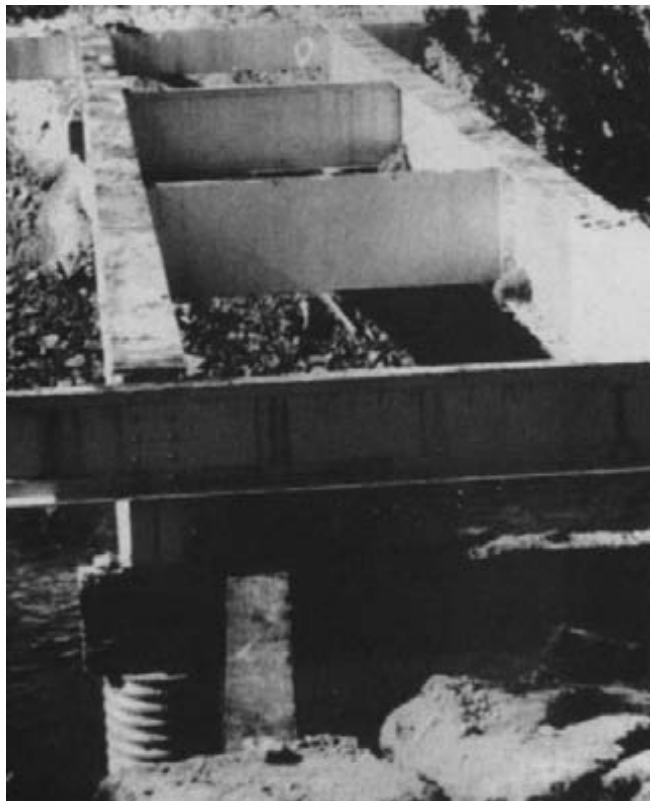
*Figure 15-59. - A view of the bridge as rehabilitation began, with the deck, curbs, and timber abutments removed.*

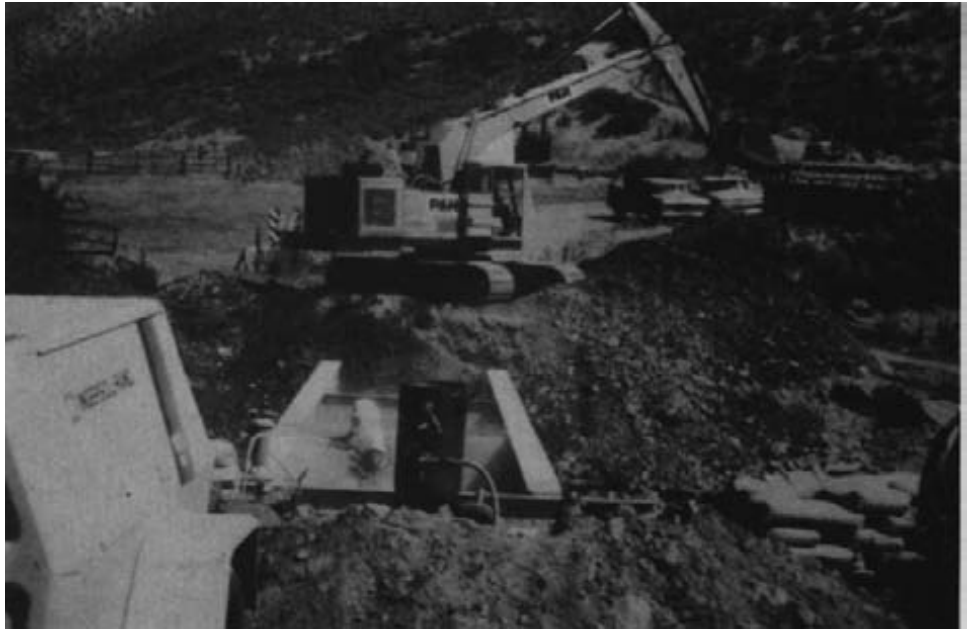
*Figure 15-60. - Blast cleaning of the existing steel work in preparation for painting, while a backhoe removes material that was placed for the temporary repair.*

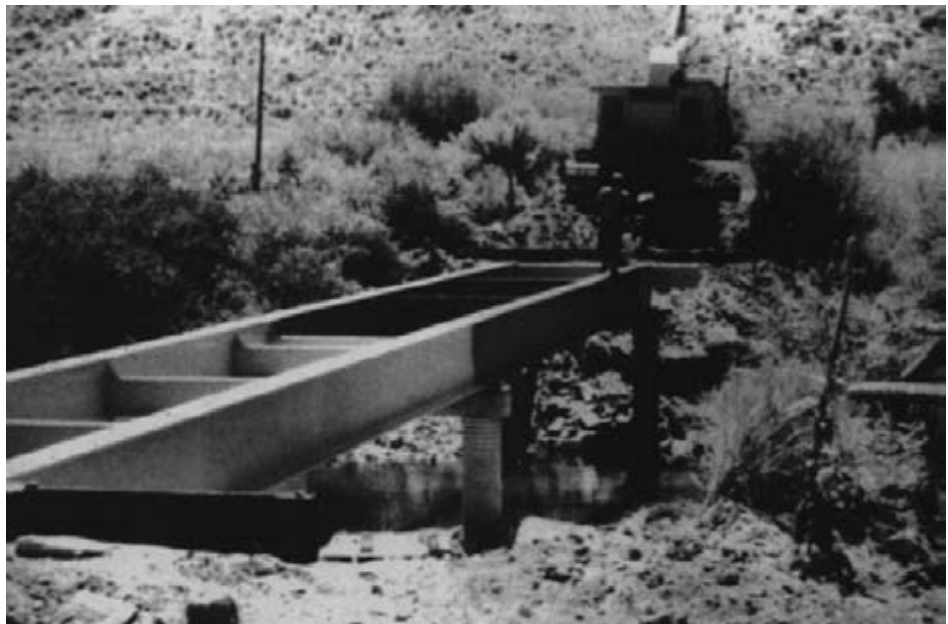
*Figure 15-61. - Steel beam extensions in place and pinned to the existing beams.*

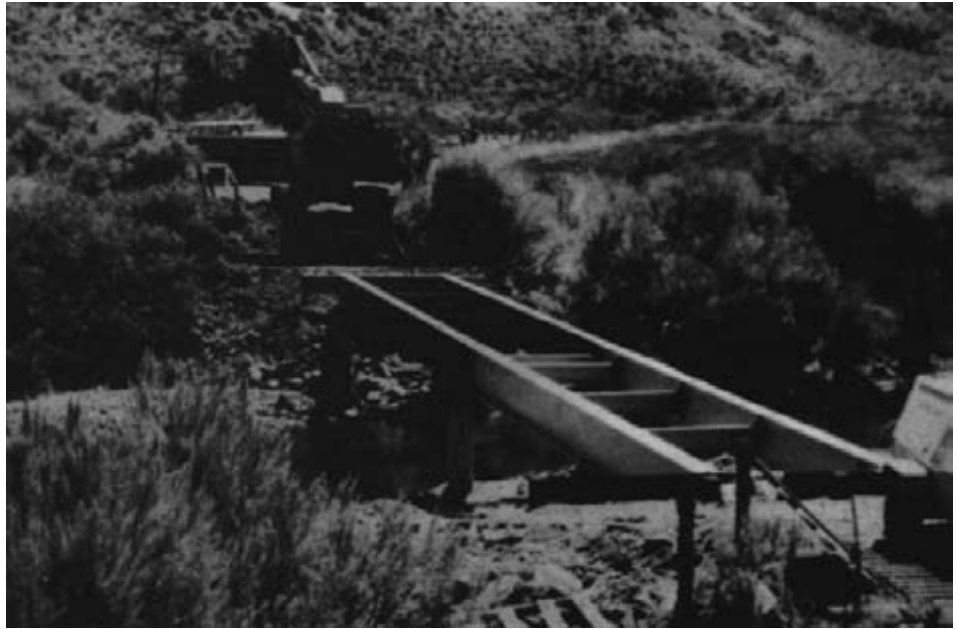
*Figure 15-62. - A portion of the final paint coat has been applied to the steel and the new treated-timber abutments are in-place. The backhoe is positioned to lift the longitudinal glulam panels for the far side approach span.*
