## **BRIDGE MAINTENANCE, REHABILITATION, AND REPLACEMENT: CASE HISTORIES**

## CASE HISTORY 15.1- IN-PLACE PRESERVATIVE TREATMENT OF DETERIORATING TIMBER BRIDGES

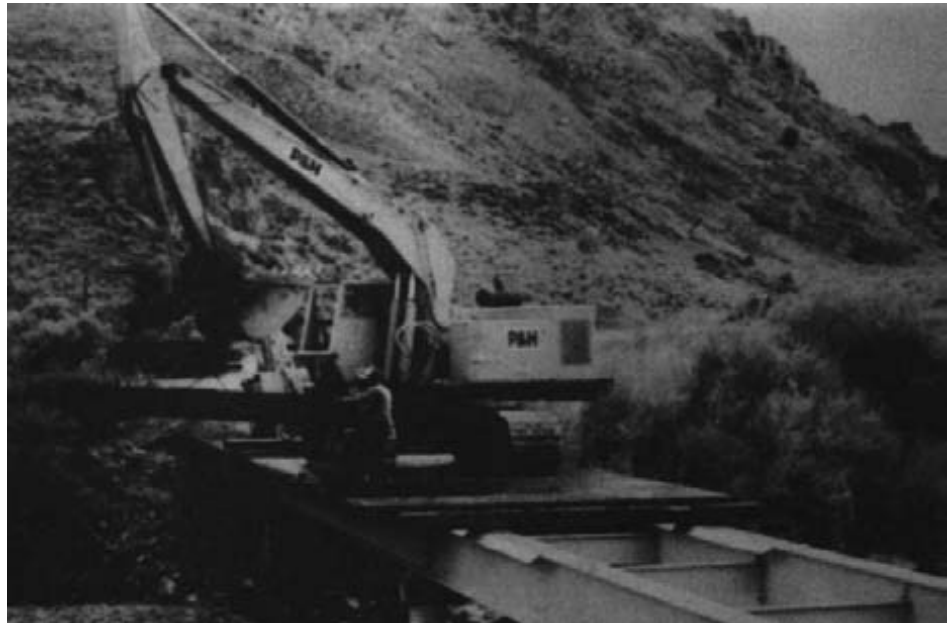
*Figure 15-63. - Transverse glulam deck panels are lifted into place.*

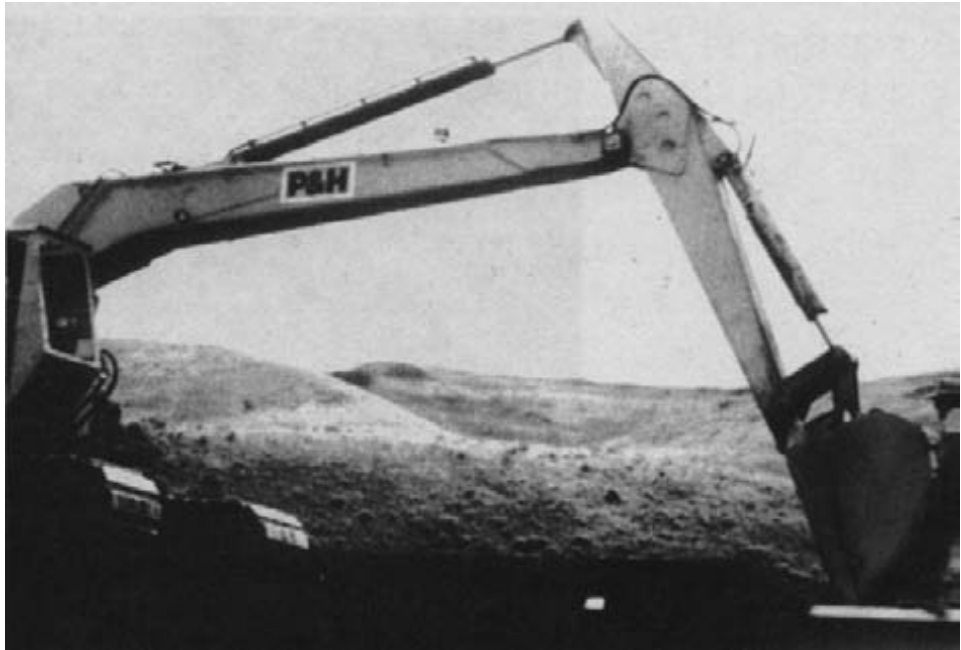
*Figure 15-64. - Backhoe pushes panels together after dowels have been aligned. A large timber block was placed across the panel edge to prevent damage from the backhoe bucket.*

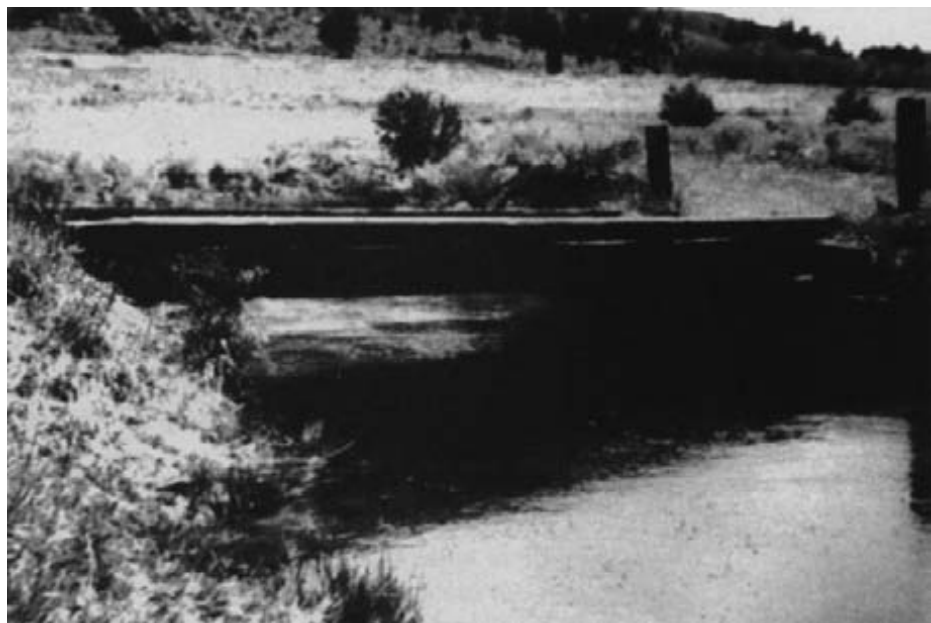
*Figure 15-66. - The longitudinal nail-laminated lumber-deck bridge before replacement. The bridge was 26 feet long with a 27-degree skew.*

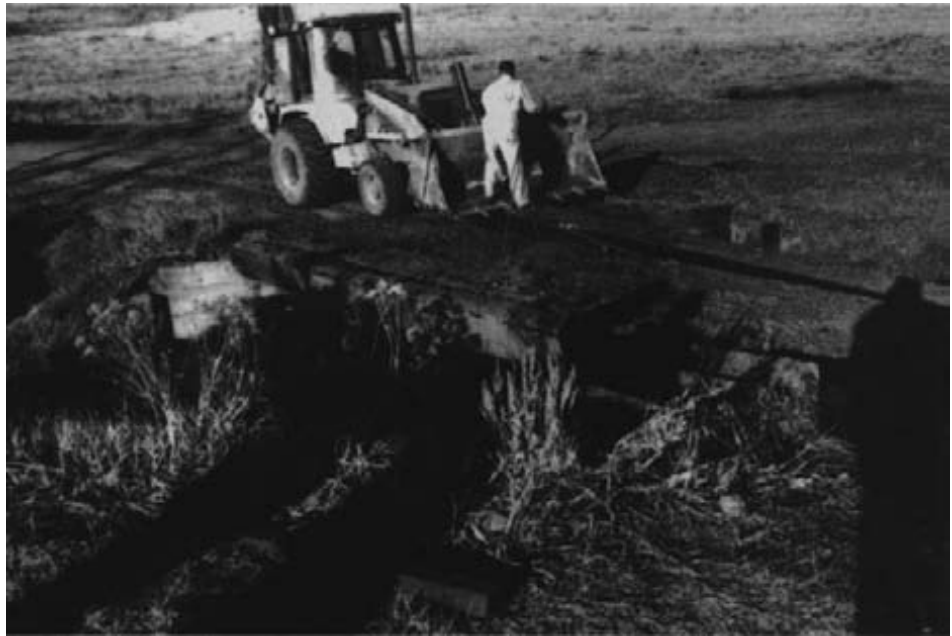
*Figure 15-67. - The existing deck was carefully removed in sections to avoid damage to the treated-timber abutment caps.*

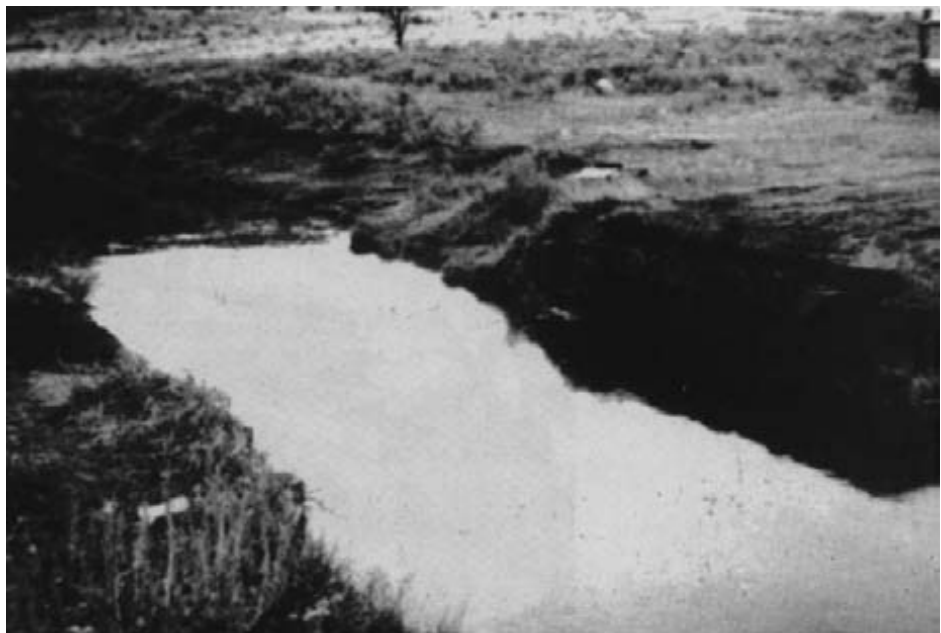
*Figure 15-68. - A view of the abutments after the bridge was removed.*

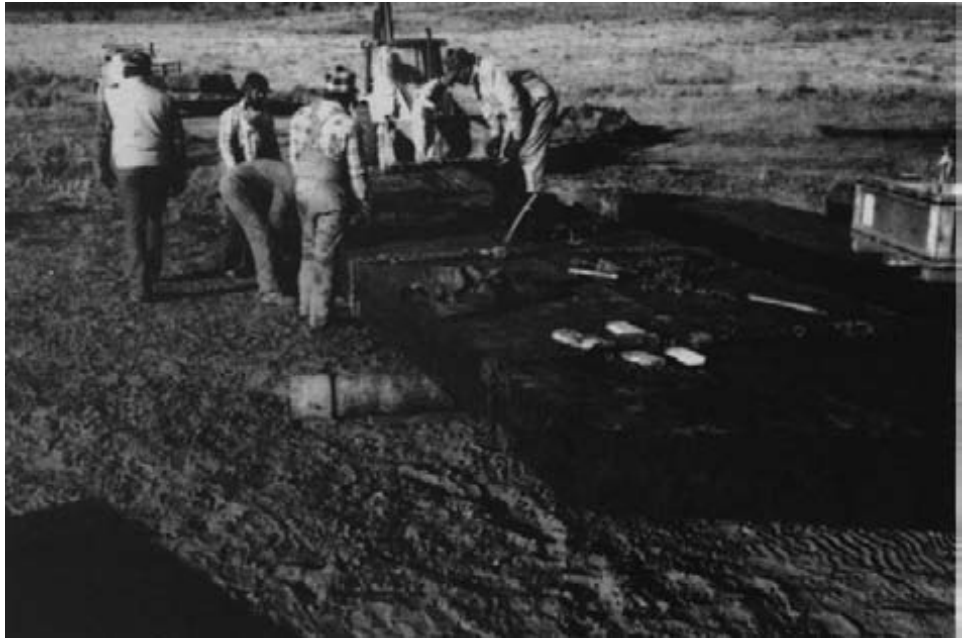
*Figure 15-69. - The first two panels of the new bridge are interconnected with steel dowels and pulled together with a come-a-long. Because the crossing was skewed, the doweled panels could not be assembled on the abutments. Assembly was completed adjacent to the site on two well casings to facilitate assembly and lifting.*

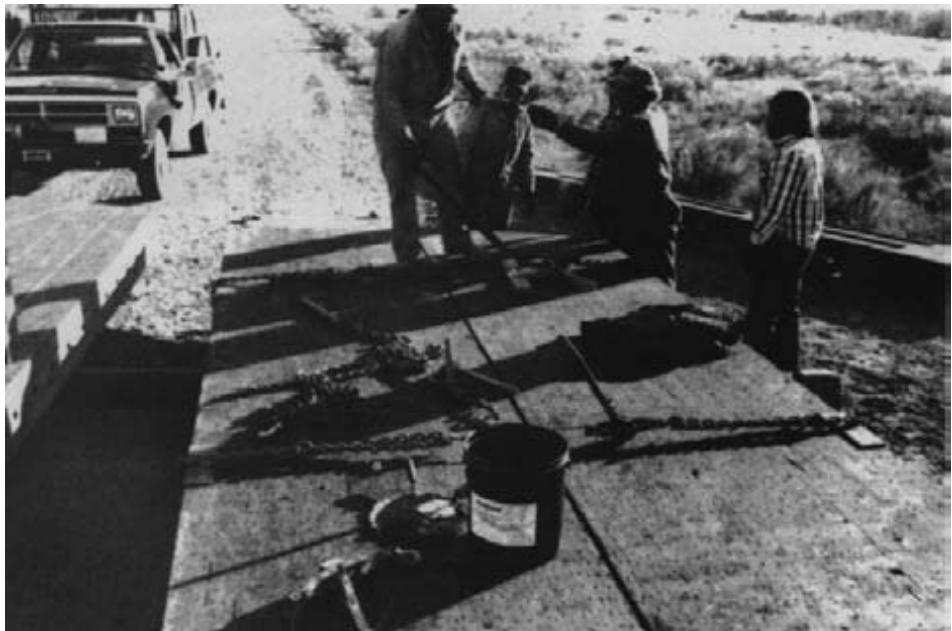
*Figure 15-70. - Another view of the first two panels being pulled together. Note the corner protectors under the come-a-long chains and the can of roofing cement on the deck. All panel joints were sealed with the roofing cement before being pulled together.*

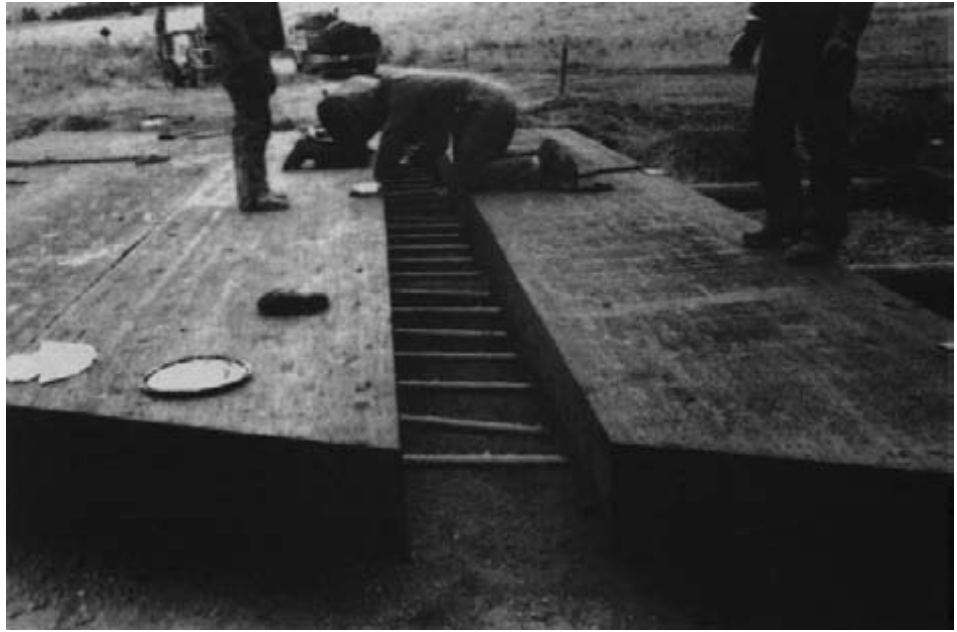
Figure 15-71. - Steel dowels are aligned before joining the fourth panel. The dowels are 1-1/2 inches in diameter, 19-1/2 inches long, and are spaced 12 inches on center.

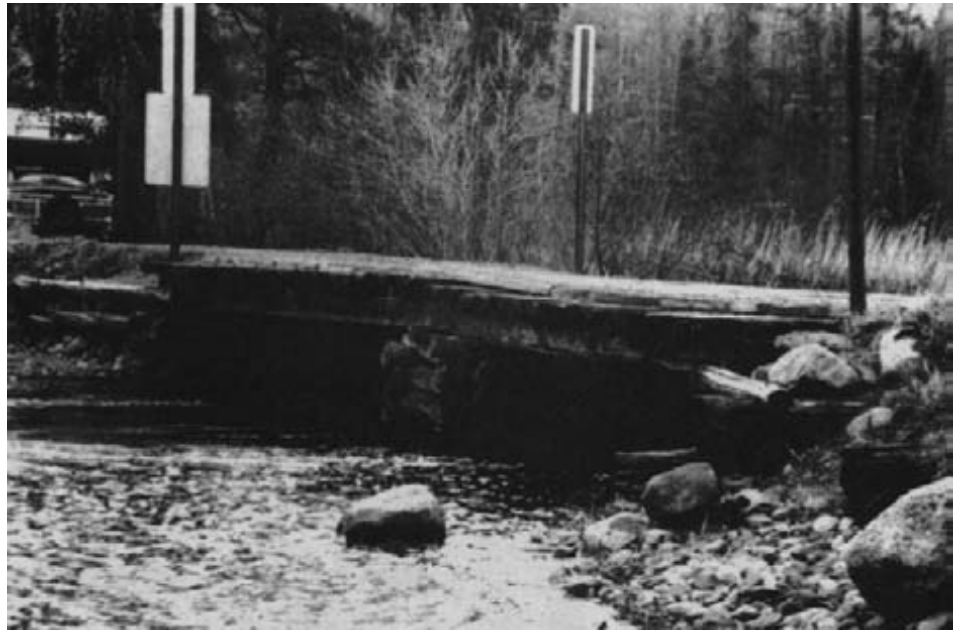
*Figure 15-76. - The existing single-lane bridge was a simply supported, two-span, untreated-timber beam bridge supported by log cribbing (photo courtesy of Wheeler Consolidated, Inc.).*

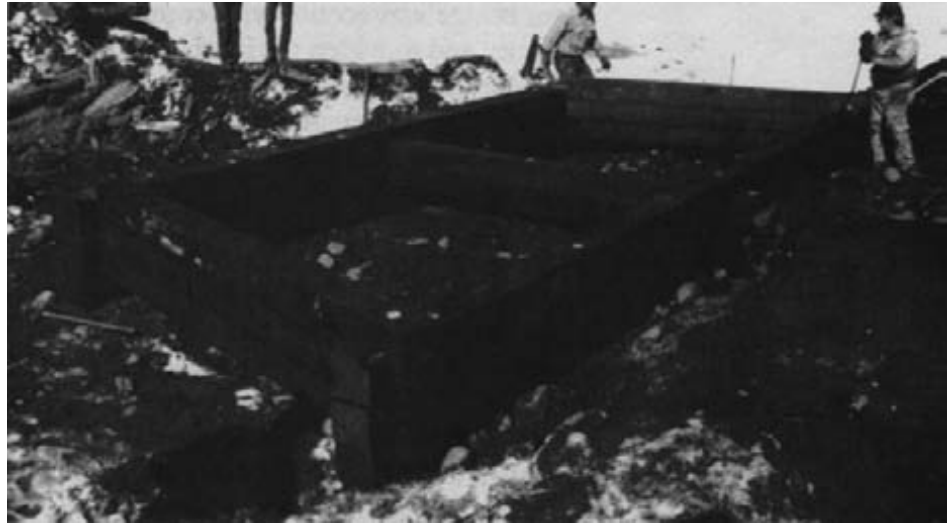
*Figure 15-78.-The new crib abutment under construction using precut and creosote-treated Douglas-fir timbers. The only field fabrication involved drilling holes in the timbers for drive spikes used for connections. Such penetration of the protective envelope should have been avoided by drilling before pressure treatment (photo courtesy of Wheeler Consolidated, Inc.).*

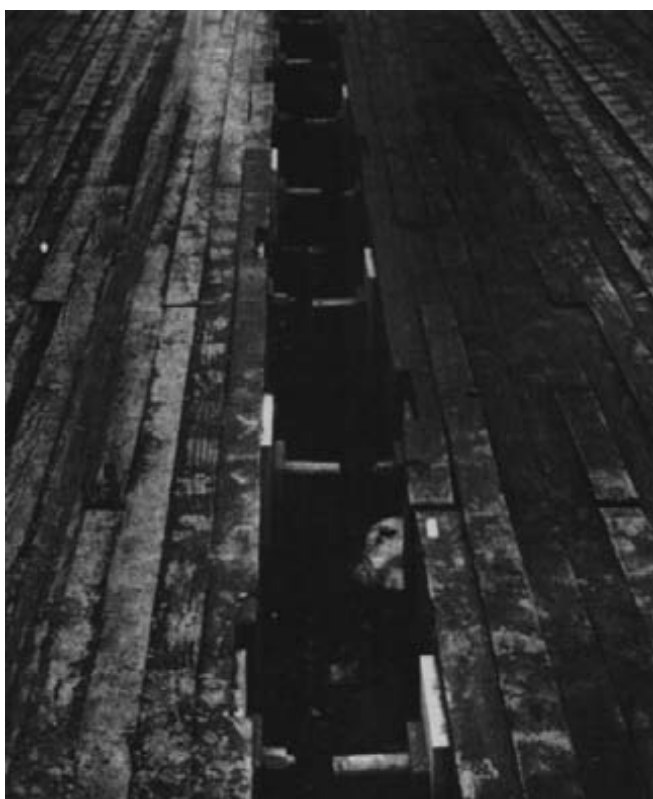
*Figure 15-80. - Prestressing rods protruding from the two prefabricated deck panels before connection. The rod opposite each coupler was released and threaded into the coupler. After all couplings were made, the released rods were restressed, causing the deck panels to be stress-laminated together as an integral bridge deck.*
