Development and Integration of Advanced Timber Bridge Inspection Techniques for NBIS

January 2015

Research Project
Final Report 2015-01

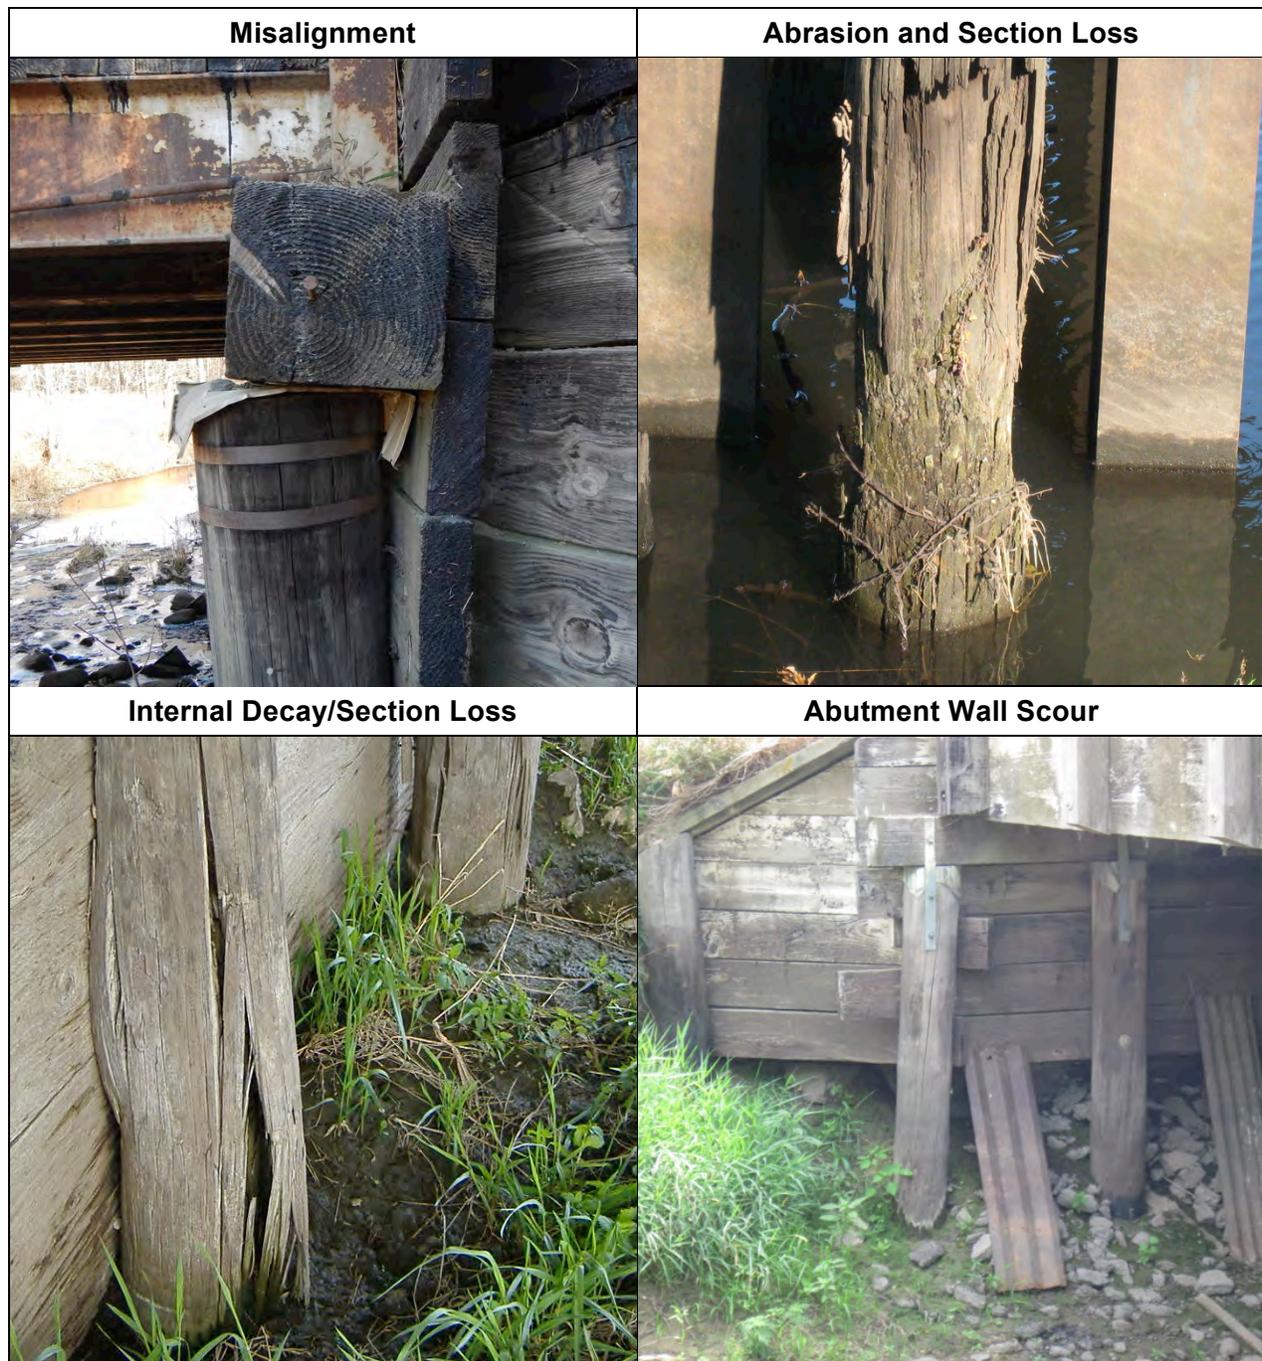
Figure 7.6. Examples of deterioration of timber substructure elements.

The use of inspection equipment can provide additional information to the definitions provided by AASHTO and MnDOT. Special attention should be focused on the steel connections, and looking for evidence of decay in timber adjacent to the connections. A pick hammer can be used to assess surface quality and possible decay. Feeler gages and awls may be used to assess the extent of cracks, checks, splits and delamination. A moisture meter can establish high levels of moisture. It is important to assess the presence of decay using hammer picks, stress wave timers and resistance microdrills to determine the actual cross-section and location of both sound and deteriorated material. Chapter 5 provided detailed information about the use of stress wave timers for identifying areas of decay. **Table 5.1** should be consulted when assessing the collected data. Chapter 6 provides detailed information about interpreting resistance drill data from a variety of different resistance drill models. **Table 6.1** should be consulted when assessing the collected data. **Figure 7.6 and 7.7** shows examples of damage to timber substructure elements.

Elements rated CS 3 have the potential to reduce the load rating of the bridge and should be recommended for structural evaluation.

Elements rated CS 4 will likely reduce the load capacity or serviceability of the bridge and structural evaluation should be required. Elements that are rated CS 4 and are primary load-carrying members often will lead to a load posting on the bridge unless repaired or replaced.

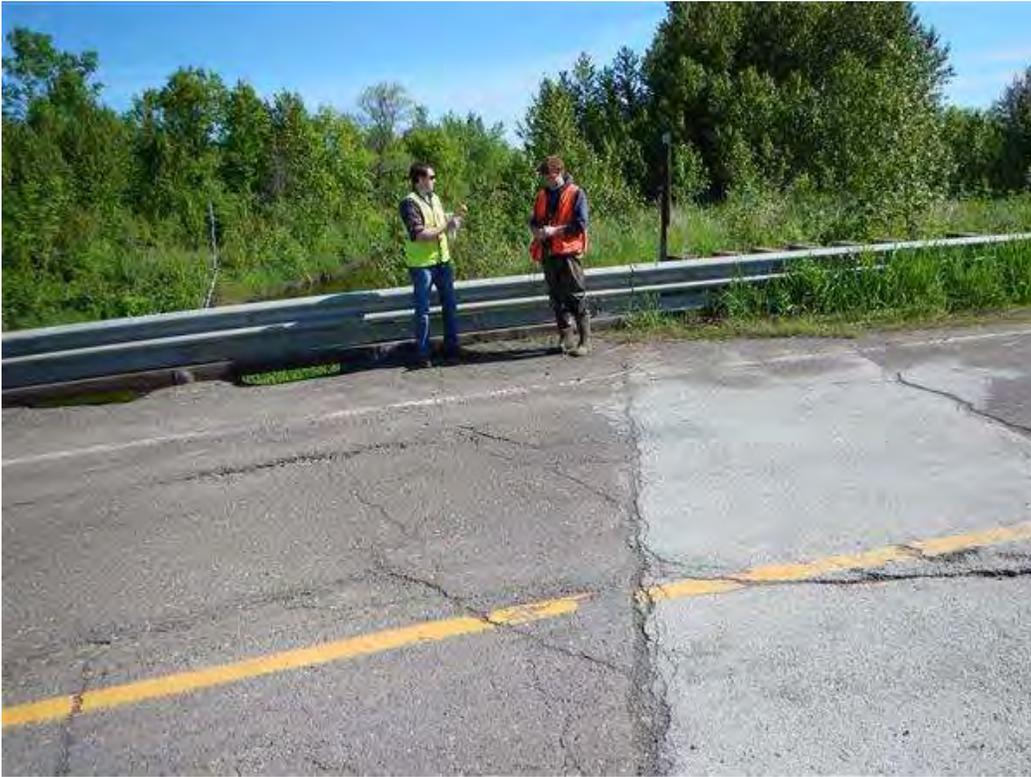
Notes: [2013] Significant deterioration evidenced as cracking and potholing in bituminous wear layer in transverse direction at both bridge abutments and at the piers. There are also longitudinal cracking present, most likely at joints for deck panels. Water infiltration is occurring at these locations, as evidenced by visual staining of the underside and water dripping through the deck. Hammer sounding and pick inspection did not identify any decay present. One area that sounded affected was drilled with Resistance drill. No decay noted using drill in these locations. Water infiltration through deck is also causing high moisture and cracking in pier 1 and pier 2 caps. This moisture is then leading to severe corrosion of CIP plates.

Photo 3 - Bituminous east end before abutment

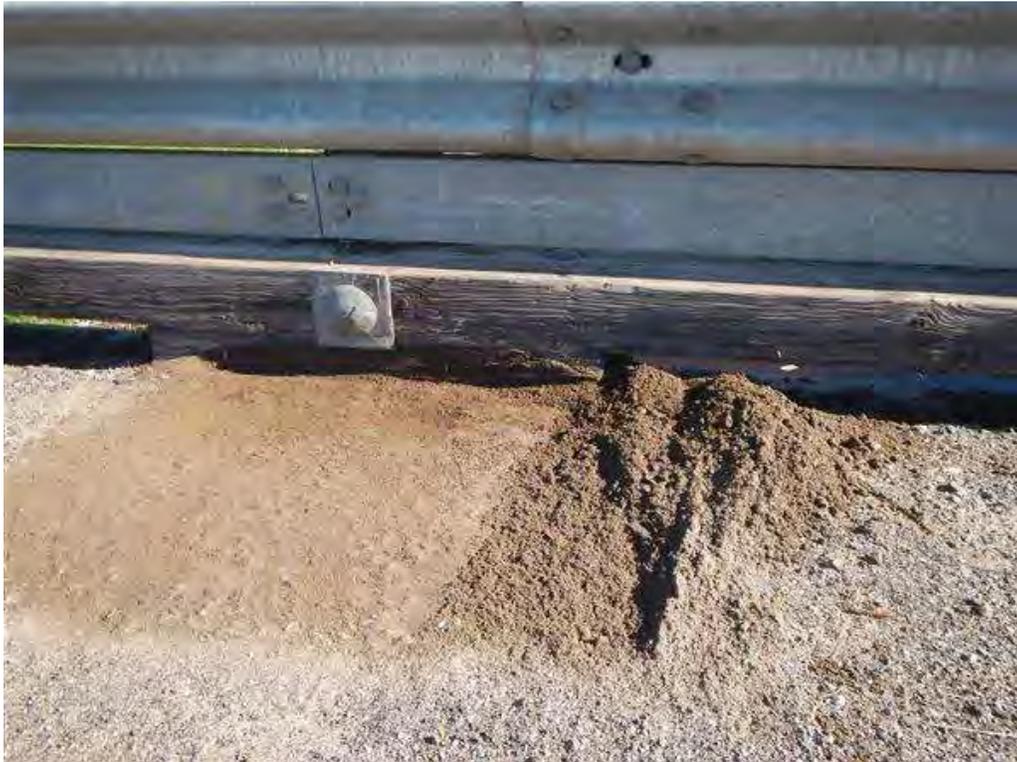
Photo 4 - N. deck-scupper 3" sand on deck

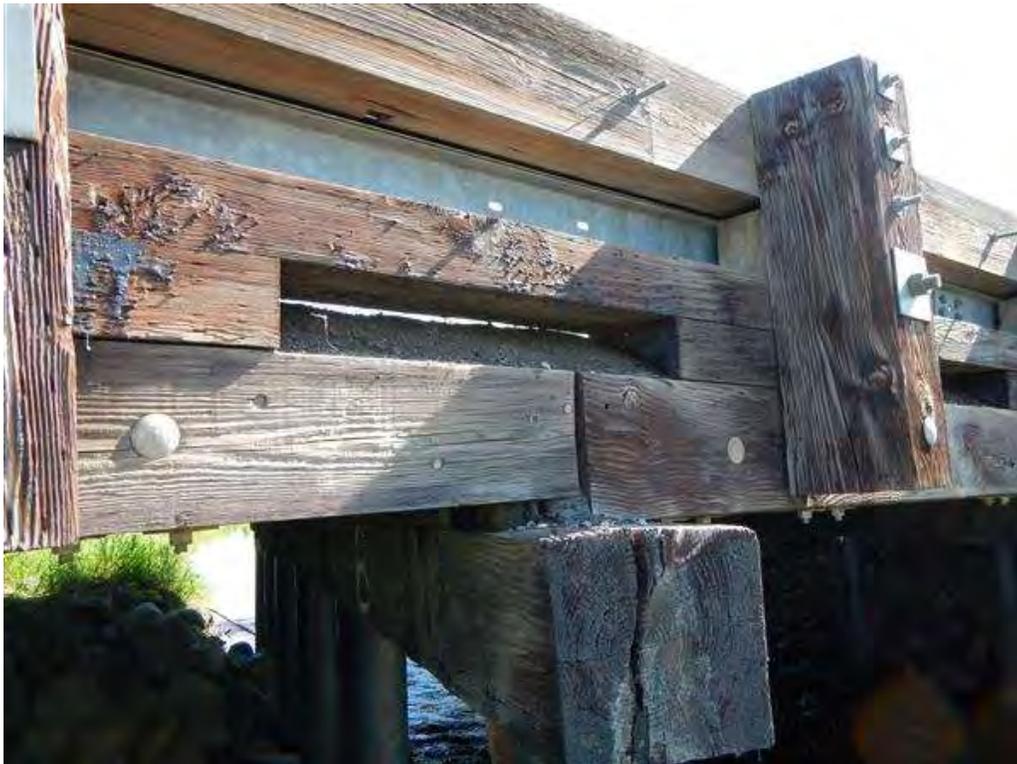
Notes: [2013] Timber pier cap showed significant visual vertical cracking caused by water infiltration at cap ends and excess weathering. Fakopp SWT were >500 microseconds for pier 1 along almost complete length. See attached sketch file. Resistance drilling completed (files 3-6) showed no evidence of decay but the presence of vertical crack causing high SWT. Significant moisture problems in pier 1 showed MC >25%. Visual water dripping through deck and into the exposed end from the deck. Pier 2 showed normal SWT (180-250 microseconds/ft transverse). Some evidence of vertical through crack on south end pier 2.

Photo 10 - Pier 2 North end - Through split extending 14" into cap.

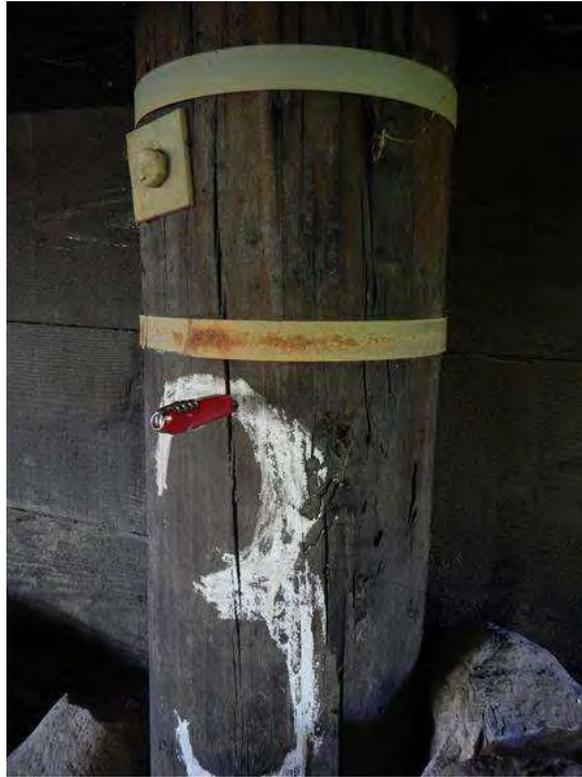
Photo 11 - W. Abut. Pile 3

Notes: [2013] For abutments, Fakopp SWT was used to collect times at 6" above ground line and 6" below pile cap. See attached sketch and file for results. Pile number 11 had SWT of 450 microseconds (12" dia.). A resist drill test was completed (drill #7) showed no deterioration. All other piling times were in normal range of 180-250 microseconds/ft of transverse time.
2012-No deterioration noted.

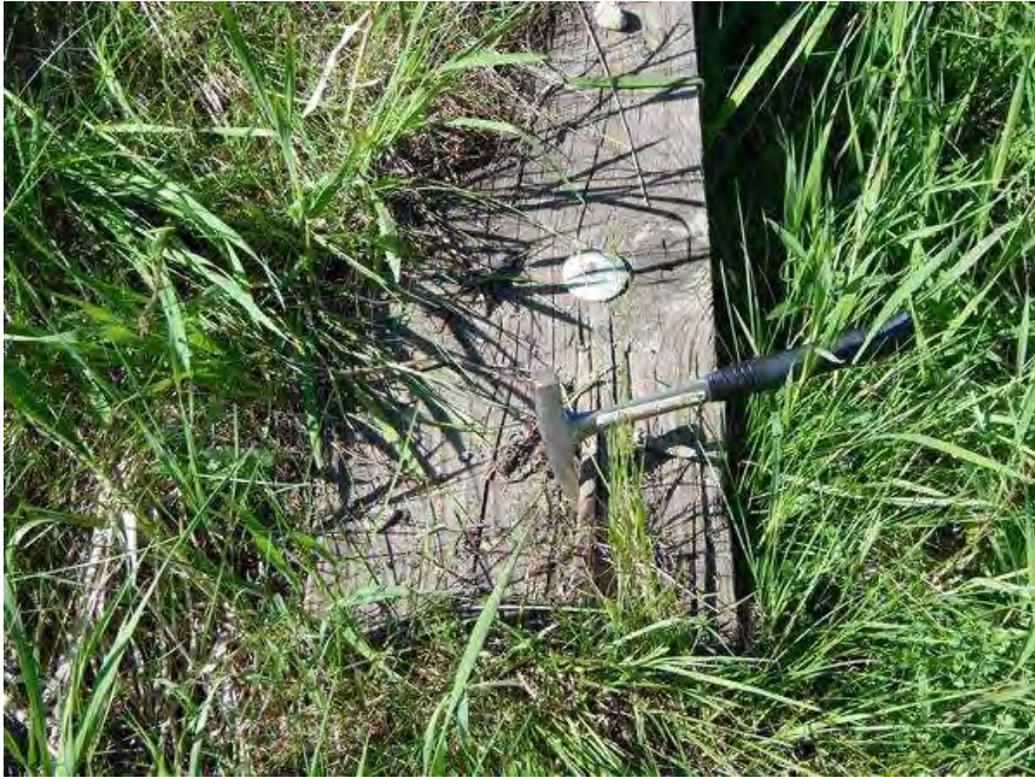
Photo 15 - Wing wall - NE

Notes: [2013] NW cap showed severe decay in pile. NE cap 50% decayed as it was almost fully covered by vegetation. SW Wing pile showed decay.

NE WING CAP DAMAGED.
SE WING CAP BURIED.
SW WING PILE ROTTED.
2012-Covered with brush.

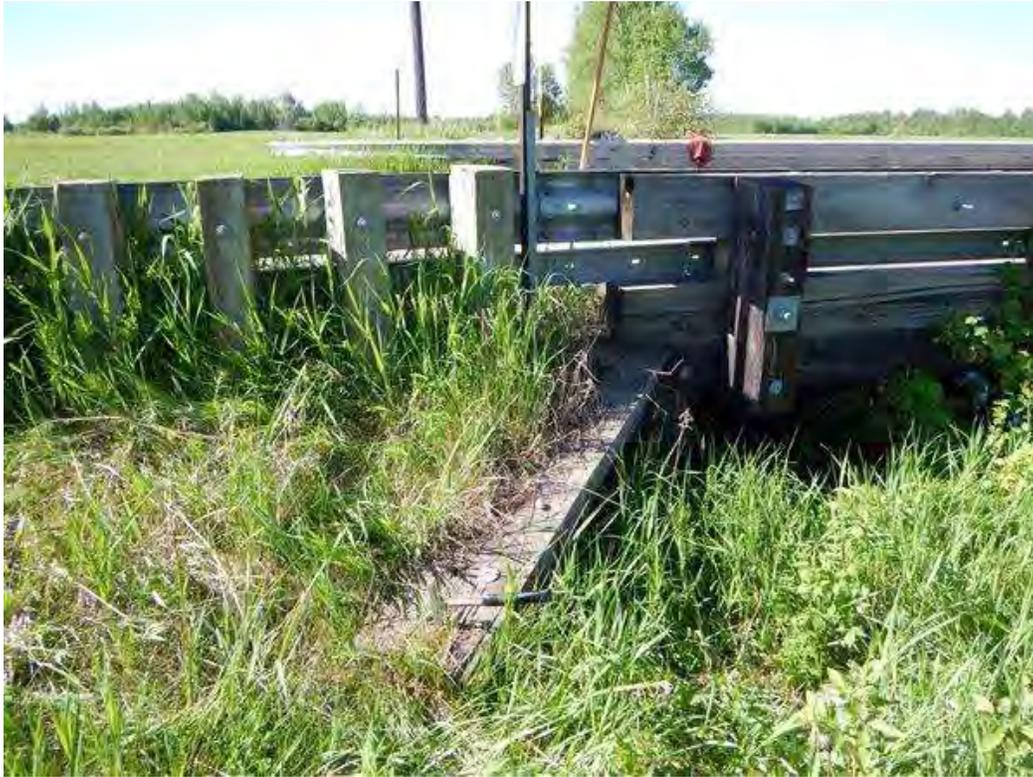
Photo 17 - Wing wall with significant vegetation

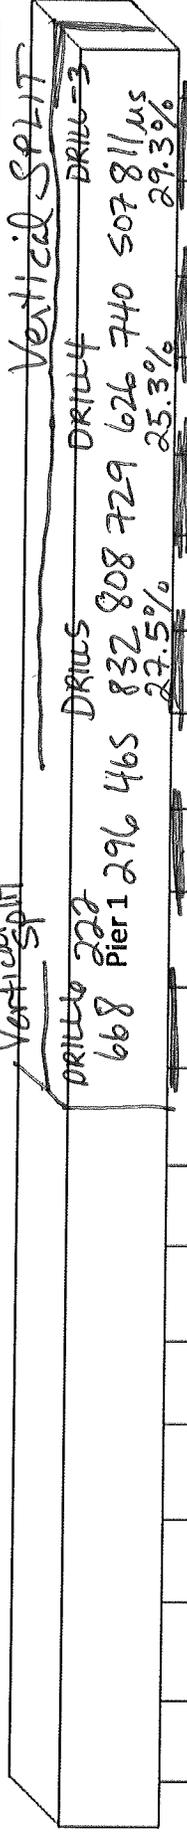
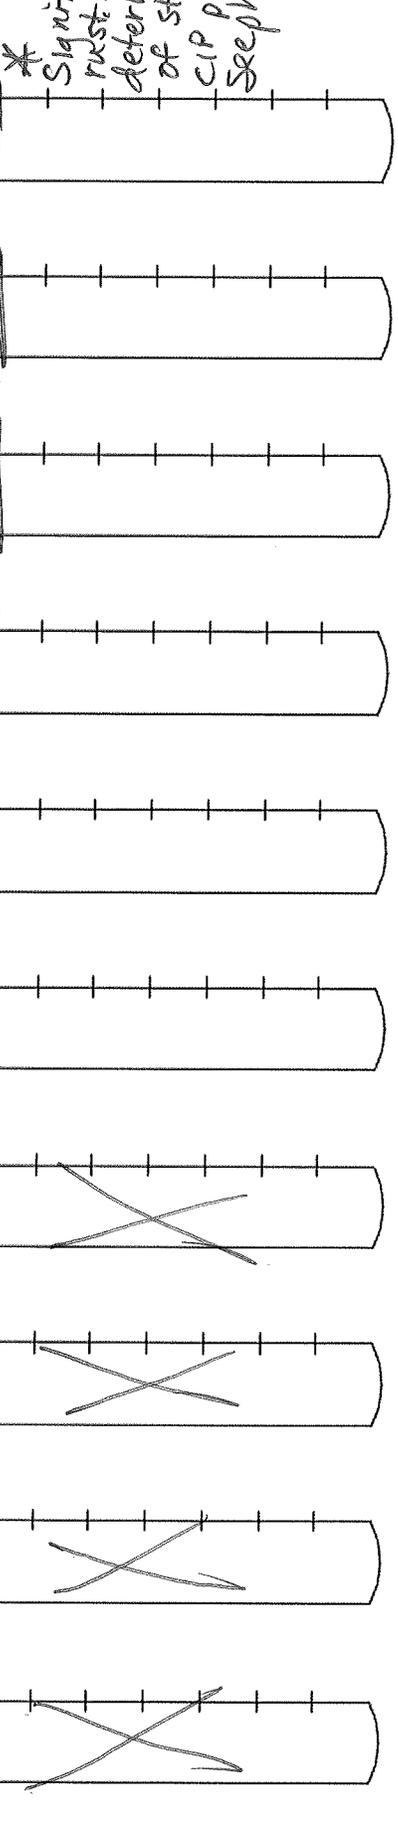
Vertical Split

* Significant rust and deterioration of steel CIP plate. See photos.

Notes: All pilings CIP. Through splits are present on both the upstream and downstream pier cap. Moisture measures are above 25% MC. Moisture is entering splits from ends and through deteriorated bituminous wear layer. Resistance drill data confirms split, but does not indicate decay.

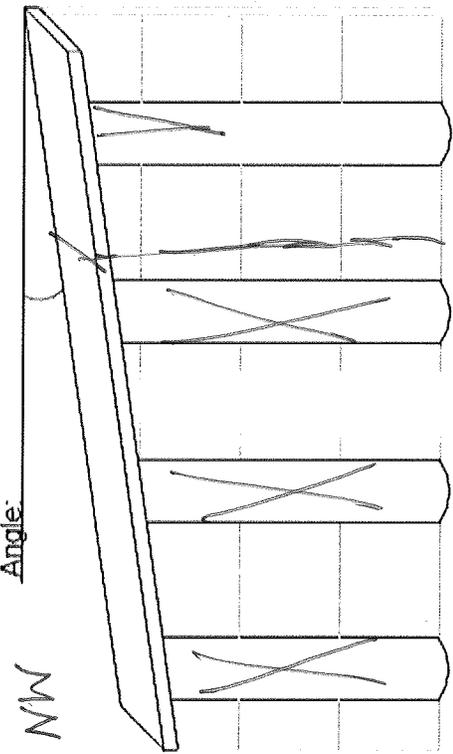
Notes: *Slight visual deterioration in piling.*

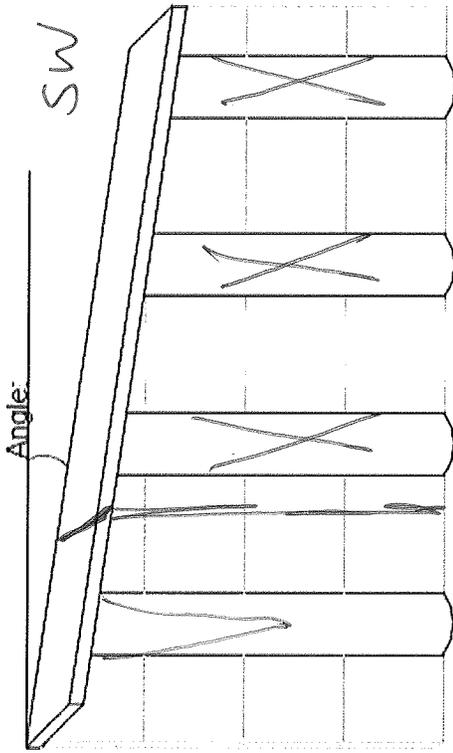
Notes: *Severe decay in piling. Visual.*

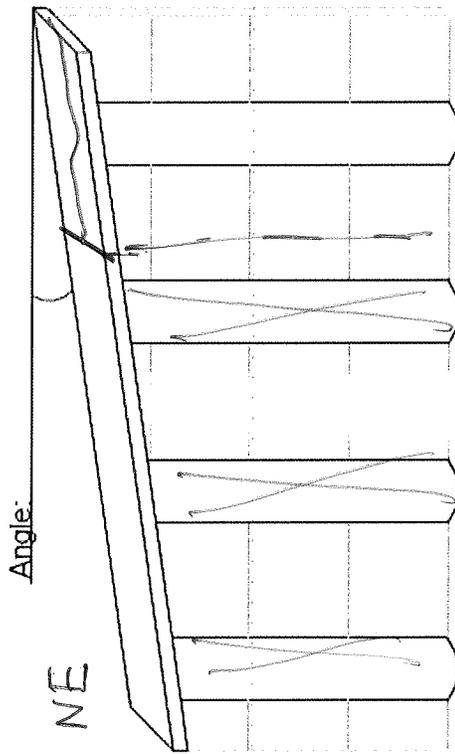
Notes: *50% of cap is decayed due to significant plant growth noted through hammer soundings & probe pick.*

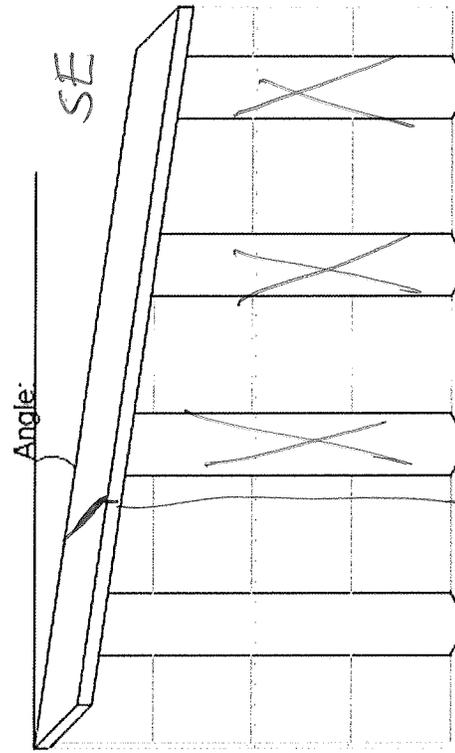
Notes: *Cap fully covered by deterioration potential future decay.*
