# Mn/DOT STRUCTURE INVENTORY SHEET

Bridge ID: 2440

TH 65 (3RD AVE S) OVER MISS R, BN RR&amp; CITY STS

STRUCTURE NO. 2440  
MINNESOTA STATE HIGHWAY NO. 65  
OVER  
THE MISSISSIPPI RIVER  
DISTRICT 5 - HENNEPIN COUNTY

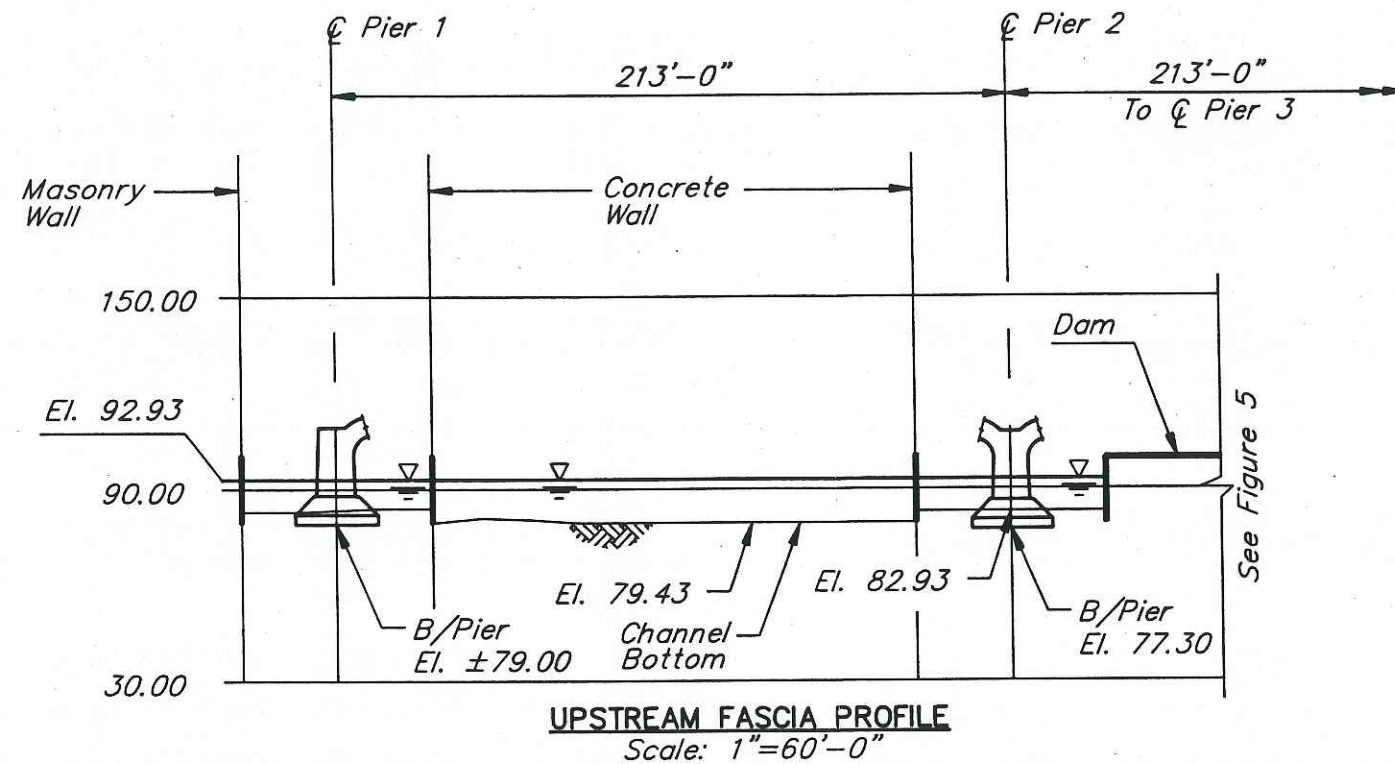
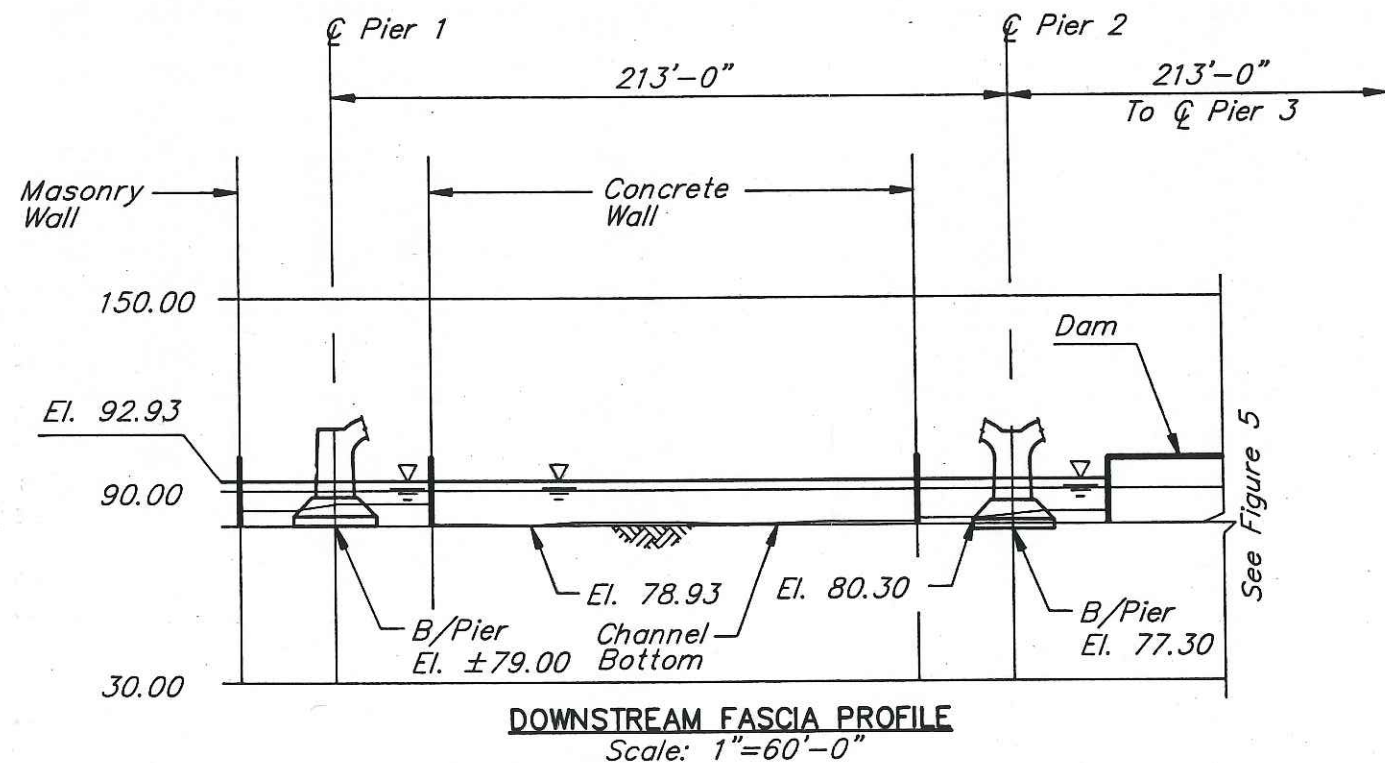
| | DATE: OCTOBER, 1991 | FIGURE 3 |

3. All of the pier shafts were lightly to moderately scaled with exposed aggregate from the waterline to the top of the footing bell (El. -2.5'). The typical penetration of this scaling was between 1/2" and 1". Areas of heavier scaling and/or spalling are identified in the inspection notes.

Note: Design plans indicate footing bells cast on rock channel bottom.

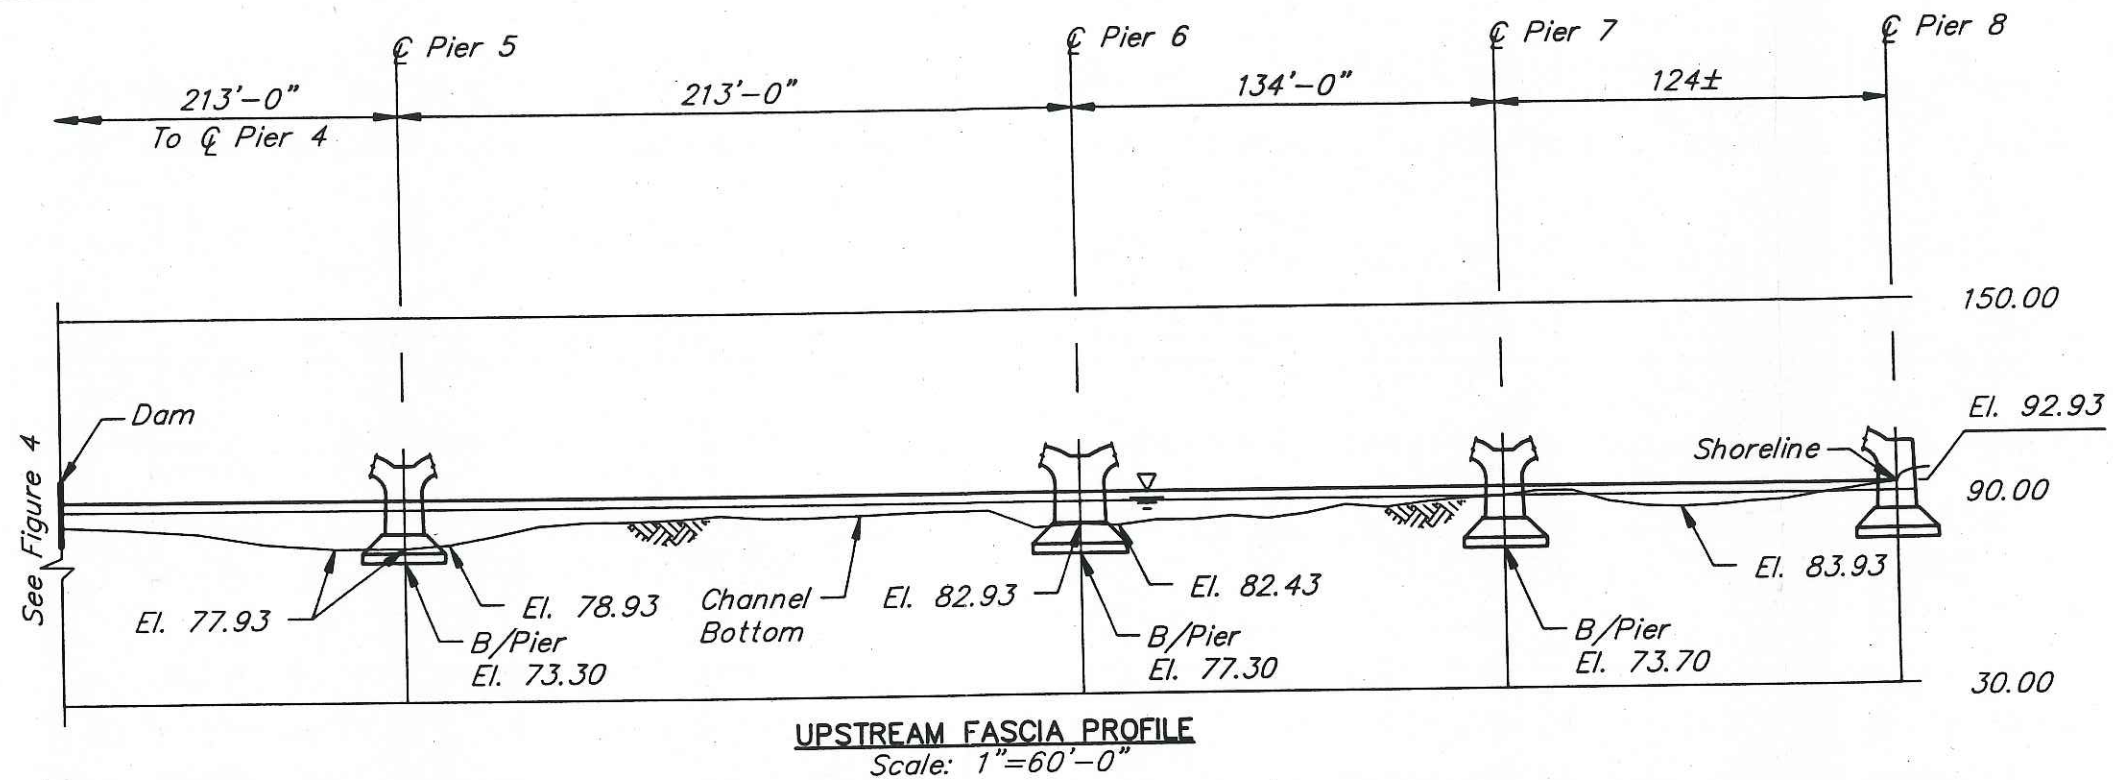
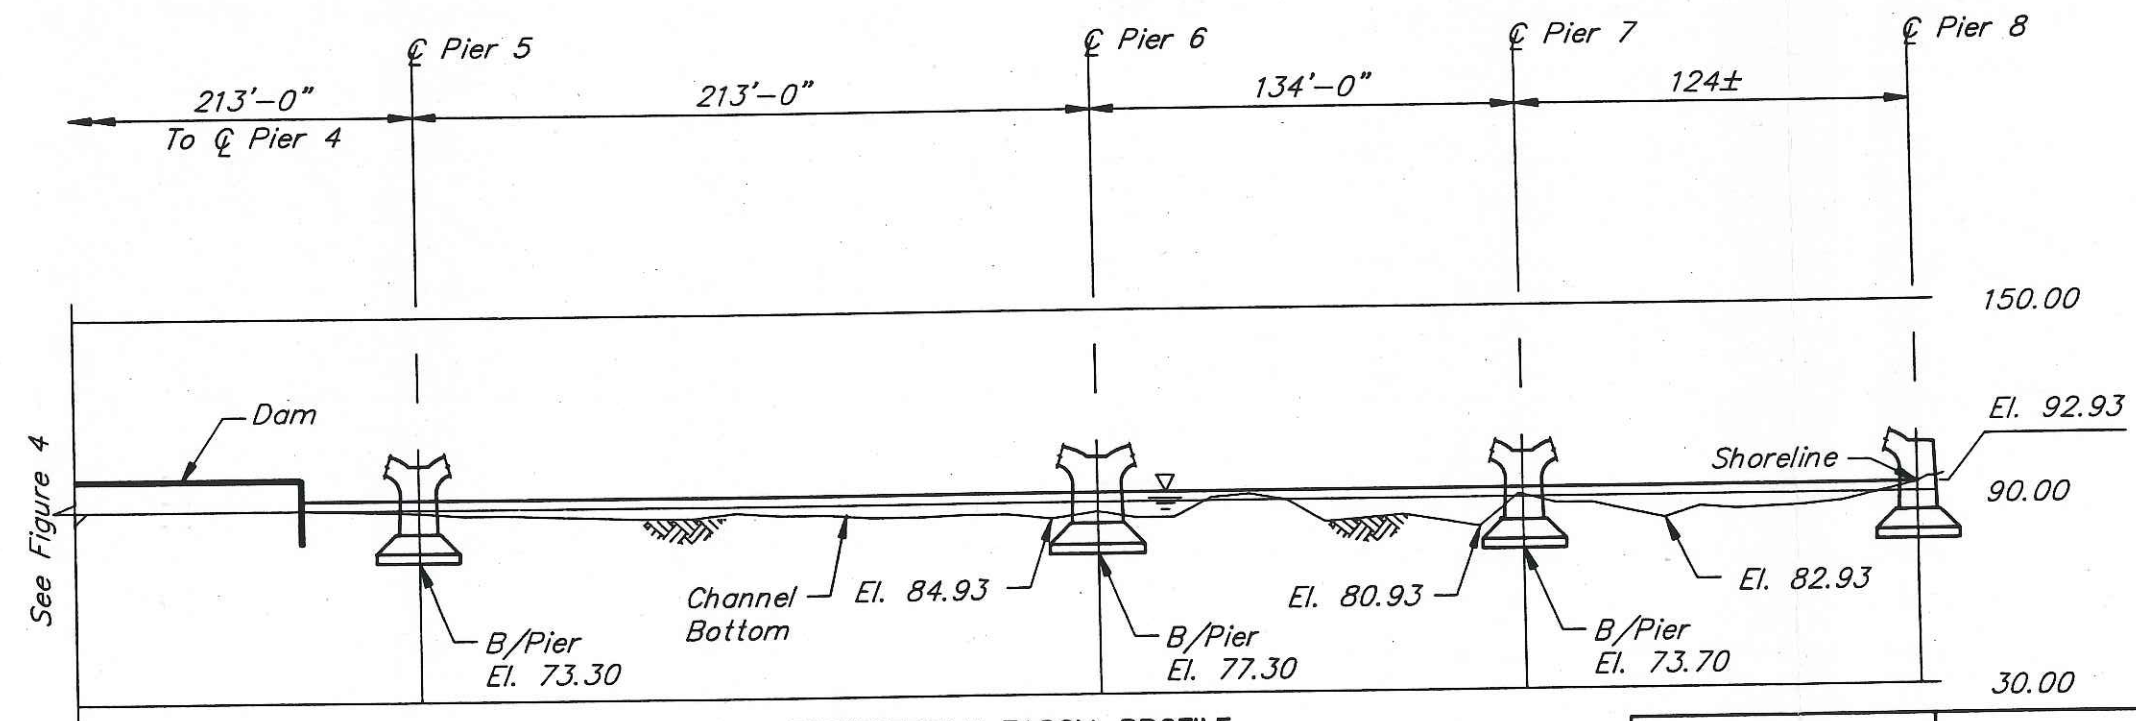
| DATE: OCTOBER, 1991 | | FIGURE 4 |

Note: Design plans indicate footing bells cast on rock channel bottom.

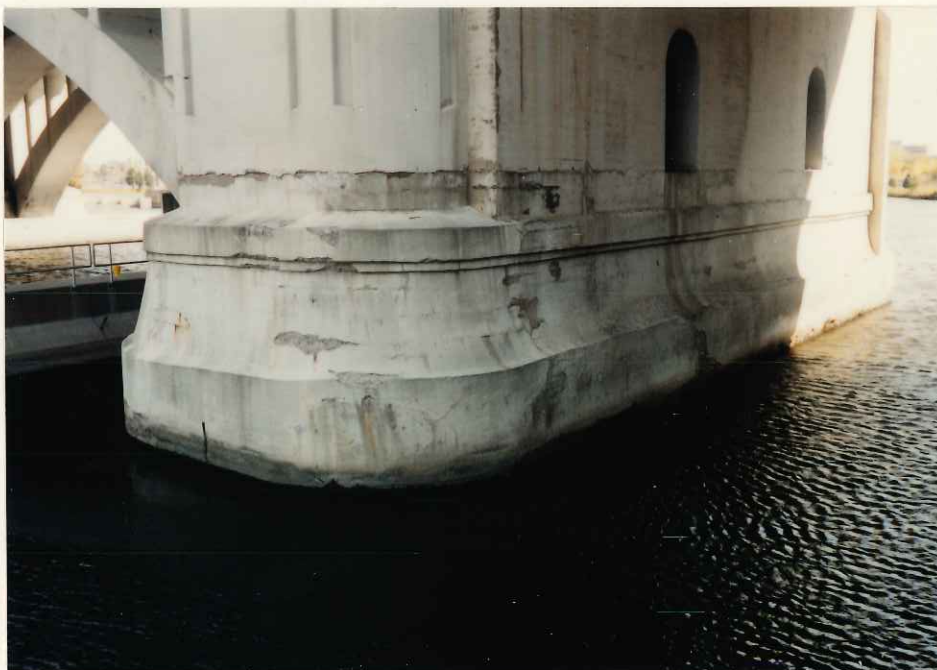
Photograph 1. Bridge No. 2440, 10/11/91.  
View of Pier 1 Looking Northeast.

\* Extent of undermining at Piers 1 and 5 is presently insignificant compare to overall size of footing. Although footings are supposed to be resting on rock, a scour and foundation stability analysis should still be performed to determine if further undermining can occur.

- (A) Perform scour and foundation stability analysis for Piers 1 and 5.
- (B) Place concrete in the undermined areas at Piers 1 and 5 unless other countermeasures are dictated by analysis.
